# REPAIR, EVALUATION, MAINTENANCE, AND REHABILITATION RESEARCH PROGRAM

TECHNICAL REPORT REMR-EI-5

## THE EFFECTS OF VEGETATION ON THE STRUCTURAL INTEGRITY OF SANDY LEVEES

Final Report

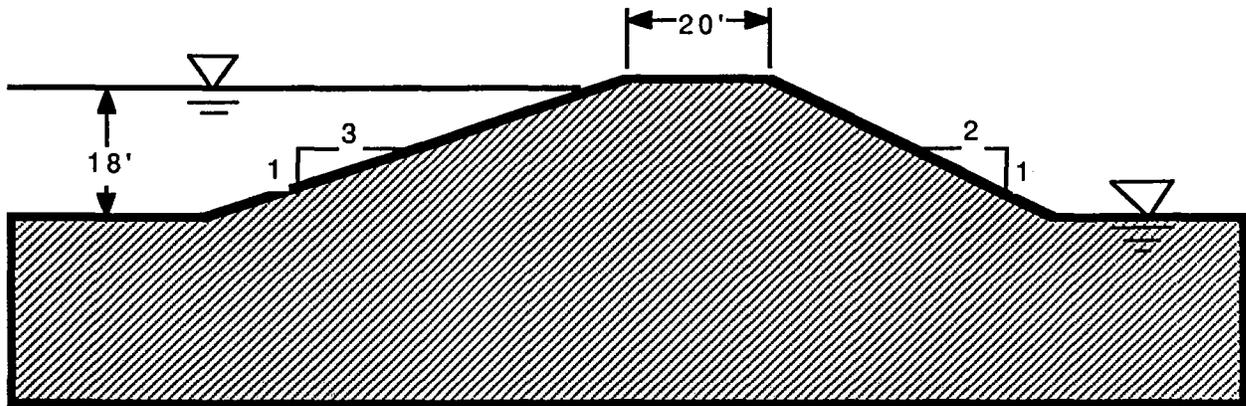
Figure 52. Standardized geometry adopted for seepage and stability analyses levee dimensions (height) are less important if the main purpose of the seepage analysis is to compare behavior with and without a modified surface layer or skin.

119. Standardized levee geometry. A standardized levee profile or geometry was adopted for the seepage analyses, as shown in Figure 52. The same side slopes and crest width specified in the standard levee sections shown in Figures 17 through 20 were retained for the seepage analyses. The embankment height was set at 20 ft. A 20-ft levee height with the use of 1-ft nodal spacings facilitated calculations in the seepage simulation. The actual

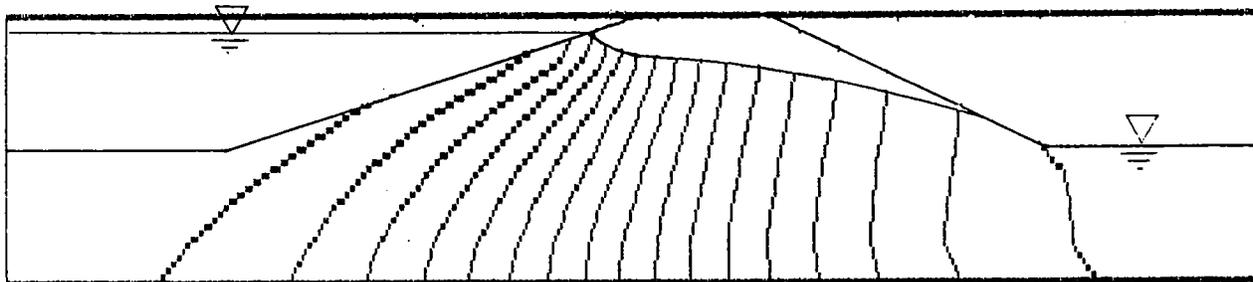
Figure 53. Equipotential lines and hydraulic head distribution for a homogeneous levee cross section

122. The spreadsheet output was converted to a data file that was used as the input to a contour or isopotential plotting program. The resulting equipotential map is shown in Figure 53 together with the location of the phreatic surface and the free water surface.

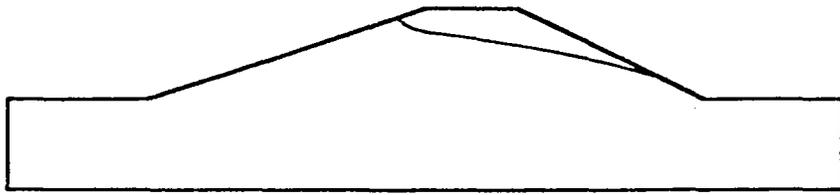
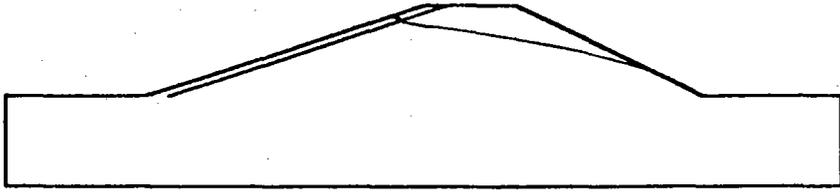
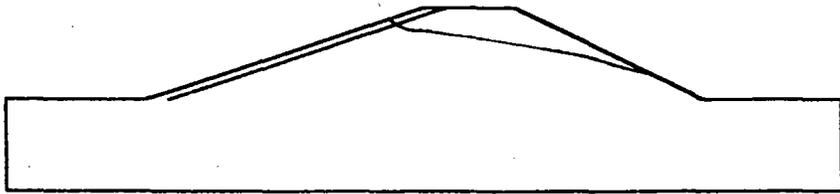
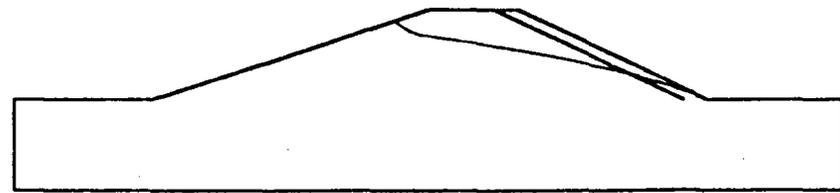
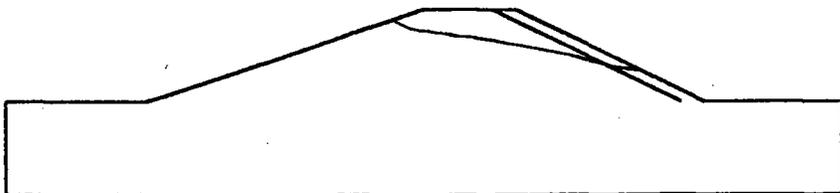
a) levee with constant permeability ,  $k_2$

b) levee with a 1-ft layer of permeability ,  $k_1$  and  $k_1 / k_2 = 10$

c) levee with a 1-ft layer of permeability ,  $k_1$  and  $k_1 / k_2 = 0.1$

d) levee with 1-ft layer of permeability ,  $k_1$  and  $k_1 / k_2 = 10$

e) levee with 1-ft layer of permeability ,  $k_1$  and  $k_1 / k_2 = 0.1$

Figure 54. Schematic illustration showing influence of a modified surface permeability on the line of seepage

124. The first task was to determine the influence of a surface layer or skin on the location of the phreatic surface as shown schematically in Figure 54. This was accomplished by following the transfer condition rules summarized earlier in Figure 51. The "skin" was assumed to be either more or less permeable than the core by a factor of 10. The subsequent influence on the location and orientation of the phreatic surface as a result of this permeability contrast is depicted schematically in Figure 55.

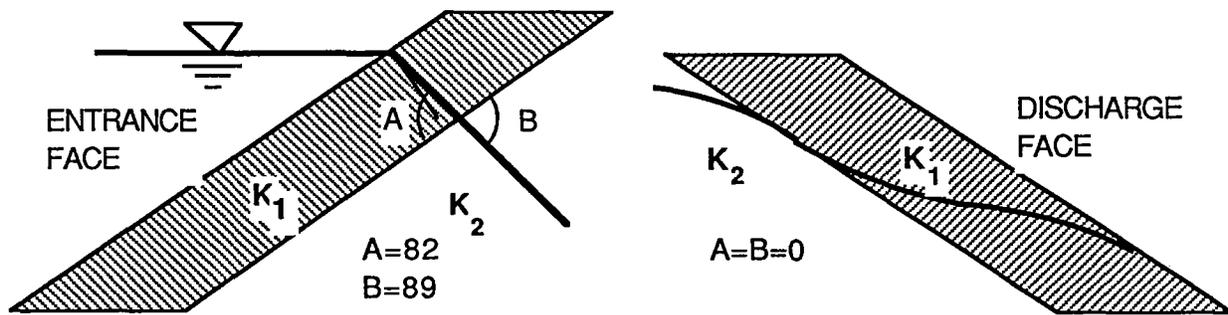
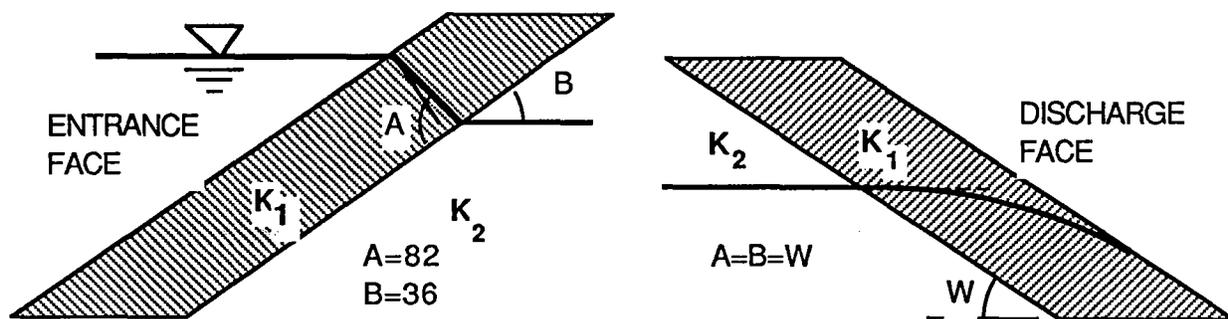
(A) MORE PERMEABLE "SKIN" ( $K_1 = 10 K_2$ )

(B) LESS PERMEABLE "SKIN" ( $K_1 = 0.1 K_2$ )

Figure 55. Influence of permeability contrast between facing or "skin" and core of levee on line of seepage

125. The location of the phreatic surface is not greatly influenced by a modified surface on the upstream slope. Nor are the consequences of the change very significant. This is not the case, however, on the downstream side. A less permeable layer elevates the phreatic surface and increases the area of discharge on the downstream face whereas a more permeable layer depresses the phreatic surface and lowers the emergence point relative to the homogeneous case. A detailed view showing the influence of a permeability contrast between a surface layer and core at the upstream and downstream faces, respectively, is presented in Figure 55.

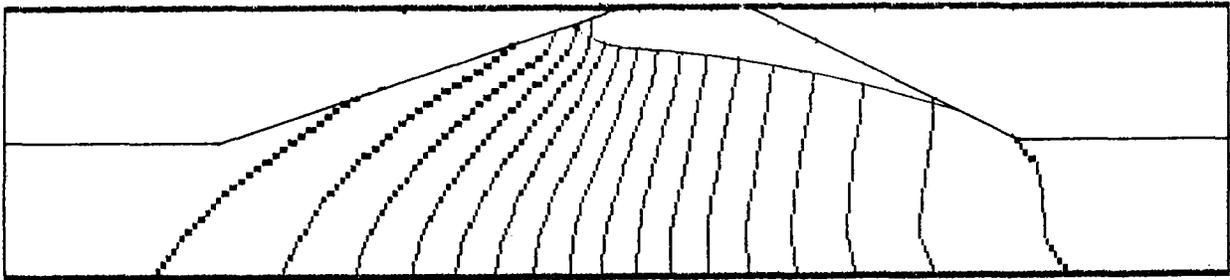
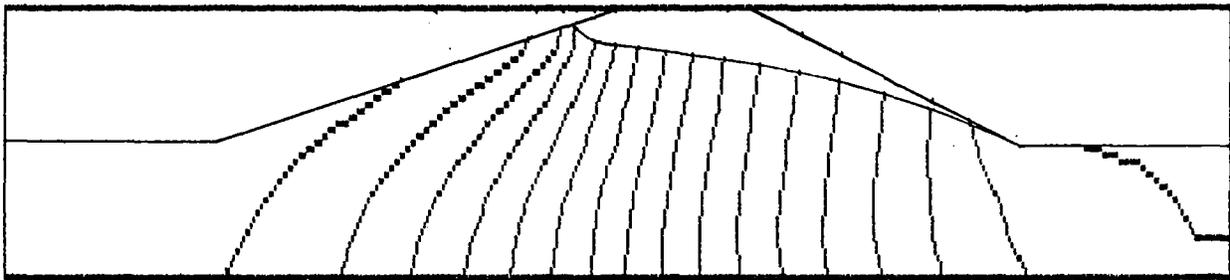
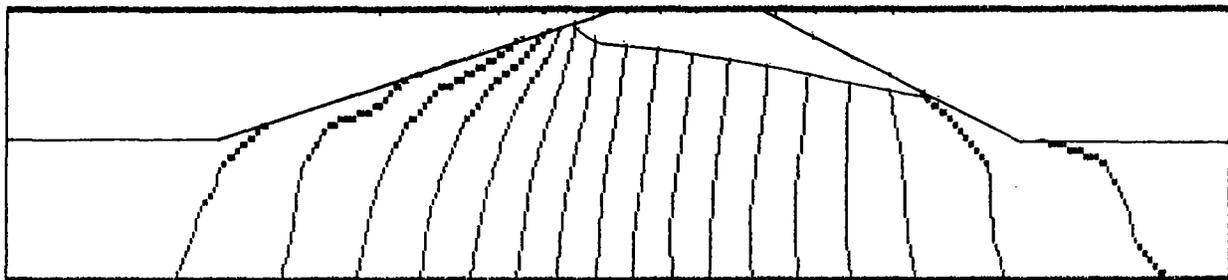
HOMOGENEOUS LEVEE

MORE PERMEABLE SKIN ( $K_1 = 10 \times K_2$ )

LESS PERMEABLE SKIN ( $K_1 = 0.1 \times K_2$ )

Figure 56. Equipotential lines and hydraulic head distribution for homogenous levee and levees with a surface layer having a different permeability on the landward face

126. The spreadsheet program EXCEL was again used to obtain the hydraulic head distribution for a levee with a modified surface layer or skin with a different permeability. The resulting equipotential lines and hydraulic head distribution for the two cases of "more" and "less" permeable skin, respectively, are plotted and compared with the results for the homogeneous case in

Figure 56. The following tentative conclusions can be drawn from the results of the comparison shown in Figure 56:

- a. A less permeable skin elevates the phreatic surface and increases the discharge area or seepage zone on the downstream face.
- b. A less permeable skin results in considerably higher exit gradients (closely spaced equipotential lines) at the discharge face near the toe.

127. Some distortion of the equipotential lines resulted from the relative coarseness of the grid or nodal spacing used in the spreadsheet analysis. A nodal spacing of 1 ft was used in the present study. The fidelity of the equipotential lines and hydraulic head distribution could be improved by using

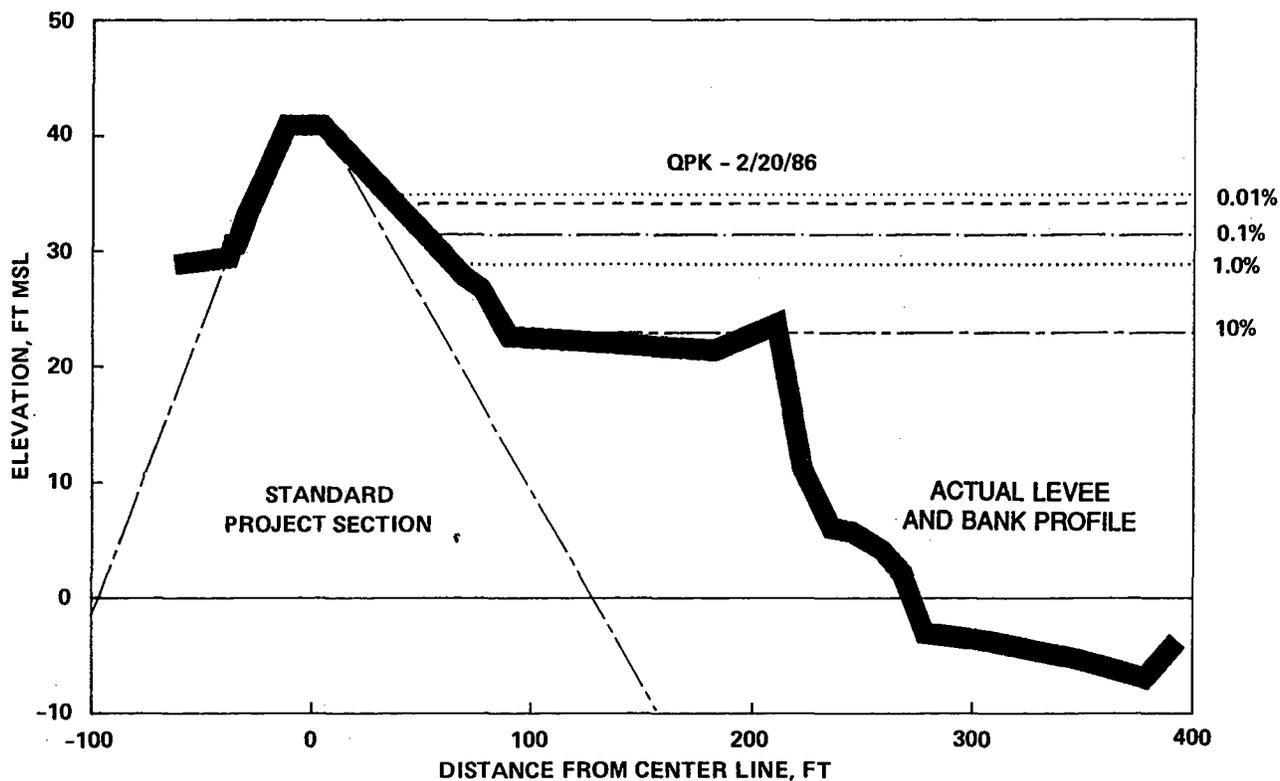
Figure 57. Typical flood-duration record for a levee site, Sacramento River channel levee (percentages represent the amount of time during the 1986 winter period during which these stages were equalled or exceeded, based on daily discharge values and supplemented by hourly values for the 1986 flood above 0.1 percent)

129. Flood stage duration records for the reach of levee in question along the Sacramento River indicate that (a) the peak flood levels have not risen more than 6-7 ft above the base of the levee, and (b) the duration of the near peak levels is not more than a few hours. A typical flood stage duration record is shown in Figure 57.

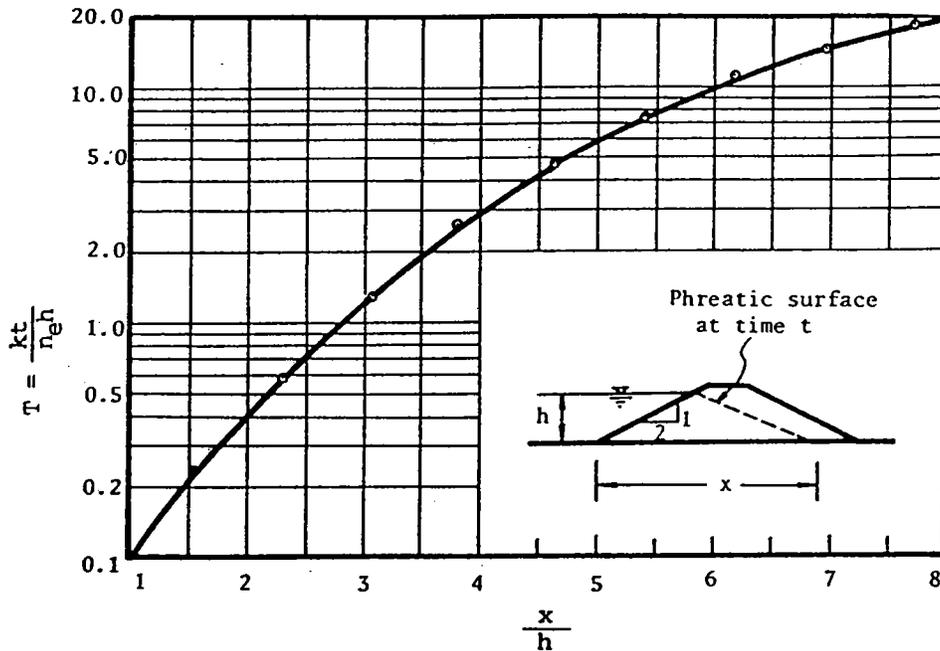
Figure 58. Plot of dimensionless time (T) versus dimensionless distance (x/h) for determining location of transient phreatic surface (from Huang 1986)

130. Huang (1986) has presented a simple method for locating the unsteady state or transient phreatic surfaces in an earth dam or levee. The phreatic surface progresses over time from the upstream to downstream face, with the upper end fixed at the pool (free water) elevation and the lower end moving along the base of the levee. Huang derived an equation to predict the distance (x) from the heel of the levee as a function of time (t). A plot of dimensionless distance (x/h) versus dimensionless time (T) is shown in Figure 58. The dimensionless time T is defined as follows:

131. At any given time,  $t$ , the distance  $x$  can be determined from Figure 58 and the phreatic surface located. The relationship in Figure 58 is, strictly speaking, only valid for cases involving an upstream slope of 2:1 and an impervious horizontal base. Flatter slopes can be handled using a procedure described by Huang, and the presence of a permeable foundation beneath the levee leads to conservative estimates.

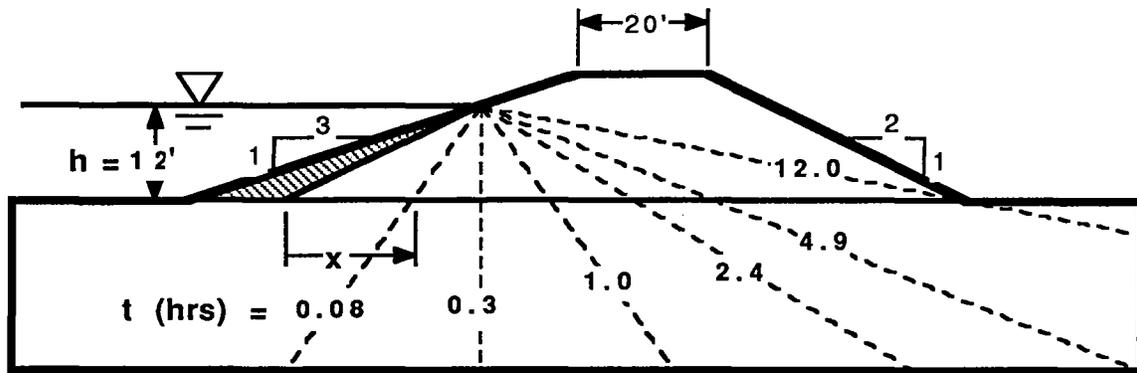
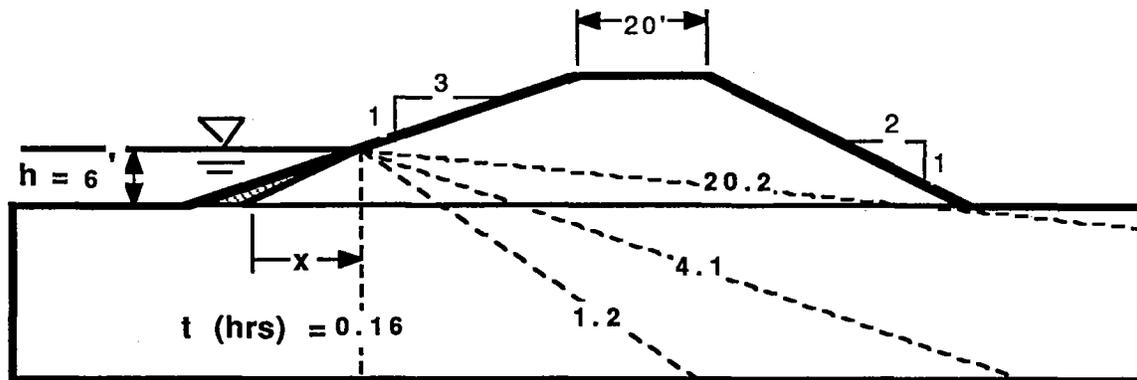
(A) HIGH FLOOD STAGE - 12 FT ABOVE BASE OF LEVEE

(A) LOW FLOOD STAGE - 6 FT ABOVE BASE OF LEVEE

Figure 59. Development of transient phreatic surfaces with time in a sandy levee for two different flood stage elevations (assumed permeability = 0.05 cm/sec)

132. Huang's method was used to plot the location of the transient phreatic surfaces for both a "low" (6-ft) and "high" (12-ft) flood stage. The results are shown in Figure 59. The time required for the phreatic surface to reach the toe of the levee under a low and high flood, respectively, are approximately 20 and 12 hr. Accordingly, not only are actual, maximum FWLs less than those assumed in the analyses described herein, they are also of

insufficient duration to develop an equilibrium phreatic surface under normal conditions, i.e., a levee having a relatively homogeneous cross section consisting of a uniform, medium sand with a hydraulic conductivity of 0.05 cm/sec measured at an average dry density of 90 pcf. The same conclusion would not hold for other conditions such as a vastly different average hydraulic conductivity or the demonstrable presence of gross hydraulic nonhomogeneities, e.g., a greatly modified surface layer (e.g.,  $K_1 \gg K_2$ ) or conduits/pipes which penetrate through the levee. Little or no evidence was observed in the present field study to indicate that vegetation growing on the levee led to either of the latter conditions.

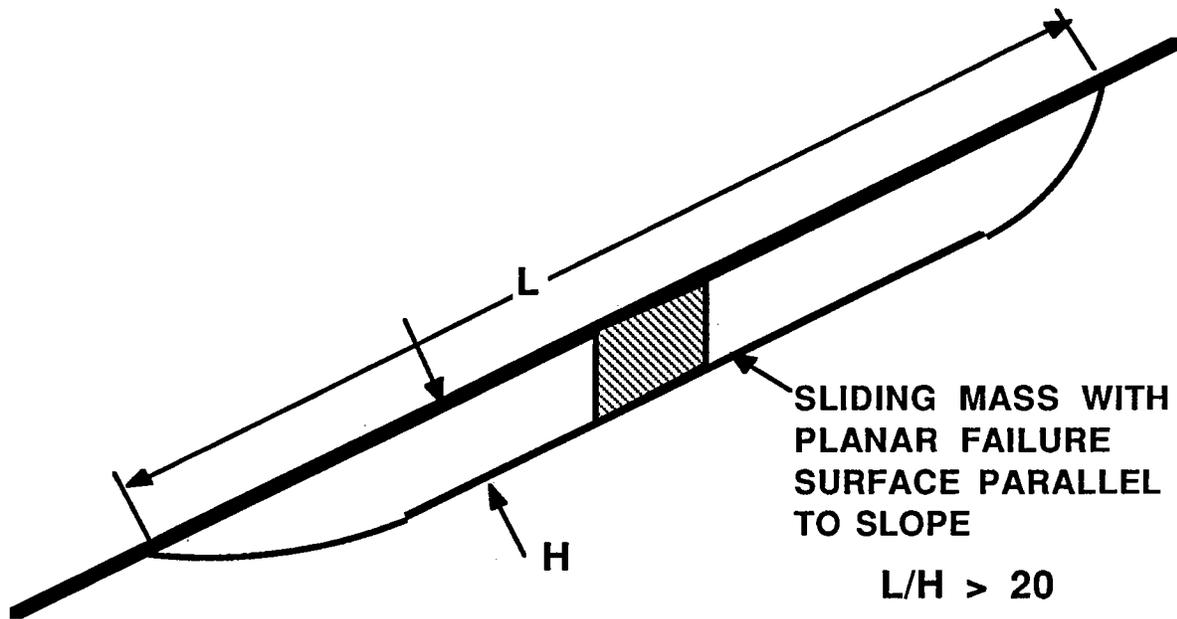
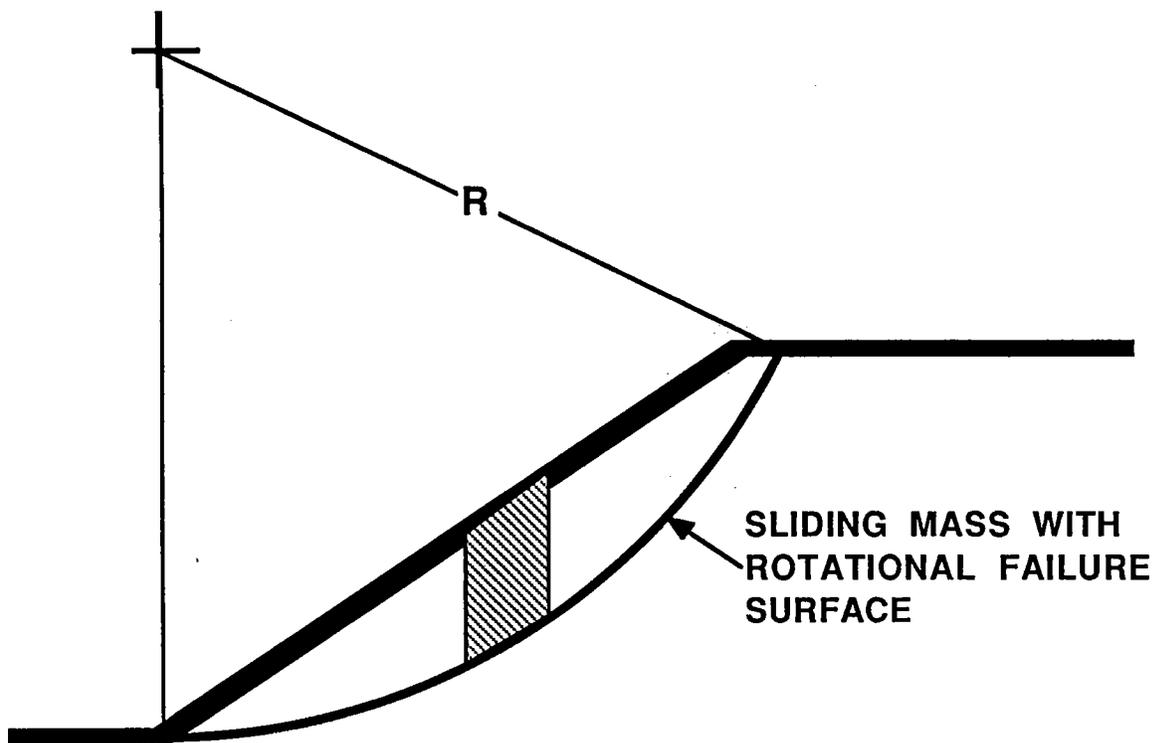
**(A) INFINITE SLOPE MODEL**

**(B) CIRCULAR ARC FAILURE MODEL**

Figure 60. Slope failure models for mass stability analysis  
((a) = infinite slope model; (b) = circular arc model)

137. Both types of failure models, infinite slope and circular arc, are depicted schematically in Figure 60. In the case of a levee embankment or dam, both the upstream and downstream slopes are vulnerable to a mass stability failure. The upstream slope can fail as a result of rapid drawdown, e.g., a rapidly subsiding flood crest, and the downstream slope as a result of steady seepage (either parallel to or emerging from the face of the levee).

model is no longer valid. This analysis assumes that the length of the sliding mass is large relative to its thickness ( $L > 20 H$ ) as shown in Figure 60. For a 15-ft-high sandy levee, this criteria translates to a thickness of 1.7 and 2.4 (or vertical depth to the sliding plane of 1.9 and 2.5) for 2:1 and 3:1 slopes, respectively. At sufficiently large depths ( $H > 4$  ft) the root concentrations and reinforcement will decrease to zero. At these depths the sliding mass will not have the dimensions or aspect ratio required by the infinite slope model. When this condition is no longer observed, then another type of analysis, either a circular arc or log spiral failure analysis, should be used as well.

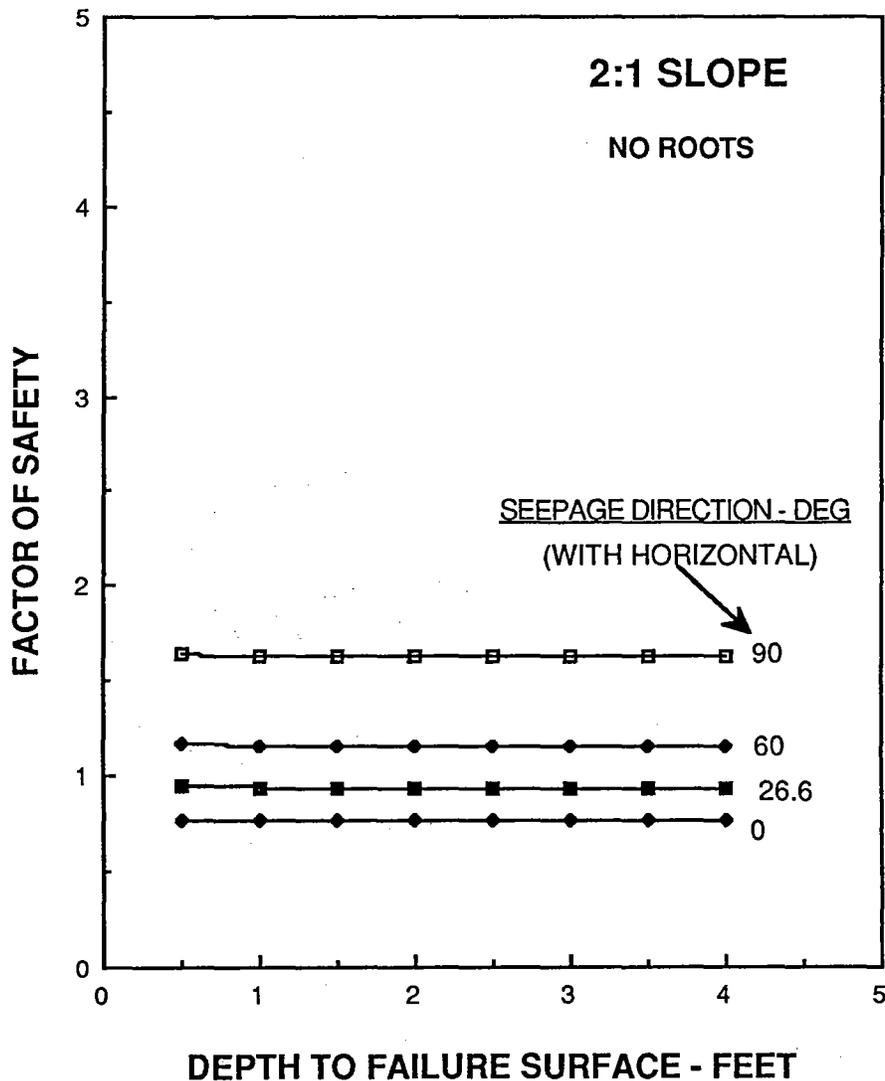
Figure 61. Infinite slope analysis of saturated (2:1) downstream slope of levee without roots (friction angle = 36°)

145. Results from the spreadsheet analyses are presented graphically in Figures 61 through 64 for the case of soil friction angle equal to  $36^\circ$ . Factor of safety is plotted as a function of depth and seepage direction for the case of no root cohesion ( $c_R = 0$ ) for the 2:1 and 3:1 slope, respectively, in Figures 61 and 62. The factor of safety drops below one when the seepage either parallels or emerges from the slope face for the 2:1 slope. The corresponding factor of safety for the case of low root concentrations is plotted in Figures 63 and 64. The factor of safety exceeds unity for all depths and seepage directions in this case (except for low seepage angle directions in the 2:1 slope).

146. The results show that both the seepage direction ( $\theta$ ) and presence of root cohesion ( $c_R$ ) have a significant effect on the factor of safety. Even a small amount of root cohesion can increase the factor of safety substantially. This influence is very pronounced at shallow depths where root concentrations are highest and reinforcement effects, therefore, greatest. In this regard grass roots appear to be just as effective as tree and shrub (woody) roots because of their high concentration at shallow depths. The RARs measured at the control site, for example, exceeded all other sites at depths under 6 in. (see Figures 35 and 36) because of the abundance of grasses and herbaceous ground cover at this location. In the presence of root cohesion, even for low root concentrations, the factor of safety exceeds unity at all depths up to 2.0 ft even for worst case scenario conditions of low friction angle ( $\phi = 28^\circ$ ) and seepage emerging from the slope ( $\theta = 0^\circ$ ).

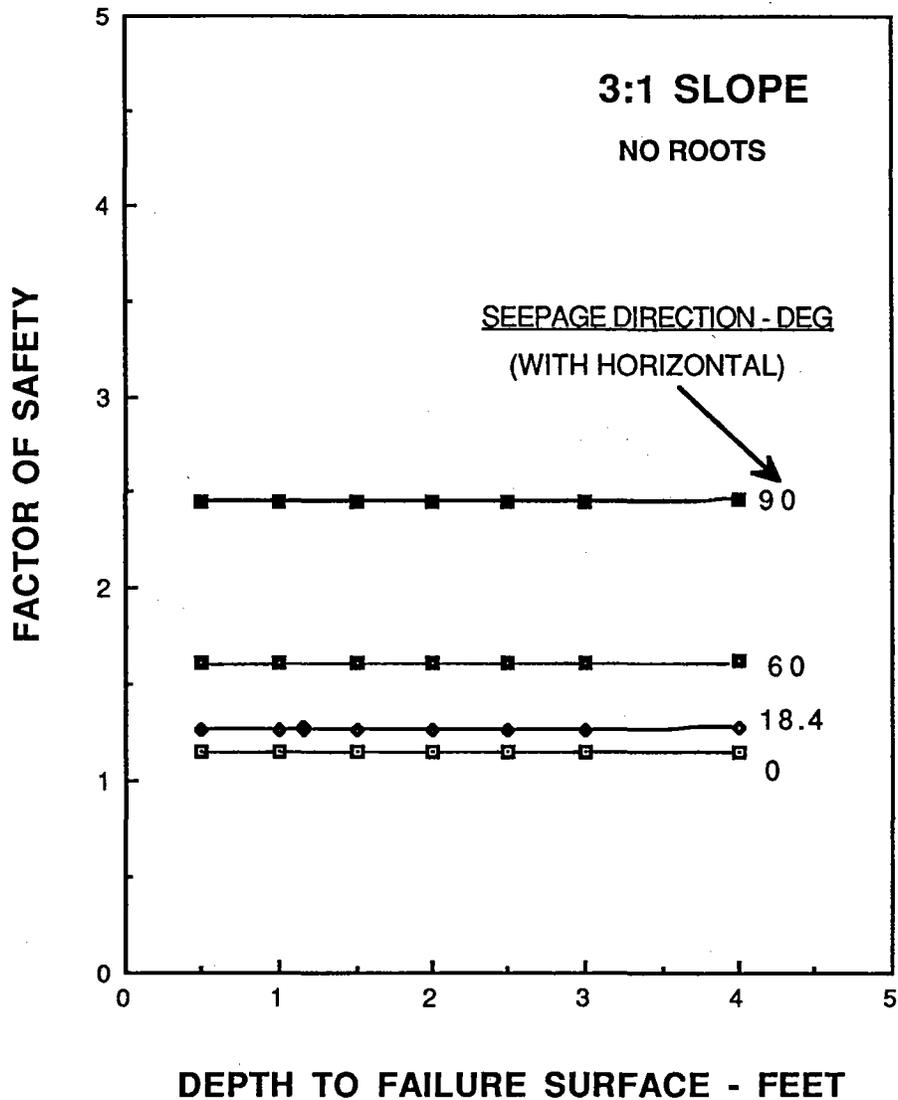
Figure 62. Infinite slope analysis of saturated (3:1) downstream slope of levee without roots (friction angle =  $36^\circ$ )

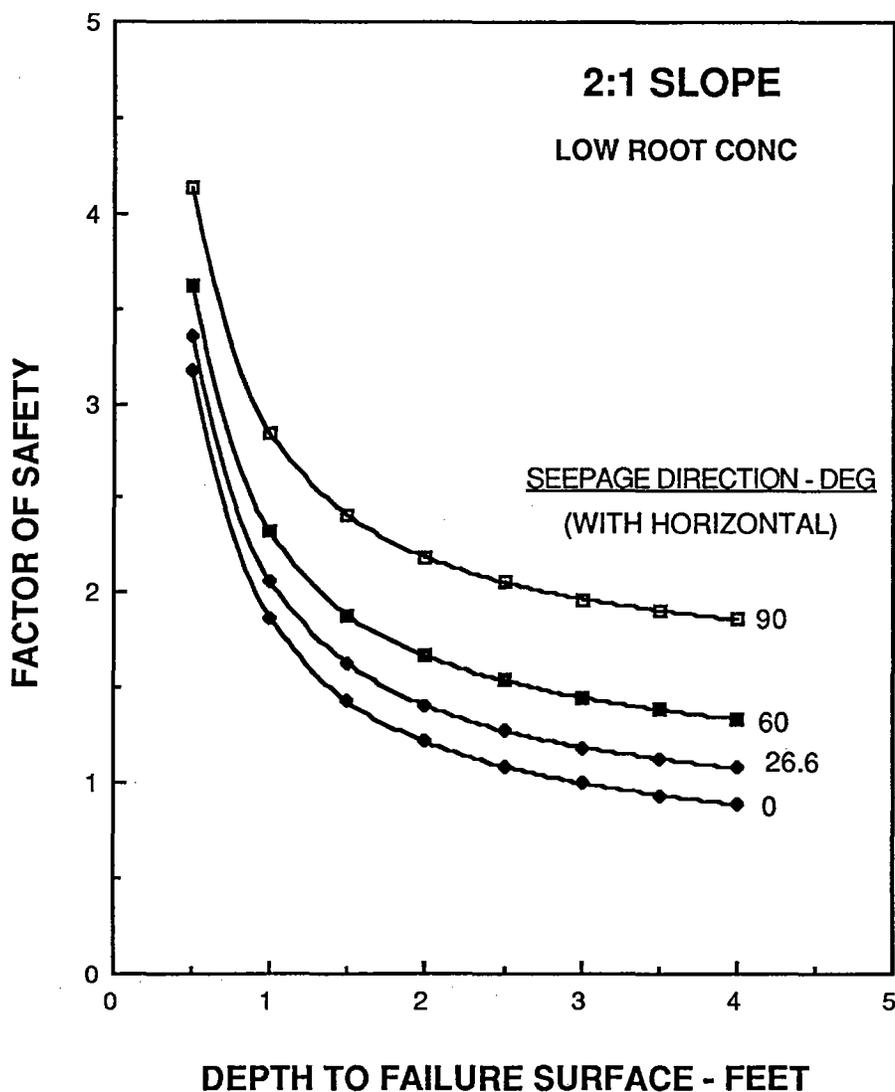
Figure 63. Infinite slope analysis of saturated (2:1) downstream slope of levee with roots (friction angle =  $36^\circ$ )

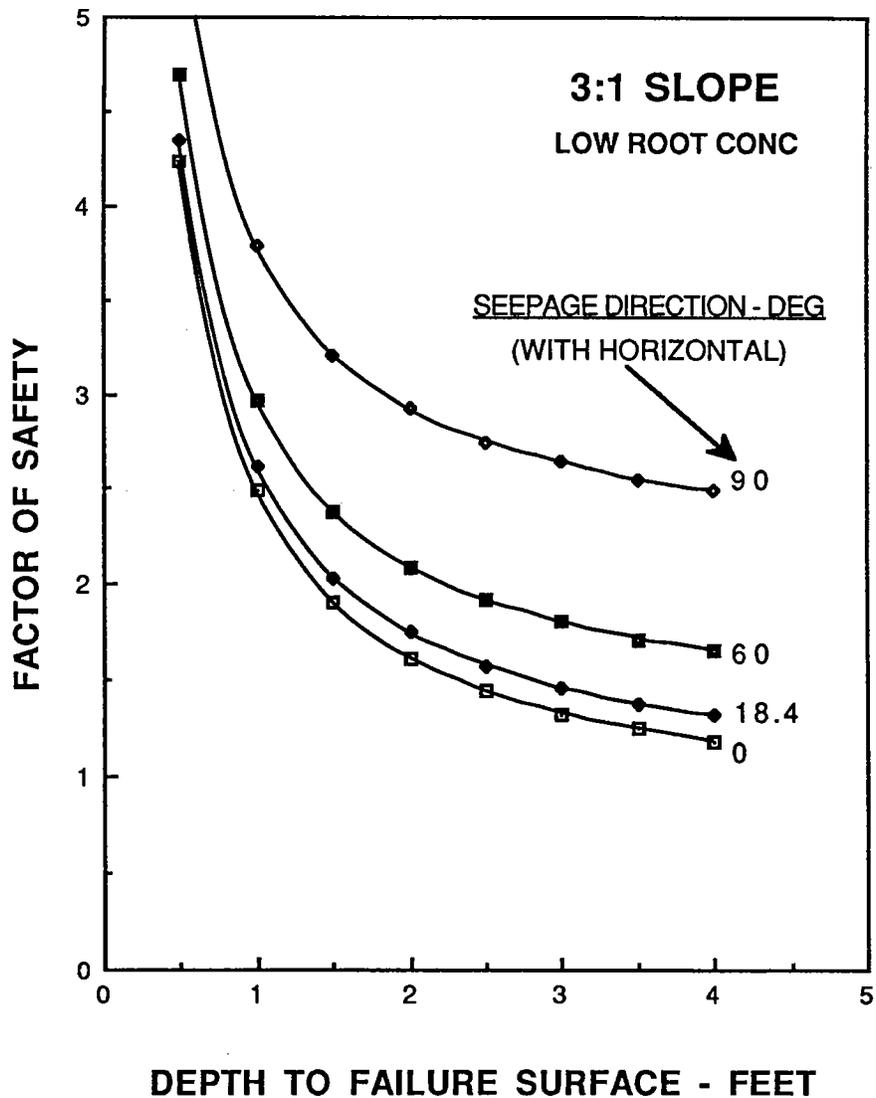
Figure 64. Infinite slope analysis of saturated (3:1) downstream slope of levee with roots (friction angle = 36°)

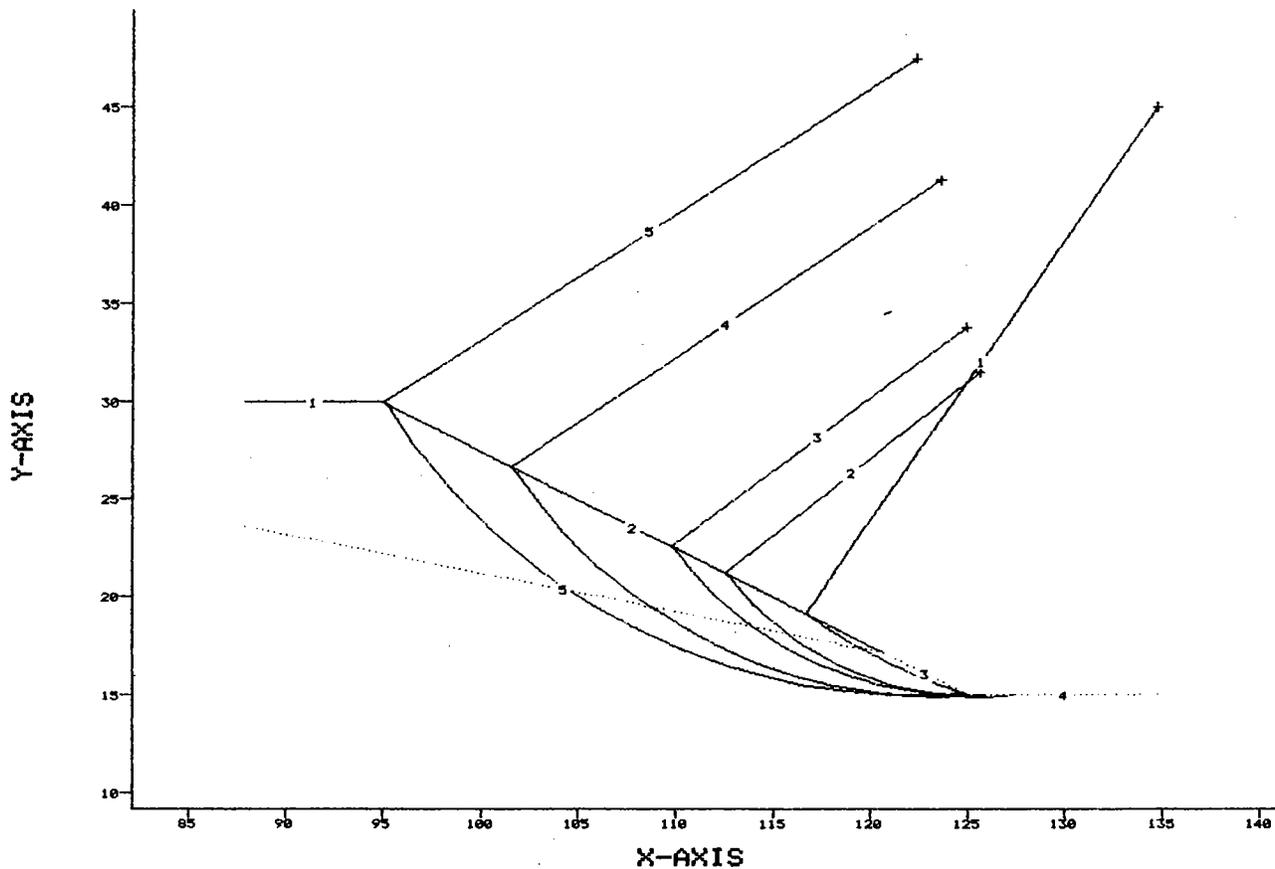
No. 1	X= 134.7	Y= 45	R= 31.5	FS= 0.65
No. 2	X= 125.6	Y= 31.5	R= 16.6	FS= 0.79
No. 3	X= 124.9	Y= 33.8	R= 18.8	FS= 0.86
No. 4	X= 123.6	Y= 41.3	R= 26.4	FS= 0.98
No. 5	X= 122.4	Y= 47.5	R= 32.5	FS= 1.04

Figure 65. Circular arc stability analysis of (2:1) landward slope of levee under steady seepage conditions. No roots are present (friction angle = 30°)

153. The factor of safety was computed for several trial circles for both steady seepage (2:1 slope) and sudden drawdown (3:1 slope) conditions, respectively, as shown in Figures 65 and 66. Successively deeper circles passing through the toe (or heel) were selected. The most critical circles were the shallow ones in both cases.

155. Results of the circular arc analysis show that in the unreinforced (no root) case, the critical failure circle ( $F < 1$ ) is quite shallow. The presence of roots, even at low concentration, completely reverses this trend. Now the shallow circles (where root concentrations are highest) have the highest factor of safety, whereas the deeper circles are relatively unaffected. Since the deeper circles are not critical in the first place ( $F > 1$ ), the influence of plant roots is less important.

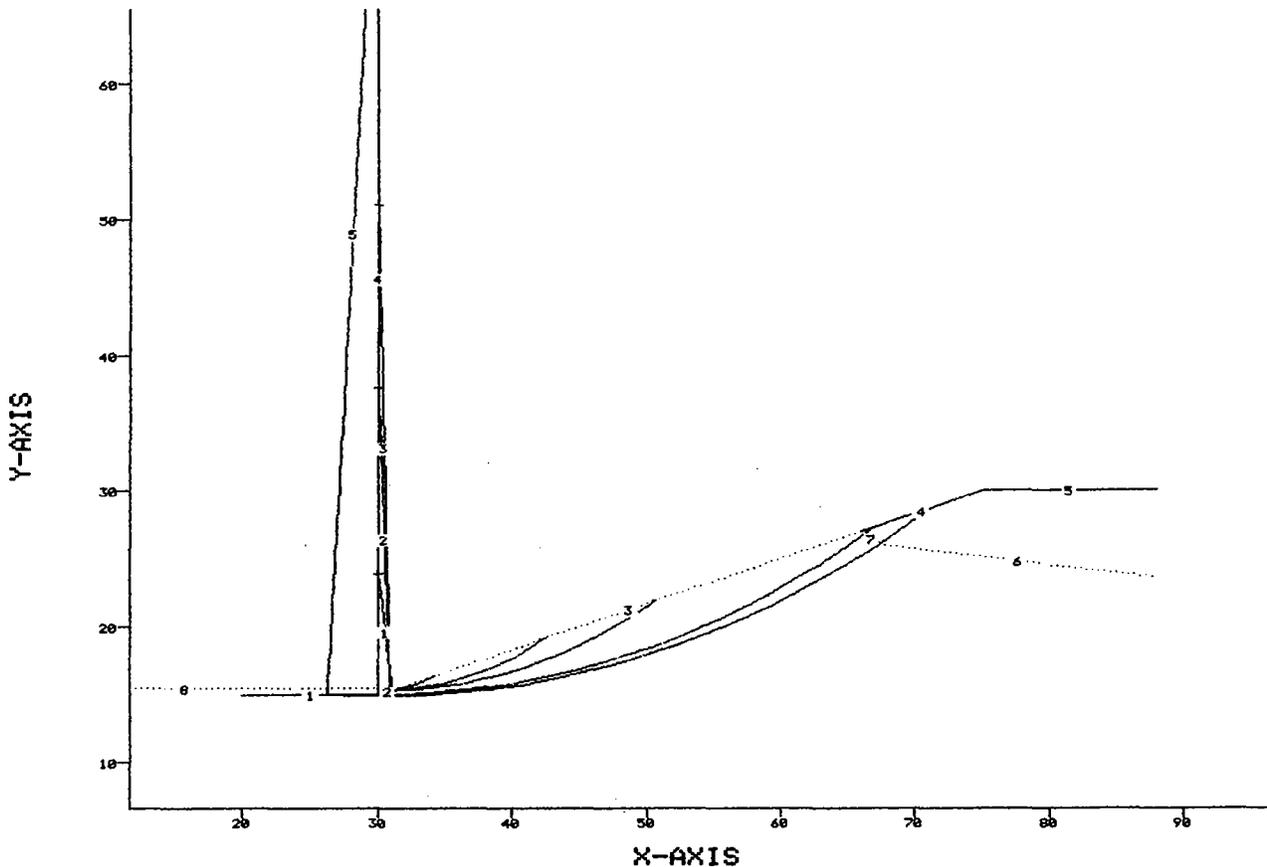
No. 1	X= 30	Y= 23.9	R= 8.6	FS= 0.72
No. 2	X= 30	Y= 37.6	R= 22.3	FS= 0.72
No. 3	X= 30	Y= 51.1	R= 35.8	FS= 0.73
No. 4	X= 30	Y= 76.4	R= 61.4	FS= 0.74
No. 5	X= 30	Y= 83	R= 68.1	FS= 0.77

Figure 66. Circular arc stability analysis of (3:1) riverward slope of levee under sudden drawdown conditions. No roots are present (friction angle = 30°)

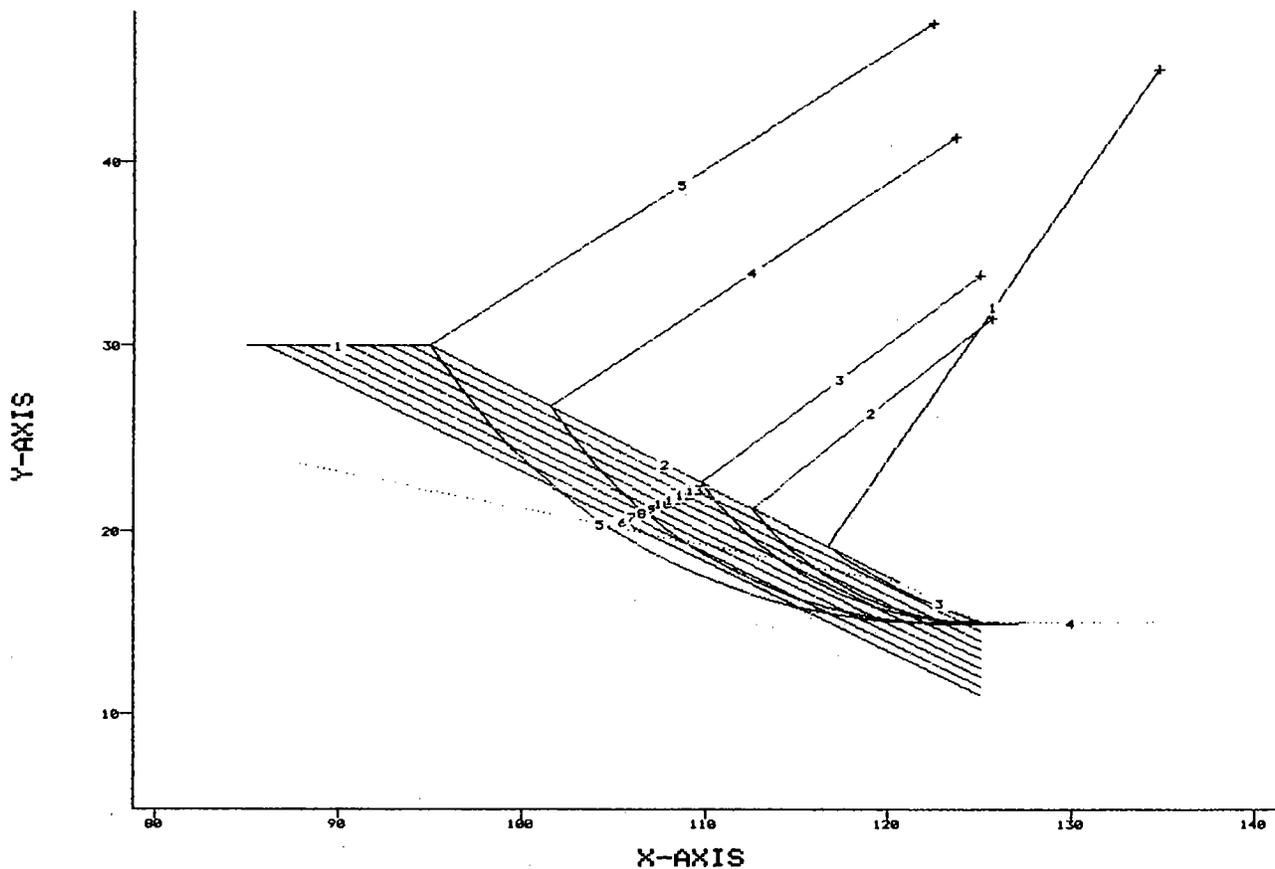
No. 1	X= 134.7	Y= 45	R= 31.5	FS= 5.57
No. 2	X= 125.6	Y= 31.5	R= 16.6	FS= 1.75
No. 3	X= 124.9	Y= 33.8	R= 18.8	FS= 1.54
No. 4	X= 123.6	Y= 41.3	R= 26.4	FS= 1.23
No. 5	X= 122.4	Y= 47.5	R= 32.5	FS= 1.16

Figure 67. Circular arc stability analysis of (2:1) landward slope of levee under steady seepage conditions. Low root concentration (friction angle = 30°)

154. The influence of root cohesion was investigated by assigning a cohesion value as a function of depth as described in the previous section. Results of safety factor calculations for the steady seepage and sudden drawdown cases are shown graphically in Figures 67 and 68, respectively, for the same failure circles used previously in Figures 65 and 66. The thin soil layers (6 in. thick) shown in the cross-section diagram of the slope represent soils with different cohesion based on a "low" root concentration in the soil.

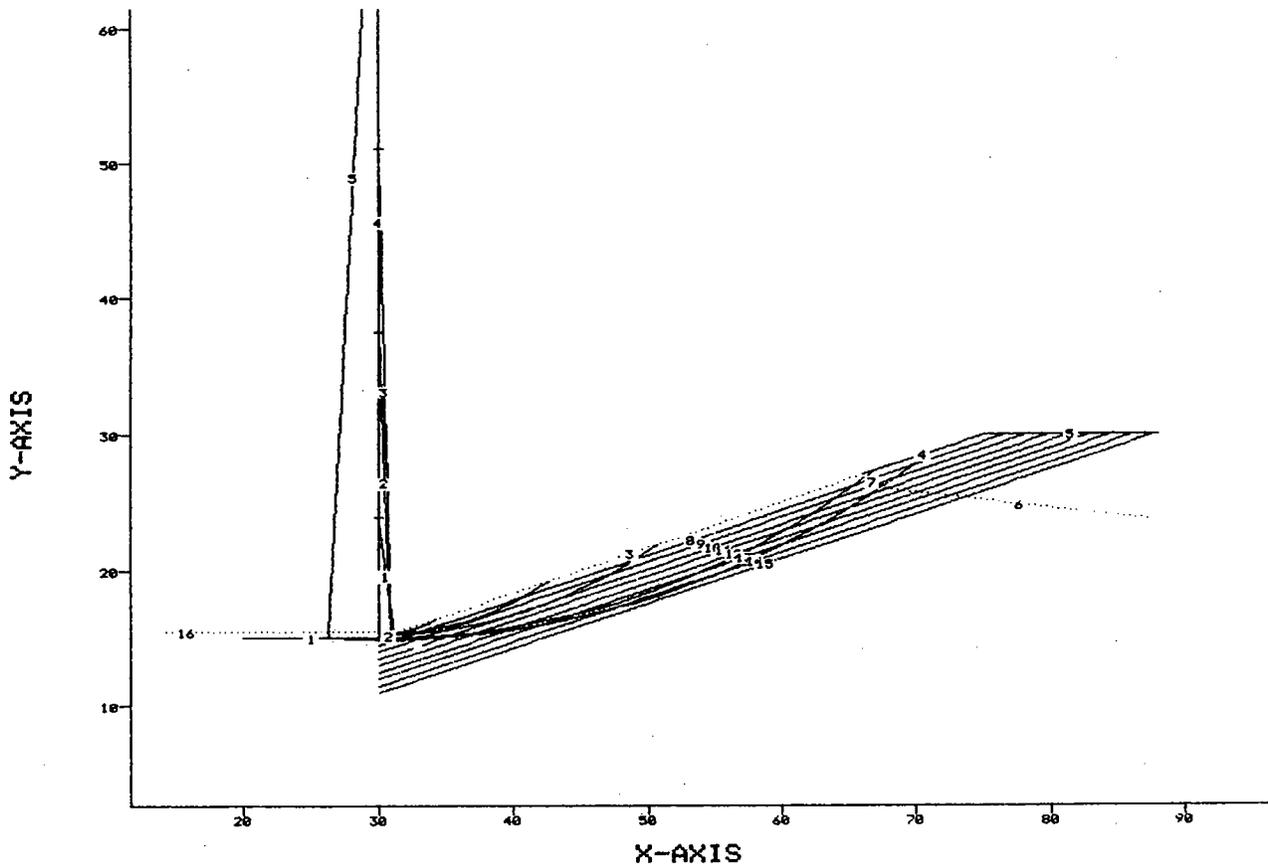
No. 1	X= 30	Y= 23.9	R= 8.6	FS= 16.5
No. 2	X= 30	Y= 37.6	R= 22.3	FS= 3.40
No. 3	X= 30	Y= 51.1	R= 35.8	FS= 2.01
No. 4	X= 30	Y= 76.4	R= 61.4	FS= 1.16
No. 5	X= 30	Y= 83	R= 68.1	FS= 1.10

Figure 68. Circular arc stability analysis of (3:1) riverward slope of levee under sudden drawdown conditions. Low root concentration (friction angle = 30°)

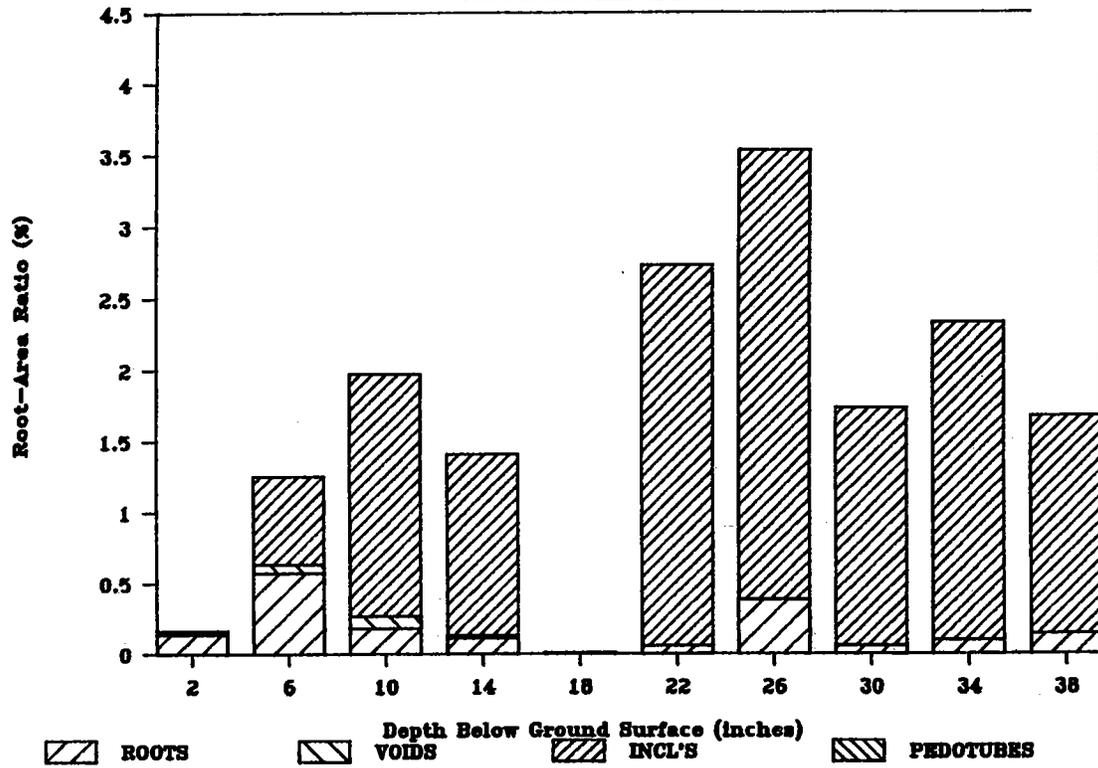
## Control Trench Root-Area Ratio

PERPENDICULAR TRENCH

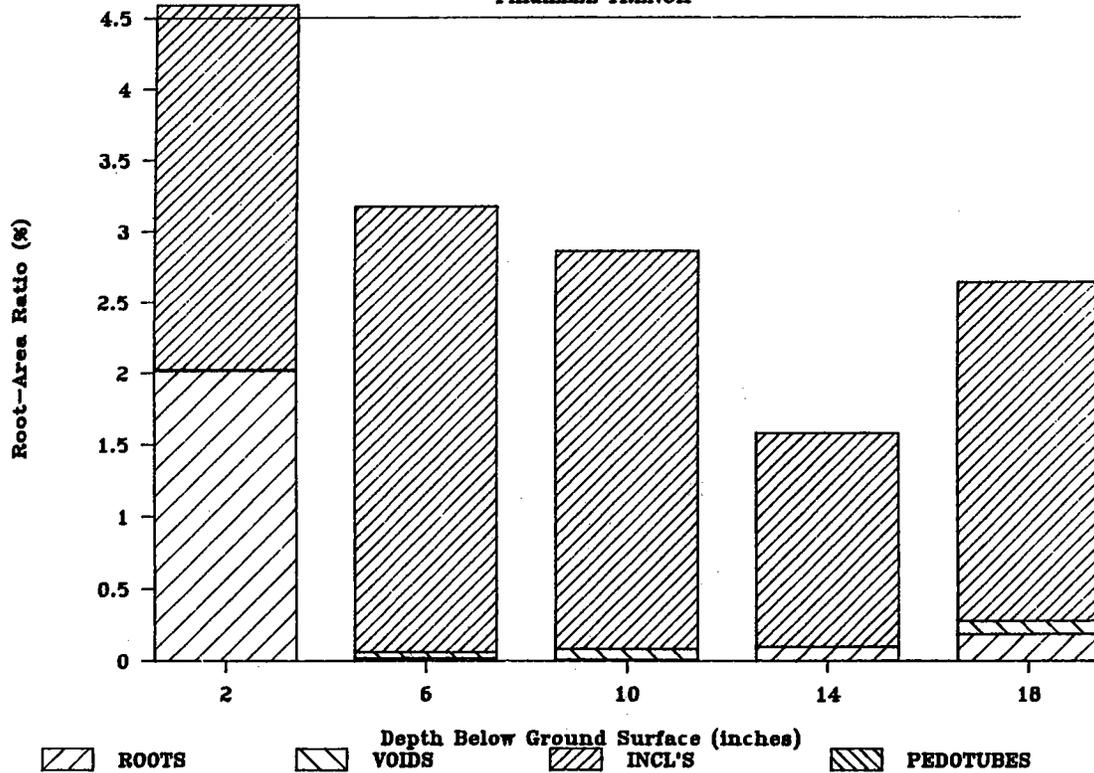
## Control Trench Root-Area Ratio

PARALLEL TRENCH

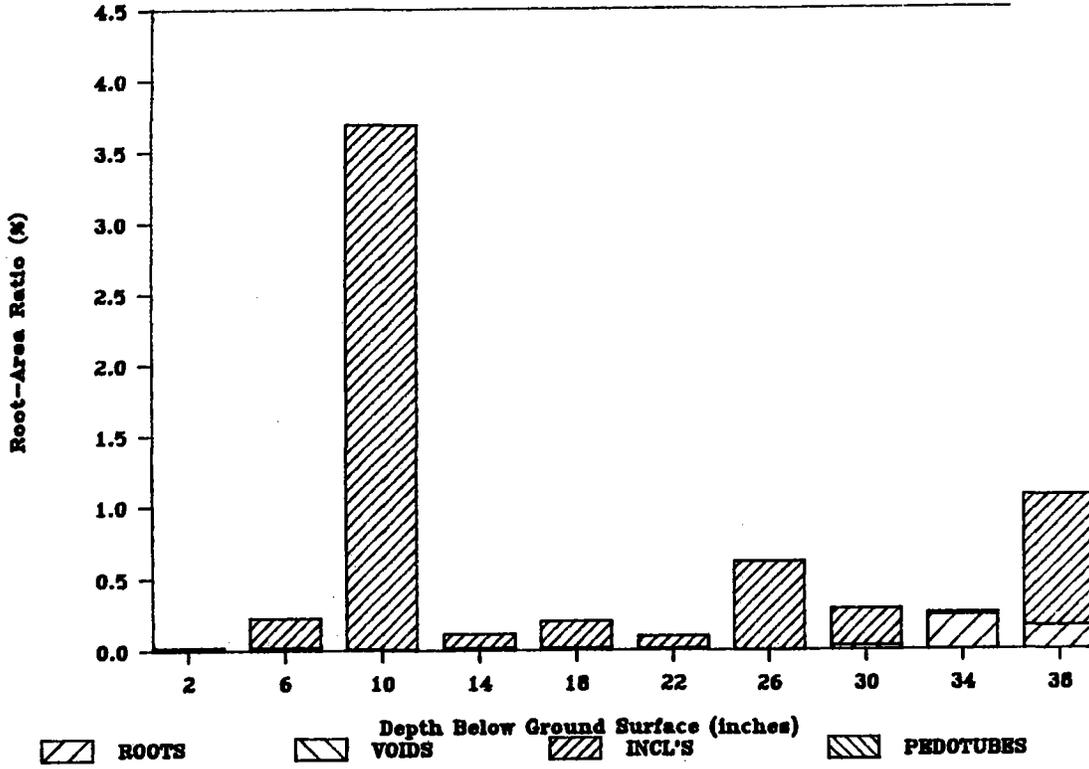
# Dead Oak Site # 3

## PERPENDICULAR TRENCH
