# REPAIR, EVALUATION, MAINTENANCE, AND REHABILITATION RESEARCH PROGRAM

TECHNICAL REPORT REMR-EI-5

## THE EFFECTS OF VEGETATION ON THE STRUCTURAL INTEGRITY OF SANDY LEVEES

Final Report

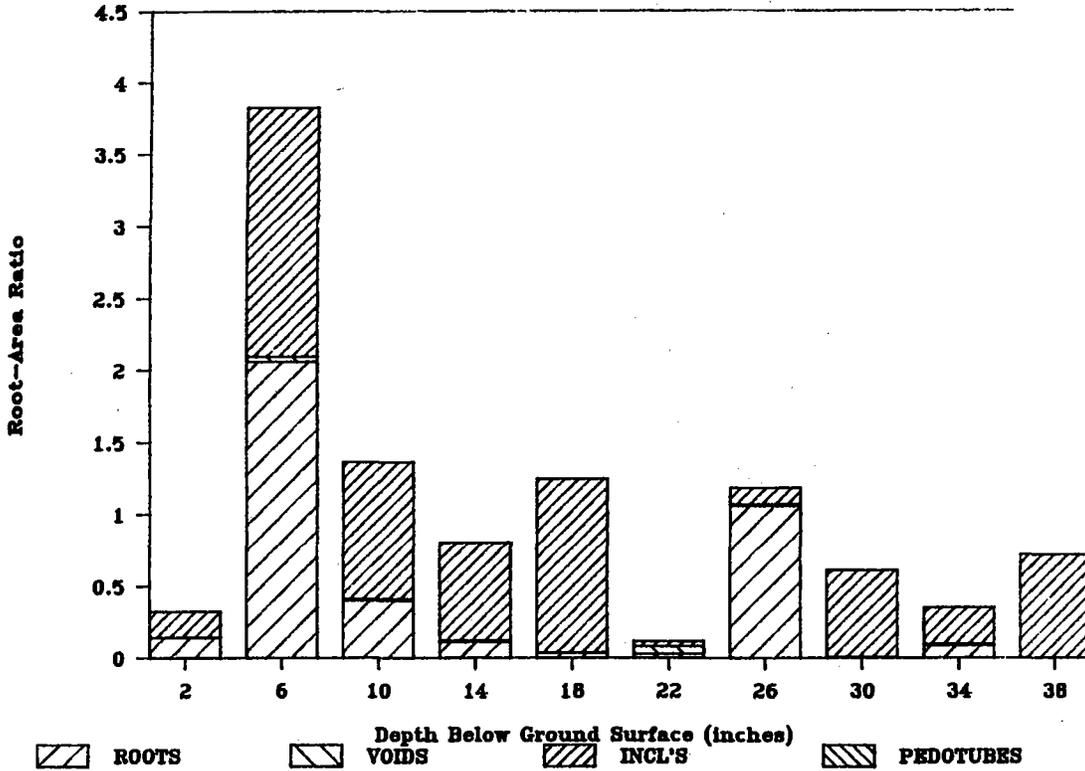
# Dead Oak Site # 3

## PARALLEL TRENCH

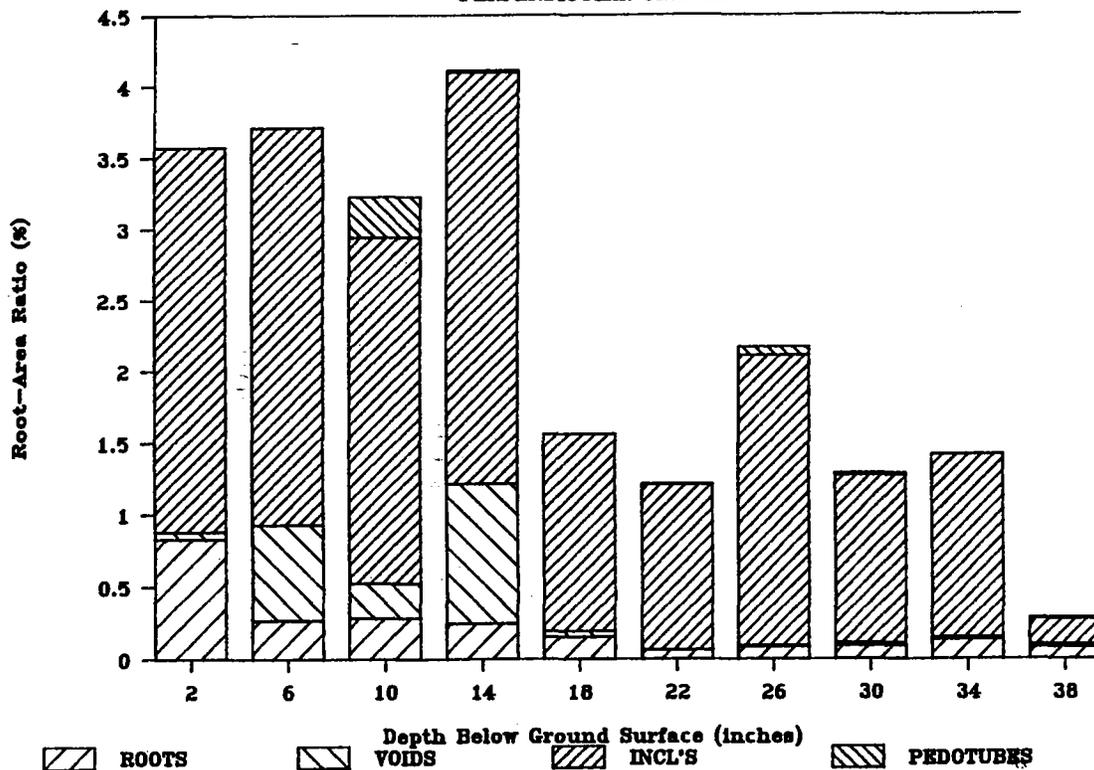
# Live Oak Site # 4

## PERPENDICULAR TRENCH

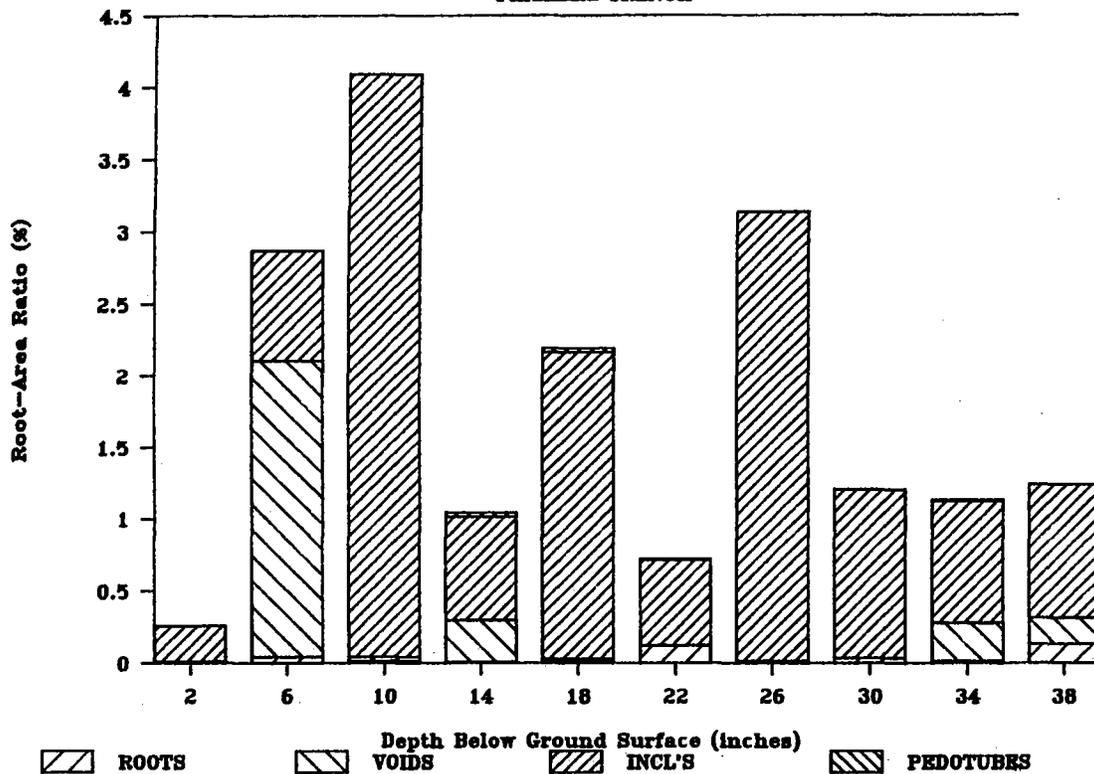
# Live Oak Site # 4

## PARALLEL TRENCH

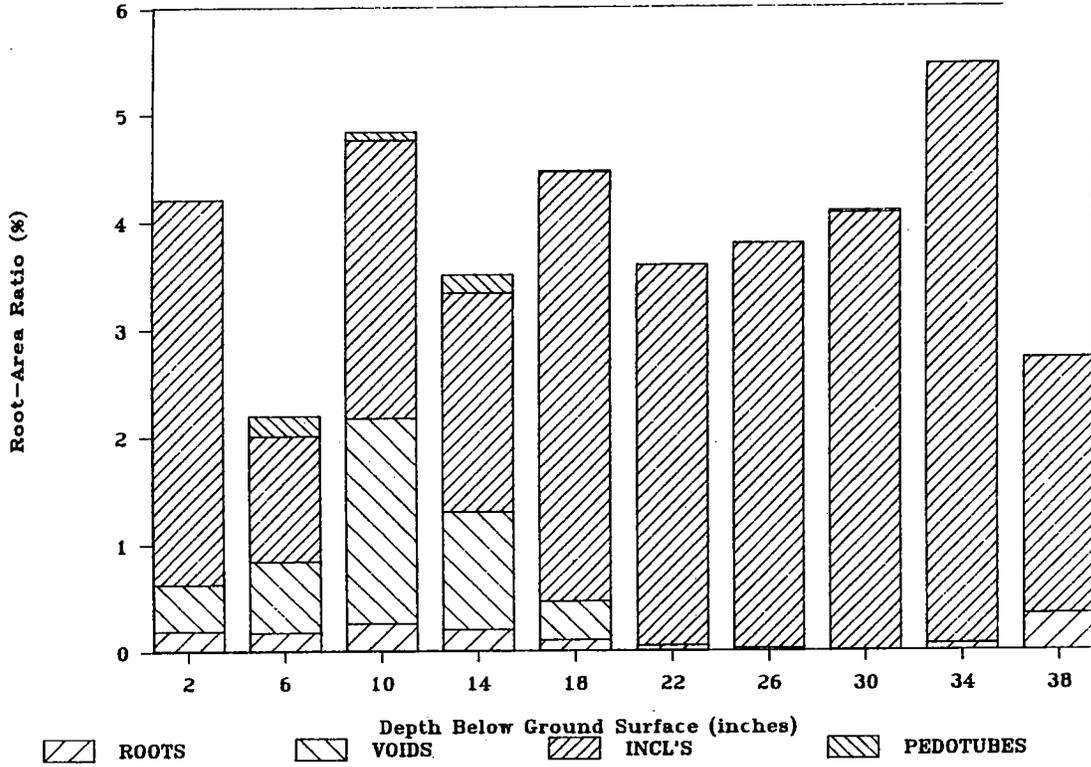
# Willow Site # 5

## PERPENDICULAR TRENCH

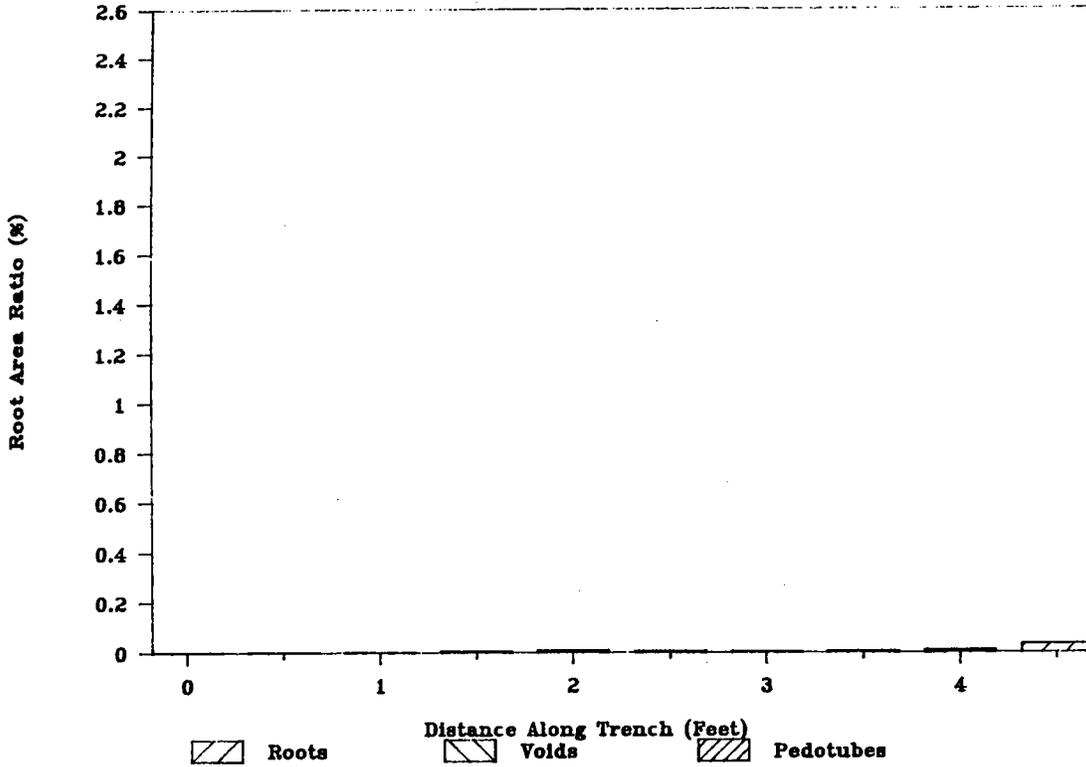
# Site #5 Willow Parallel Trench

## Root Area Ratio

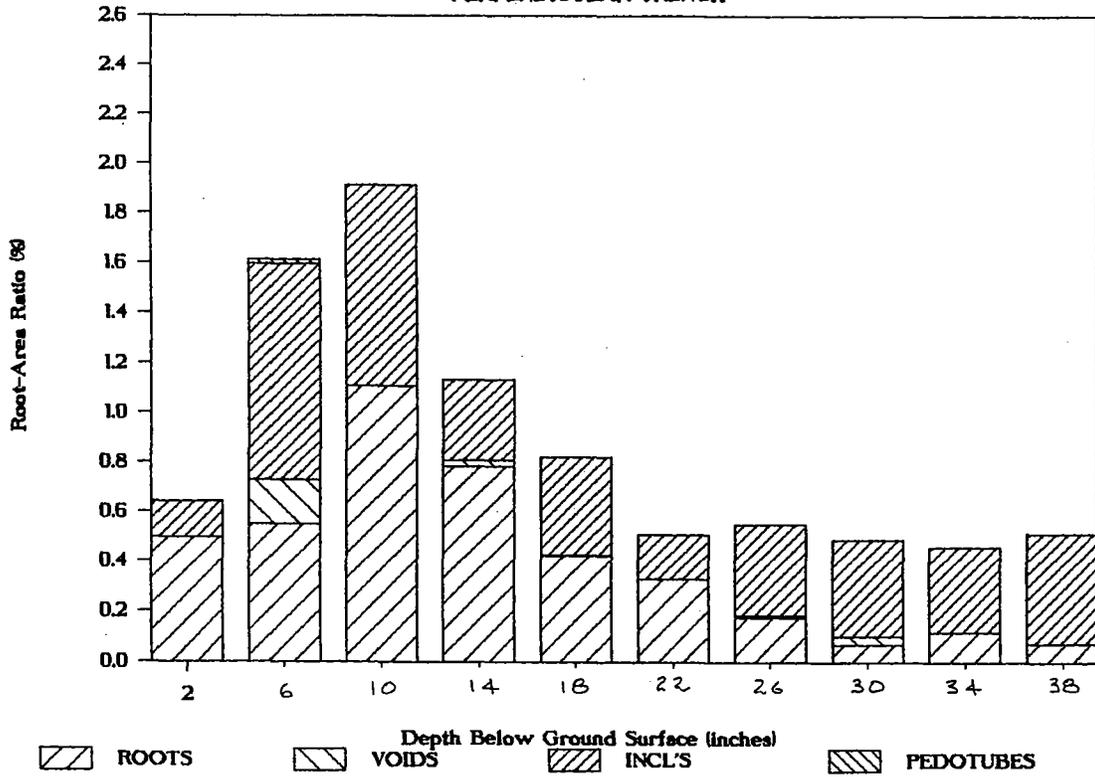
# Elderberry Site # 7

PERPENDICULAR TRENCH

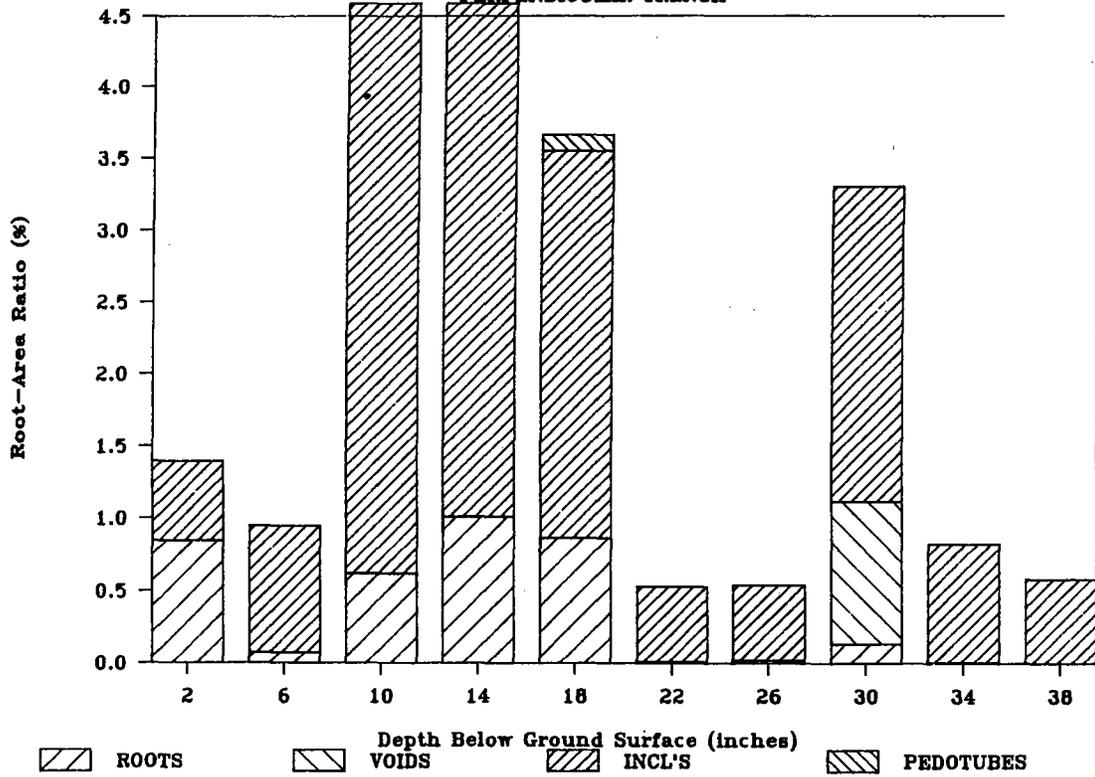
# Levee Vegetation Site # 8

PERPENDICULAR TRENCH

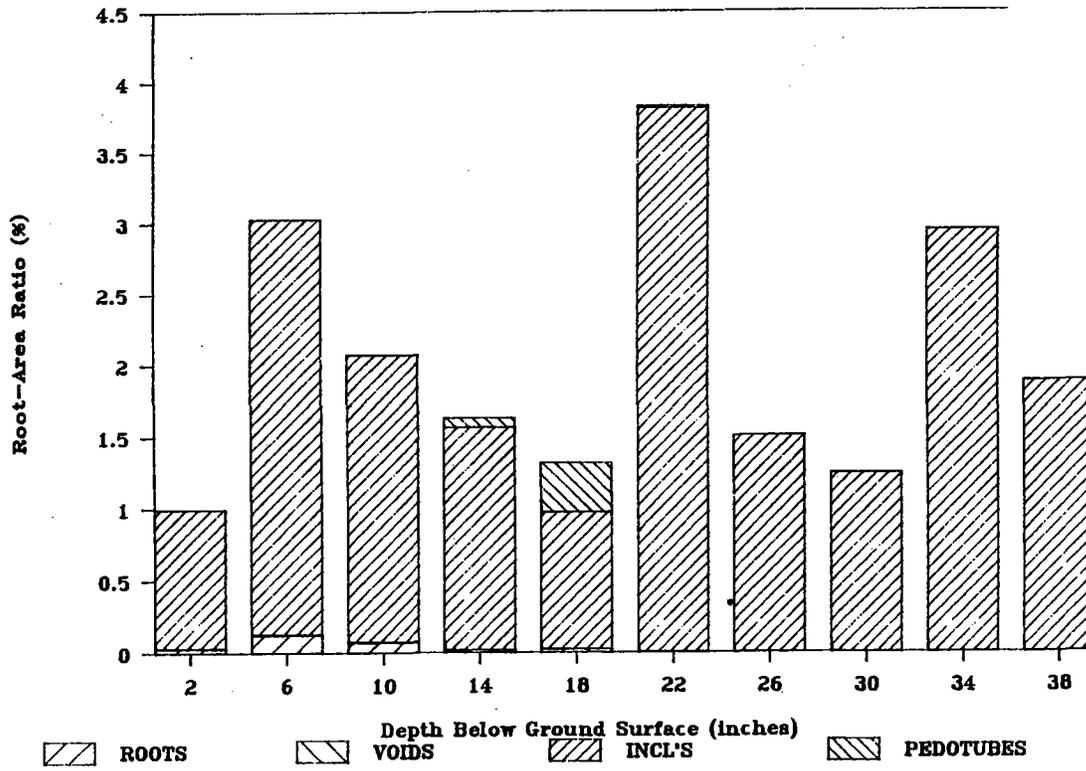
# Levee Vegetation Site # 8

## PARALLEL TRENCH

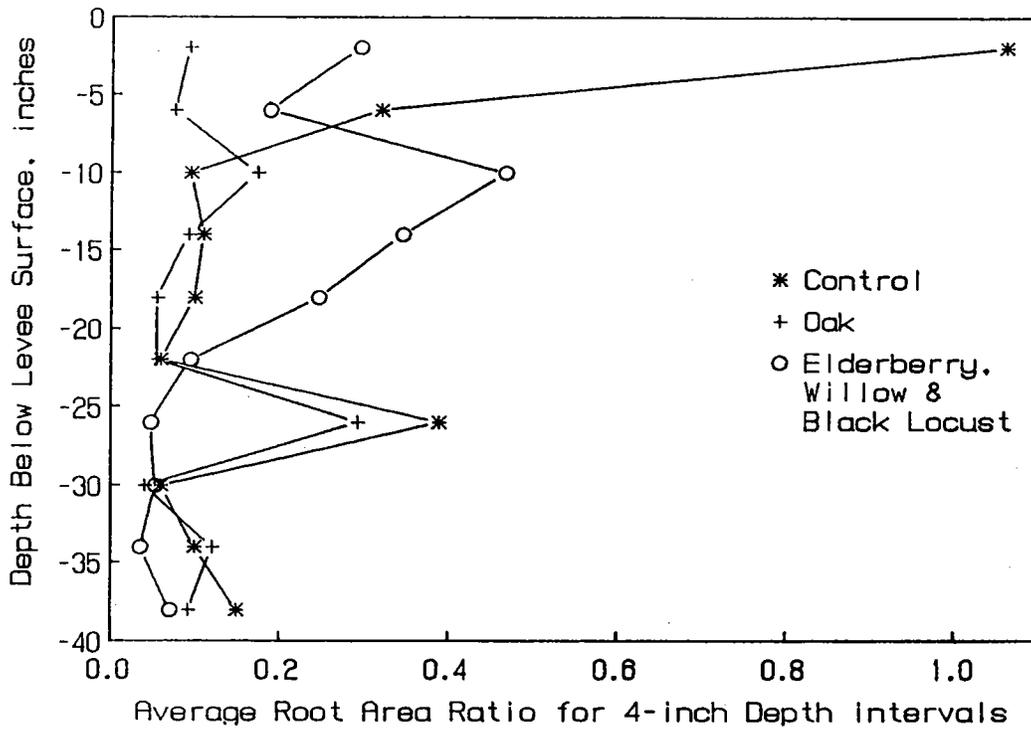
## Sacramento River Levee Root Area Ratio Profiles

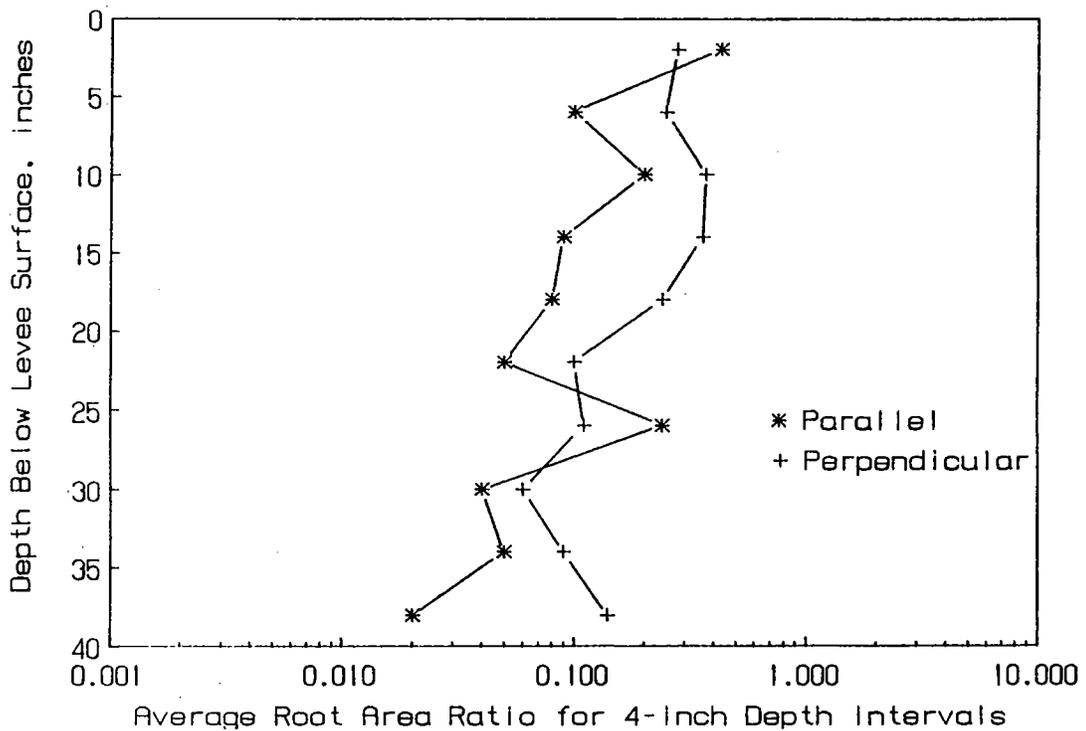
## Sacramento River Levee: Average Root Area Ratio Profiles

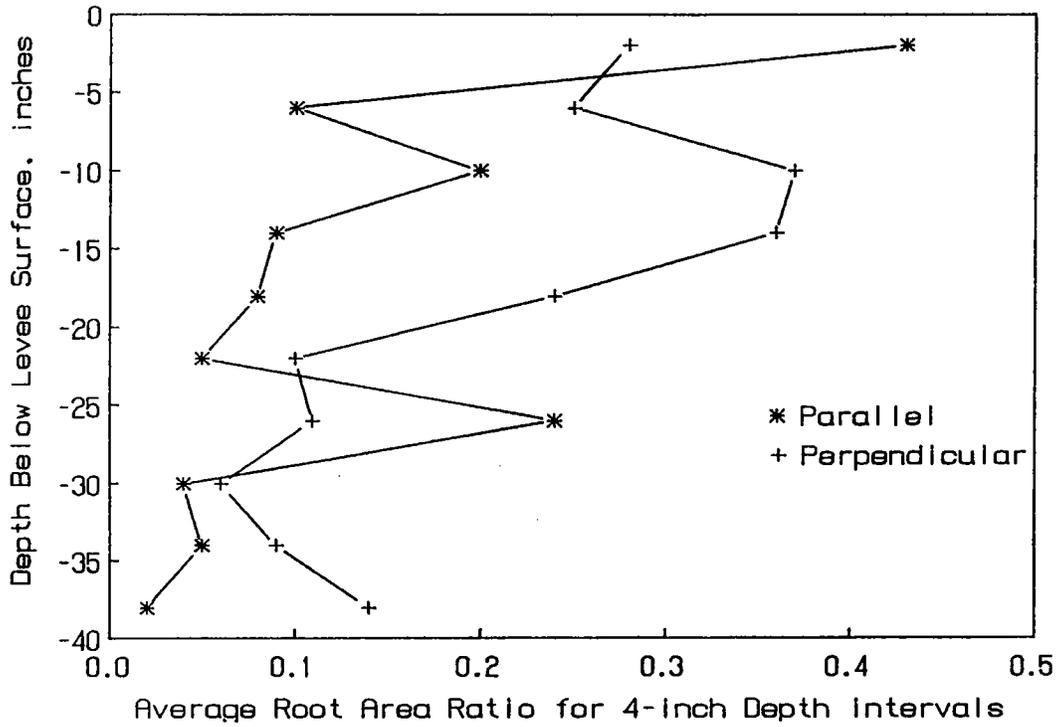
## Sacramento River Levee: Average Root Area Ratio Profiles

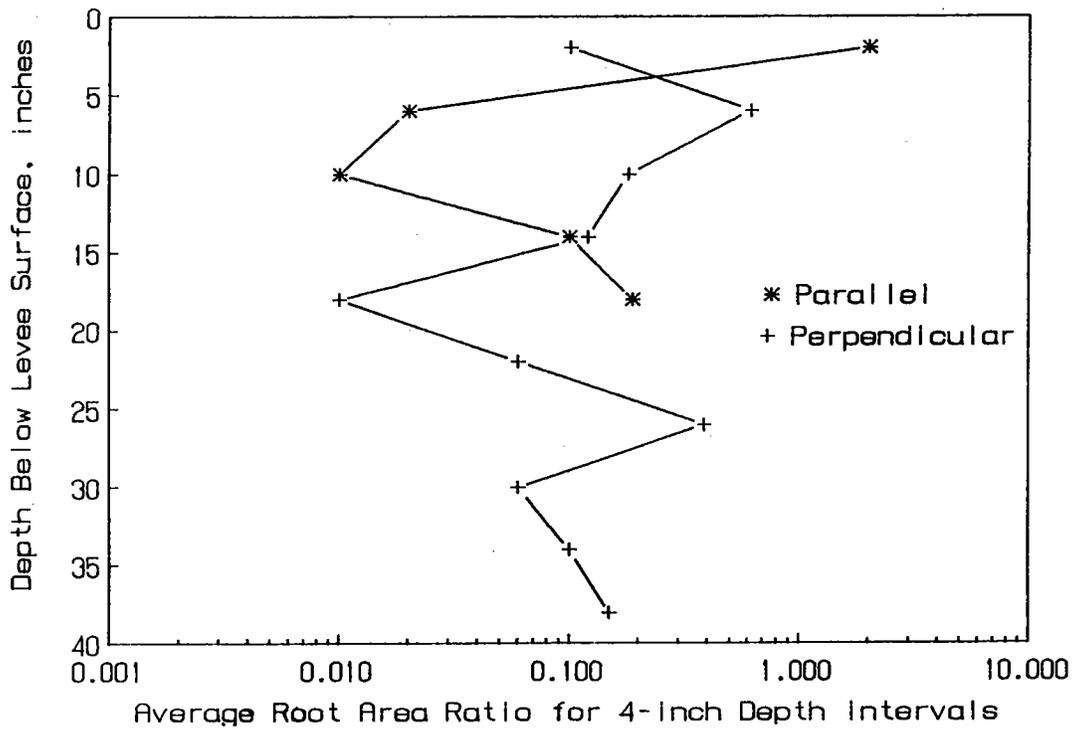
## Sacramento River Levee: Control Root Area Ratio Profiles

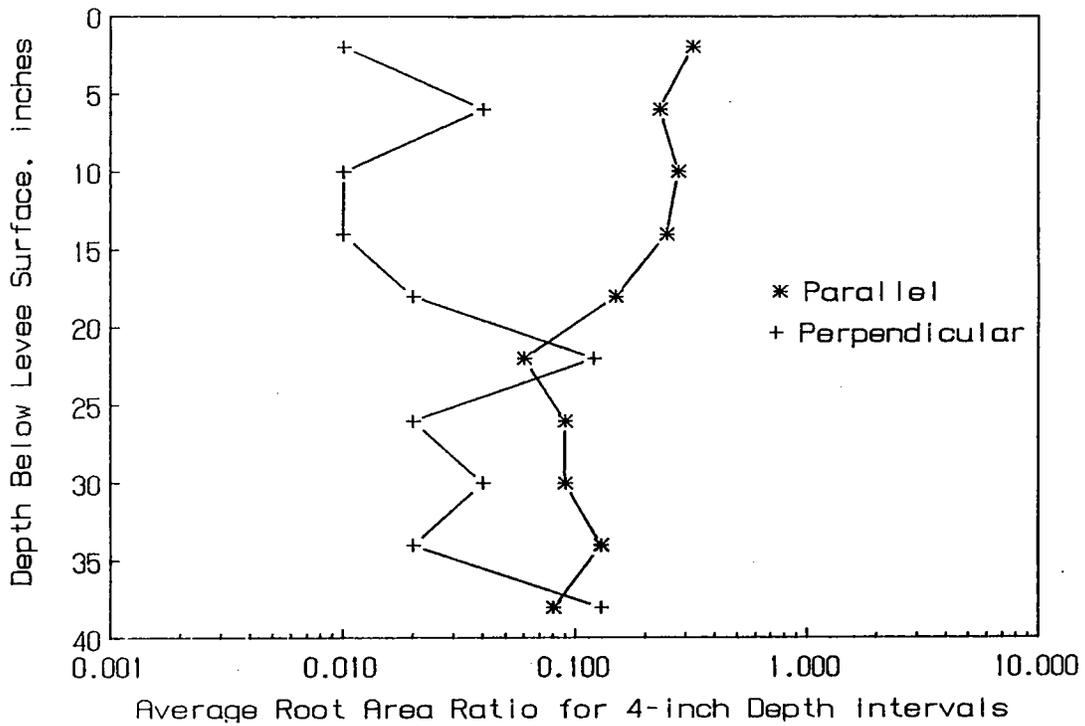
## Sacramento River Levee: Live Oak Root Area Ratio Profiles

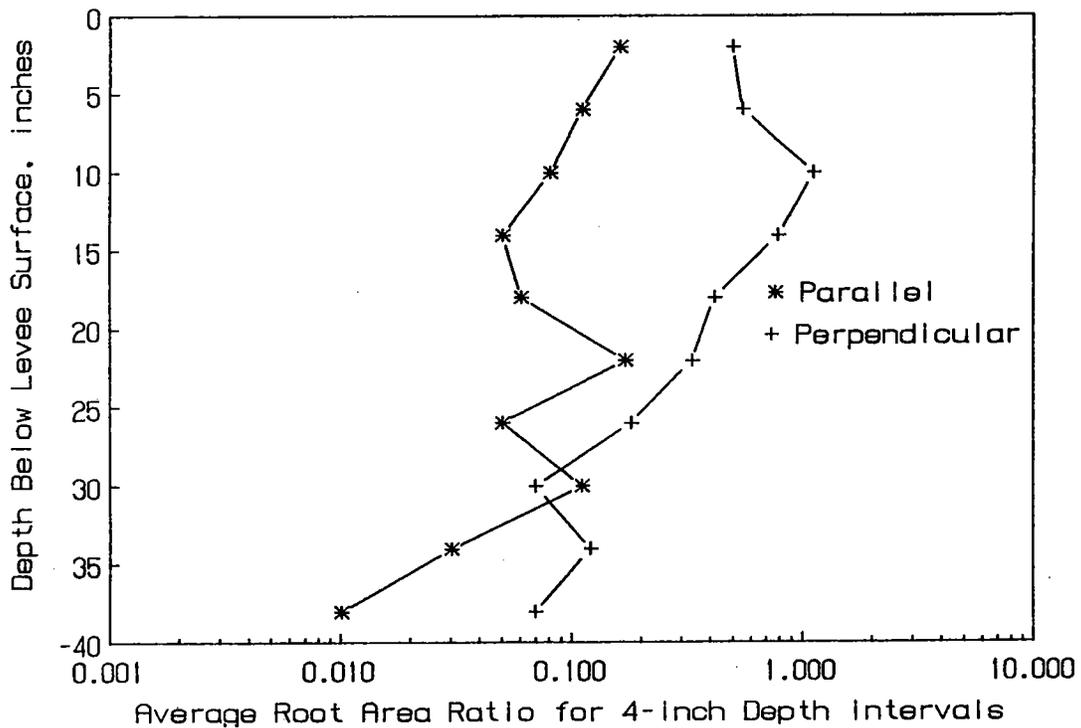
## Sacramento River Levee: Elderberry Root Area Ratio Profiles

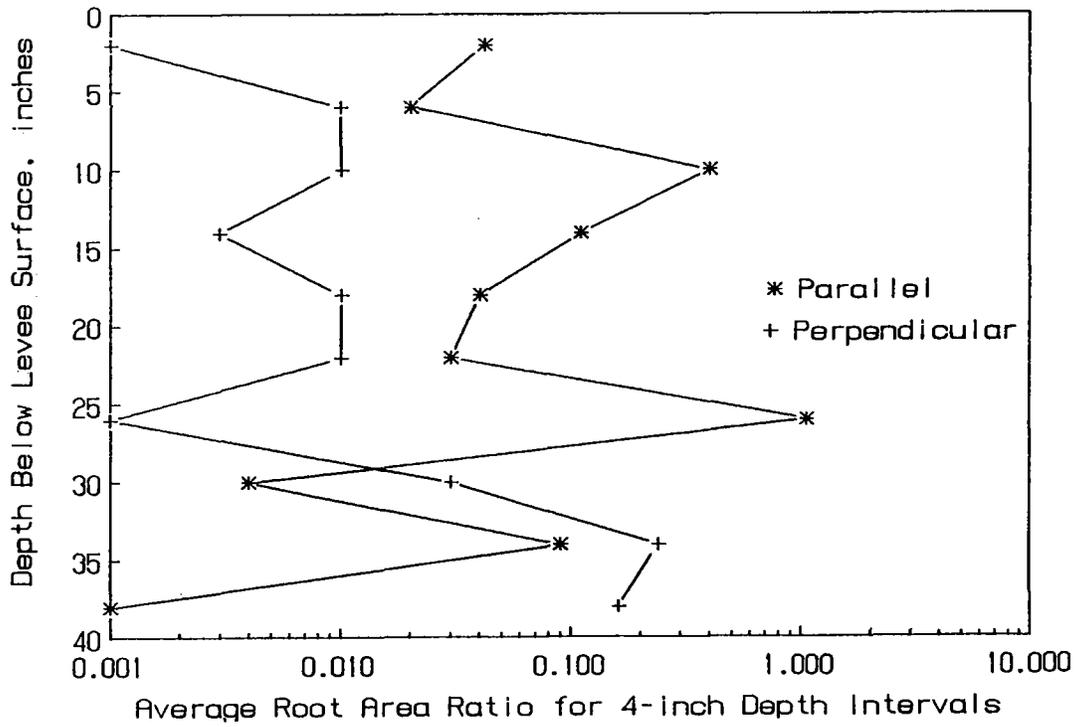
## Sacramento River Levee: Dead Oak Root Area Ratio Profiles

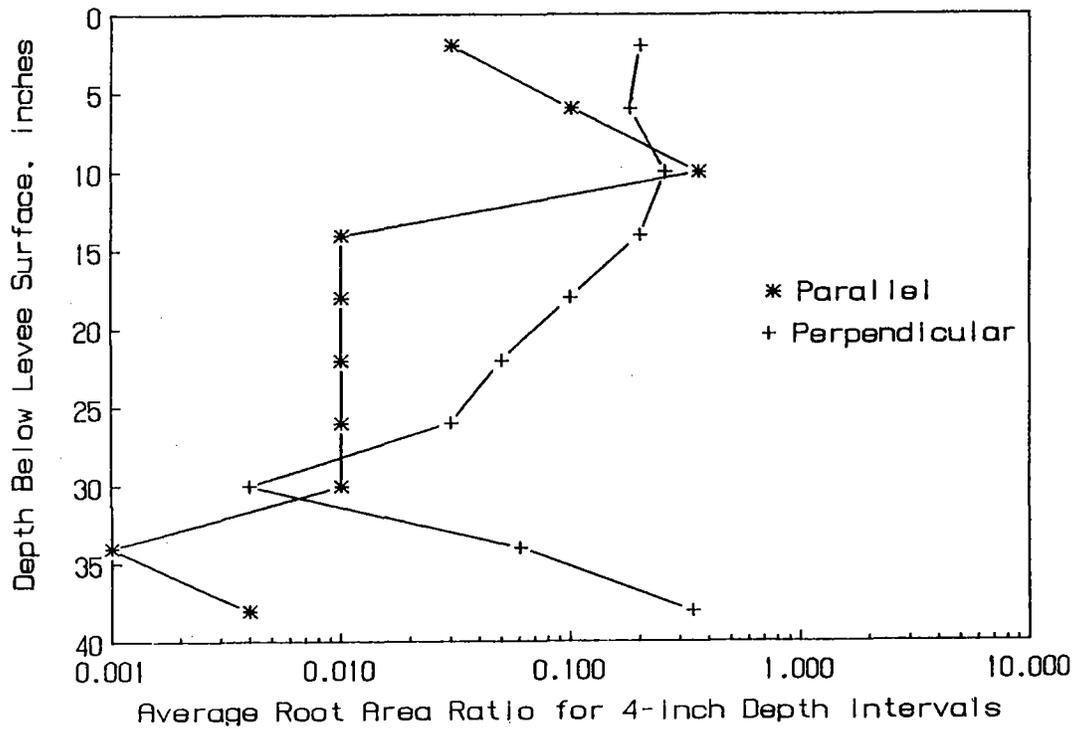
## Sacramento River Levee: Willow Root Area Ratio Profiles

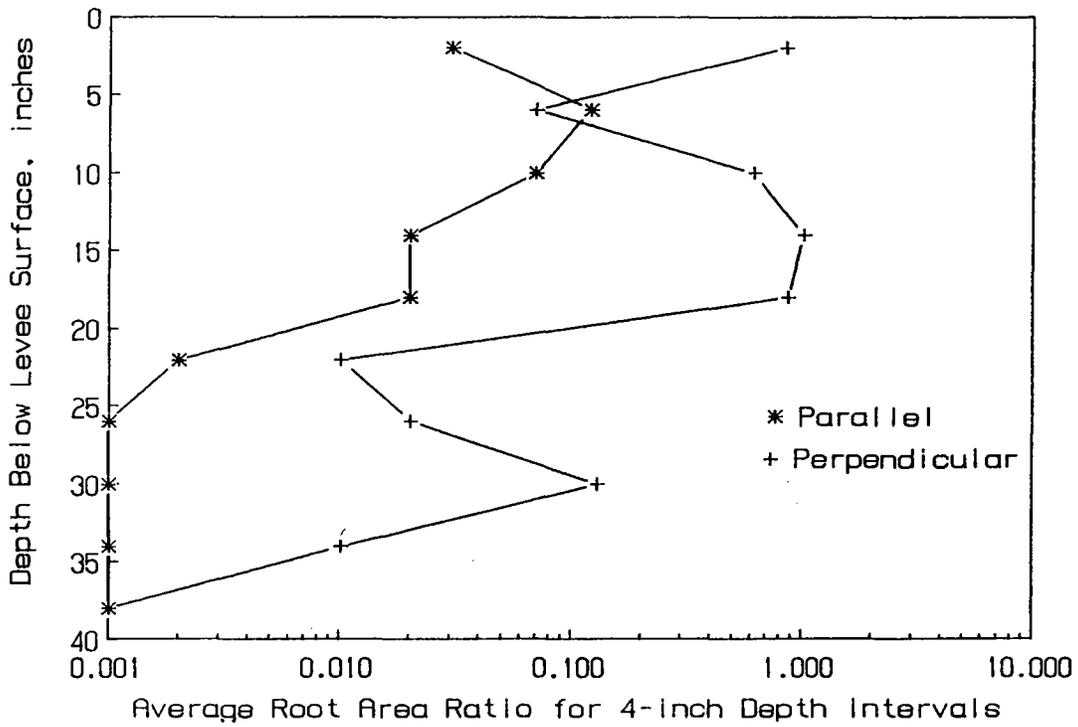
## Sacramento River Levee: Black Locust Root Area Ratio Profiles

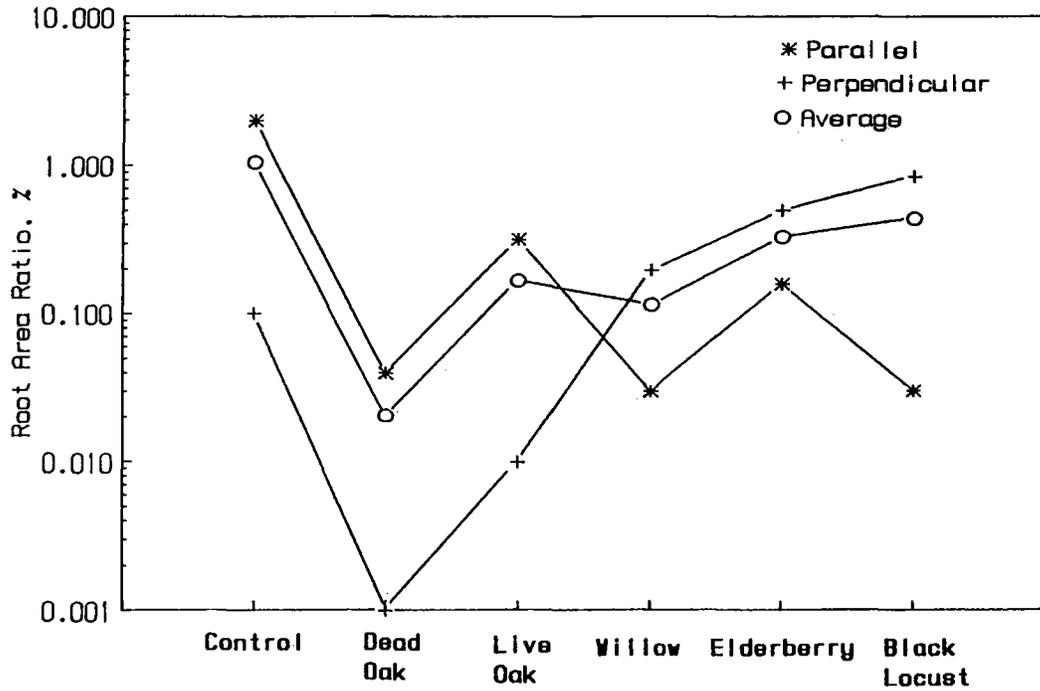
## Sacramento River Levee Root Area Ratio for 0-4 inches Below Ground Surface

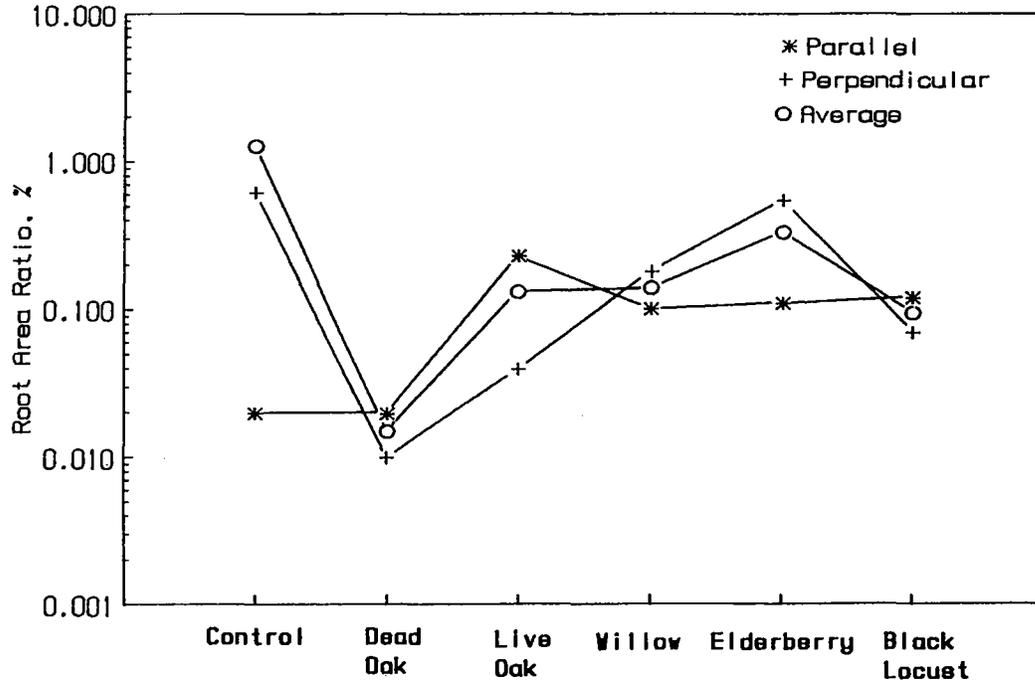
## Sacramento River Levee

Root Area Ratio for 4-8 inches Below Ground Surface

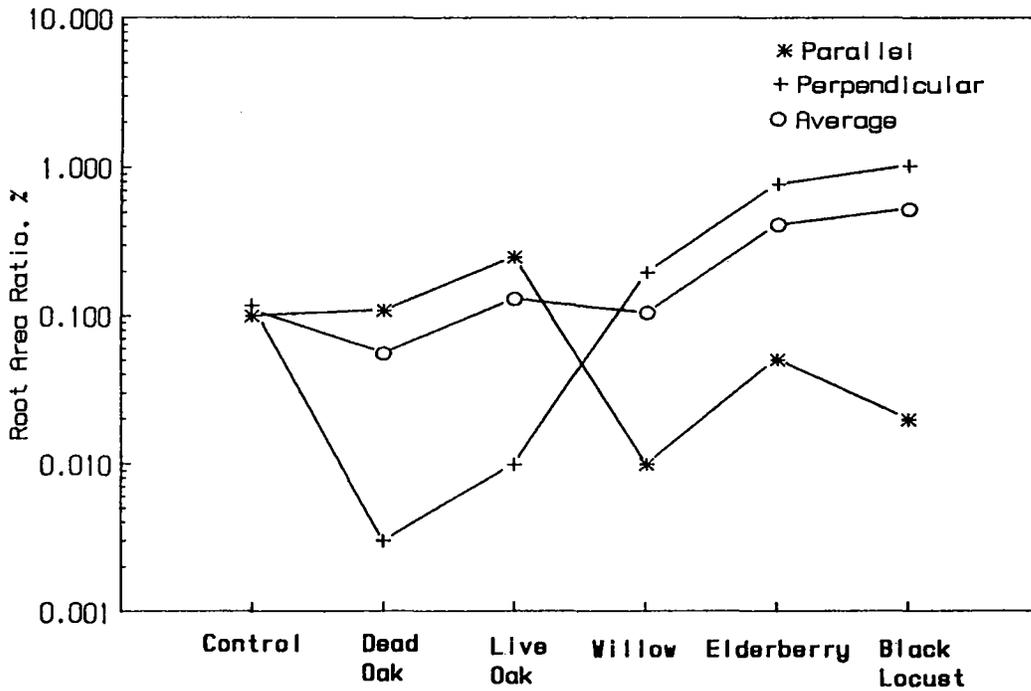
## Sacramento River Levee

Root Area Ratio for 12-16 inches Below Ground Surface

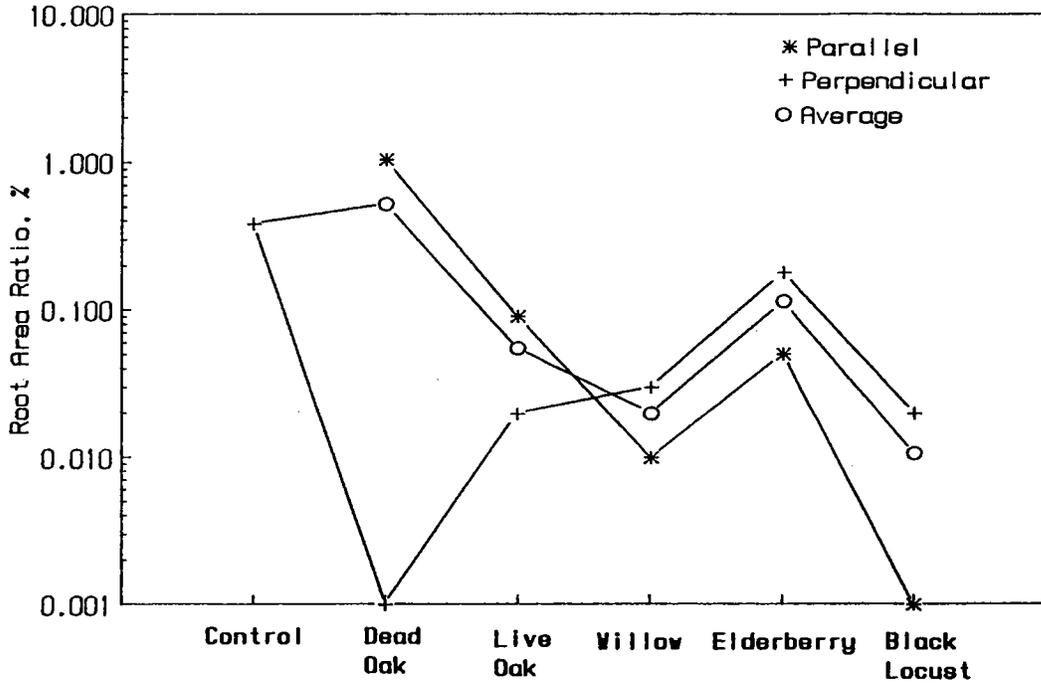
## Sacramento River Levee

Root Area Ratio for 24-28 inches Below Ground Surface

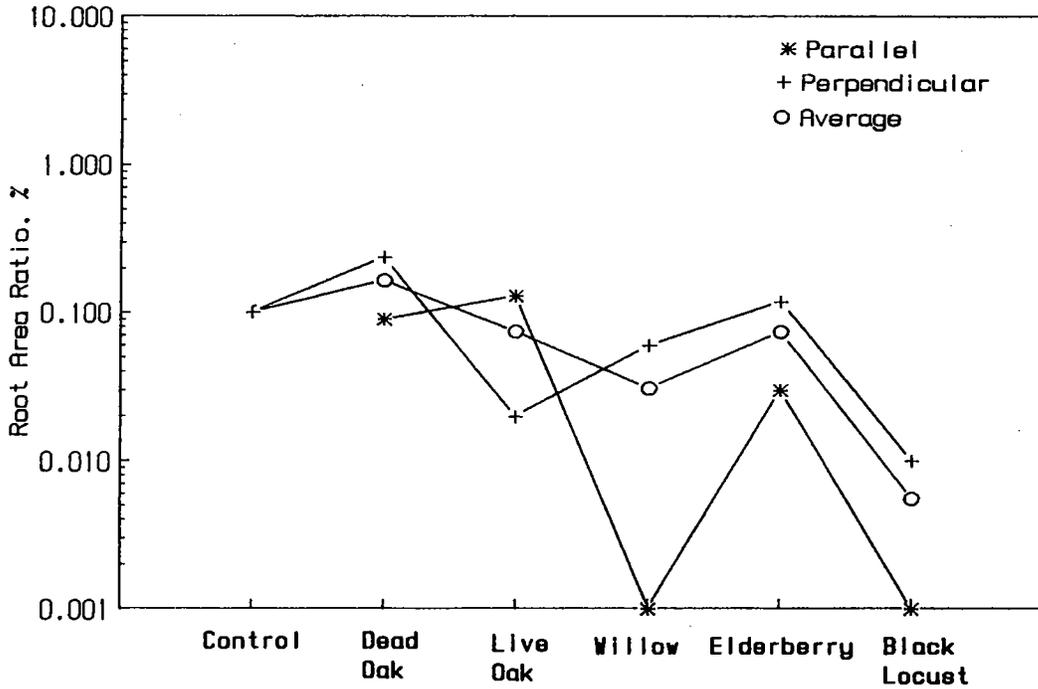
## Sacramento River Levee

Root Area Ratio for 32-36 inches Below Ground Surface

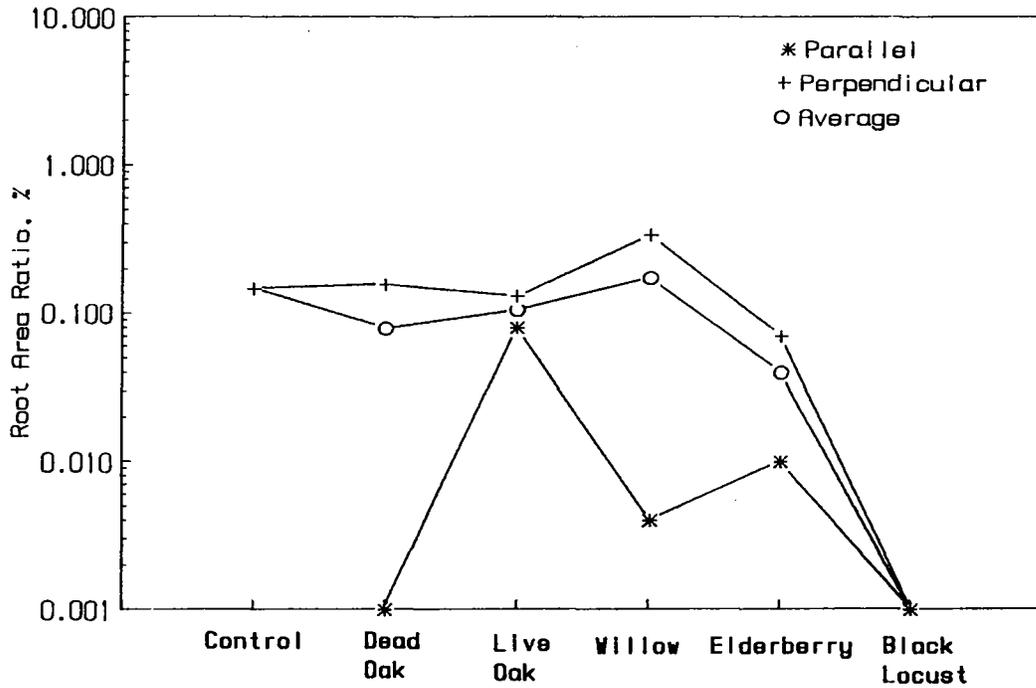
# Sacramento River Levee

Root Area Ratio for 36-40 inches Below Ground Surface

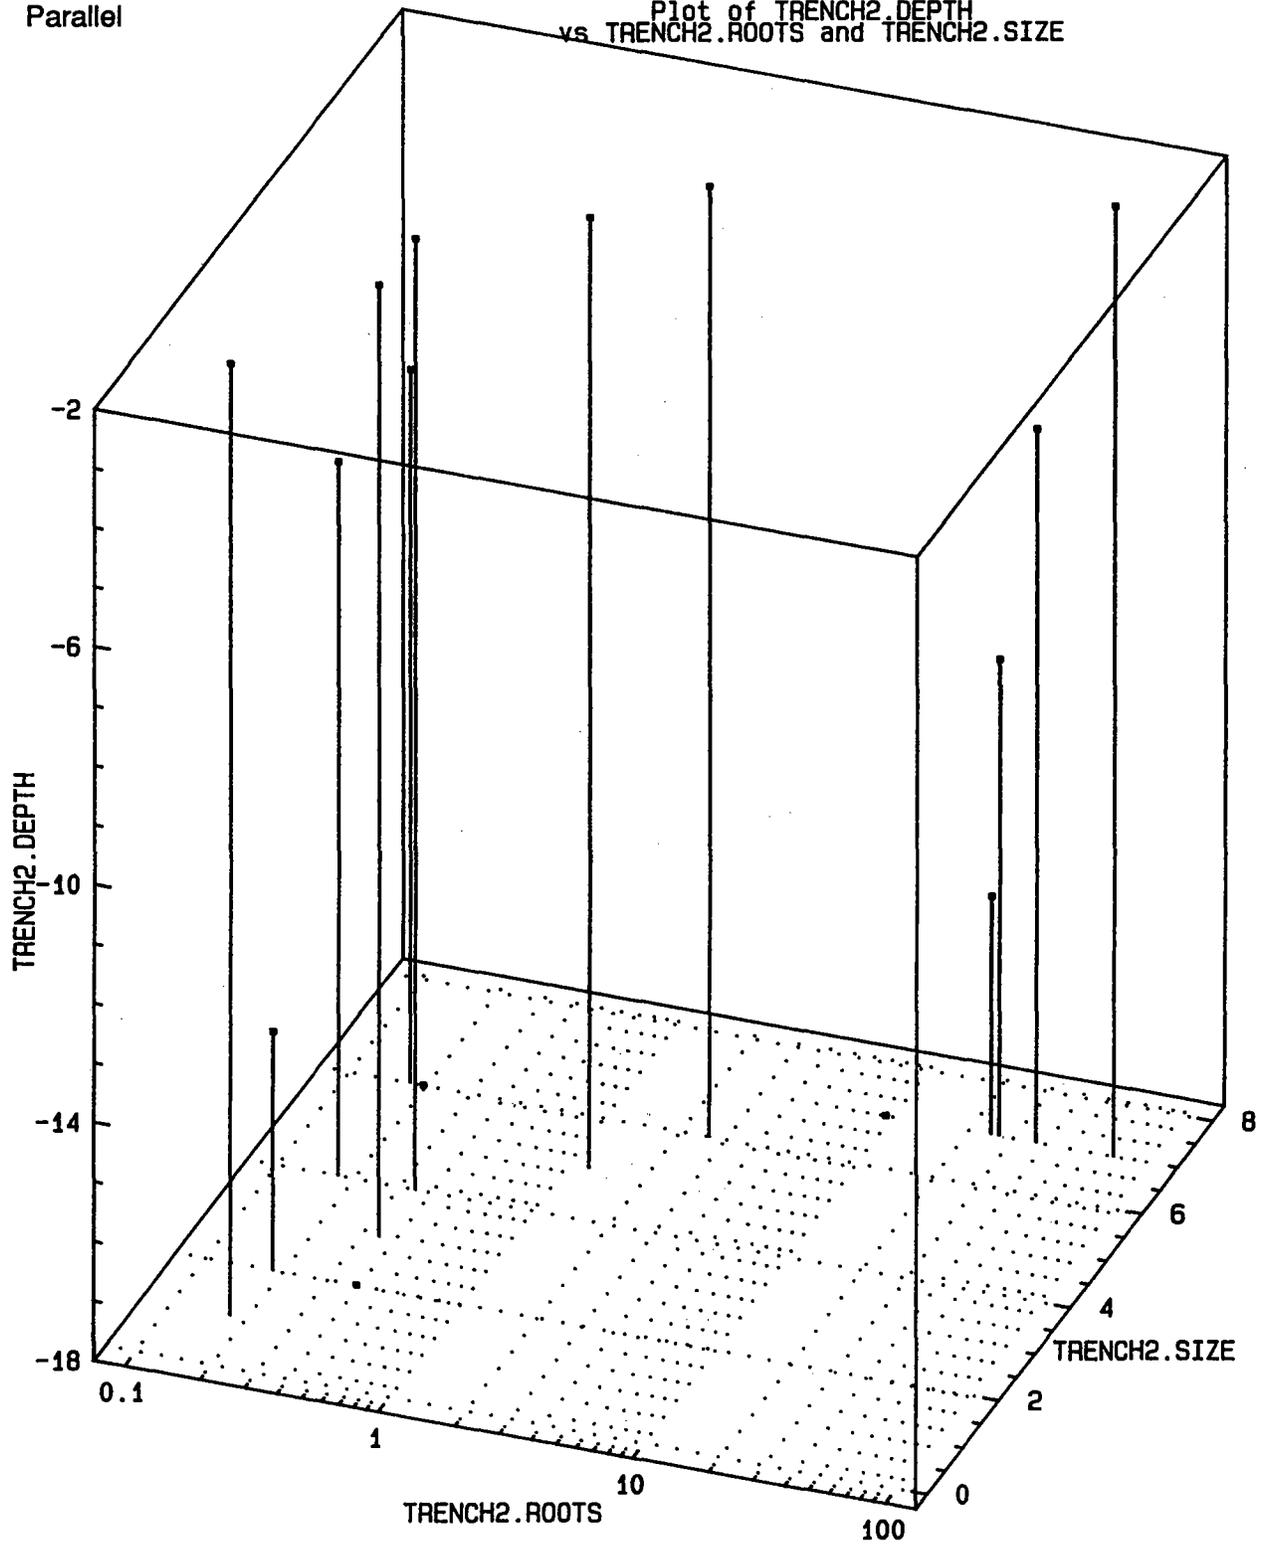
Site 2  
Parallel

Plot of TRENCH2\_DEPTH  
vs TRENCH2\_ROOTS and TRENCH2\_SIZE

Z (vertical) axis--depth below surface in inches times -1. The upper limit of +2 was set by the automatic scaling routine in the plot software--there has been some trouble with the software when attempts are made to manually set the scales. Note that all plots have Z axes scaled from +2 to -38, except site 2 (parallel) and site 3 (perpendicular).

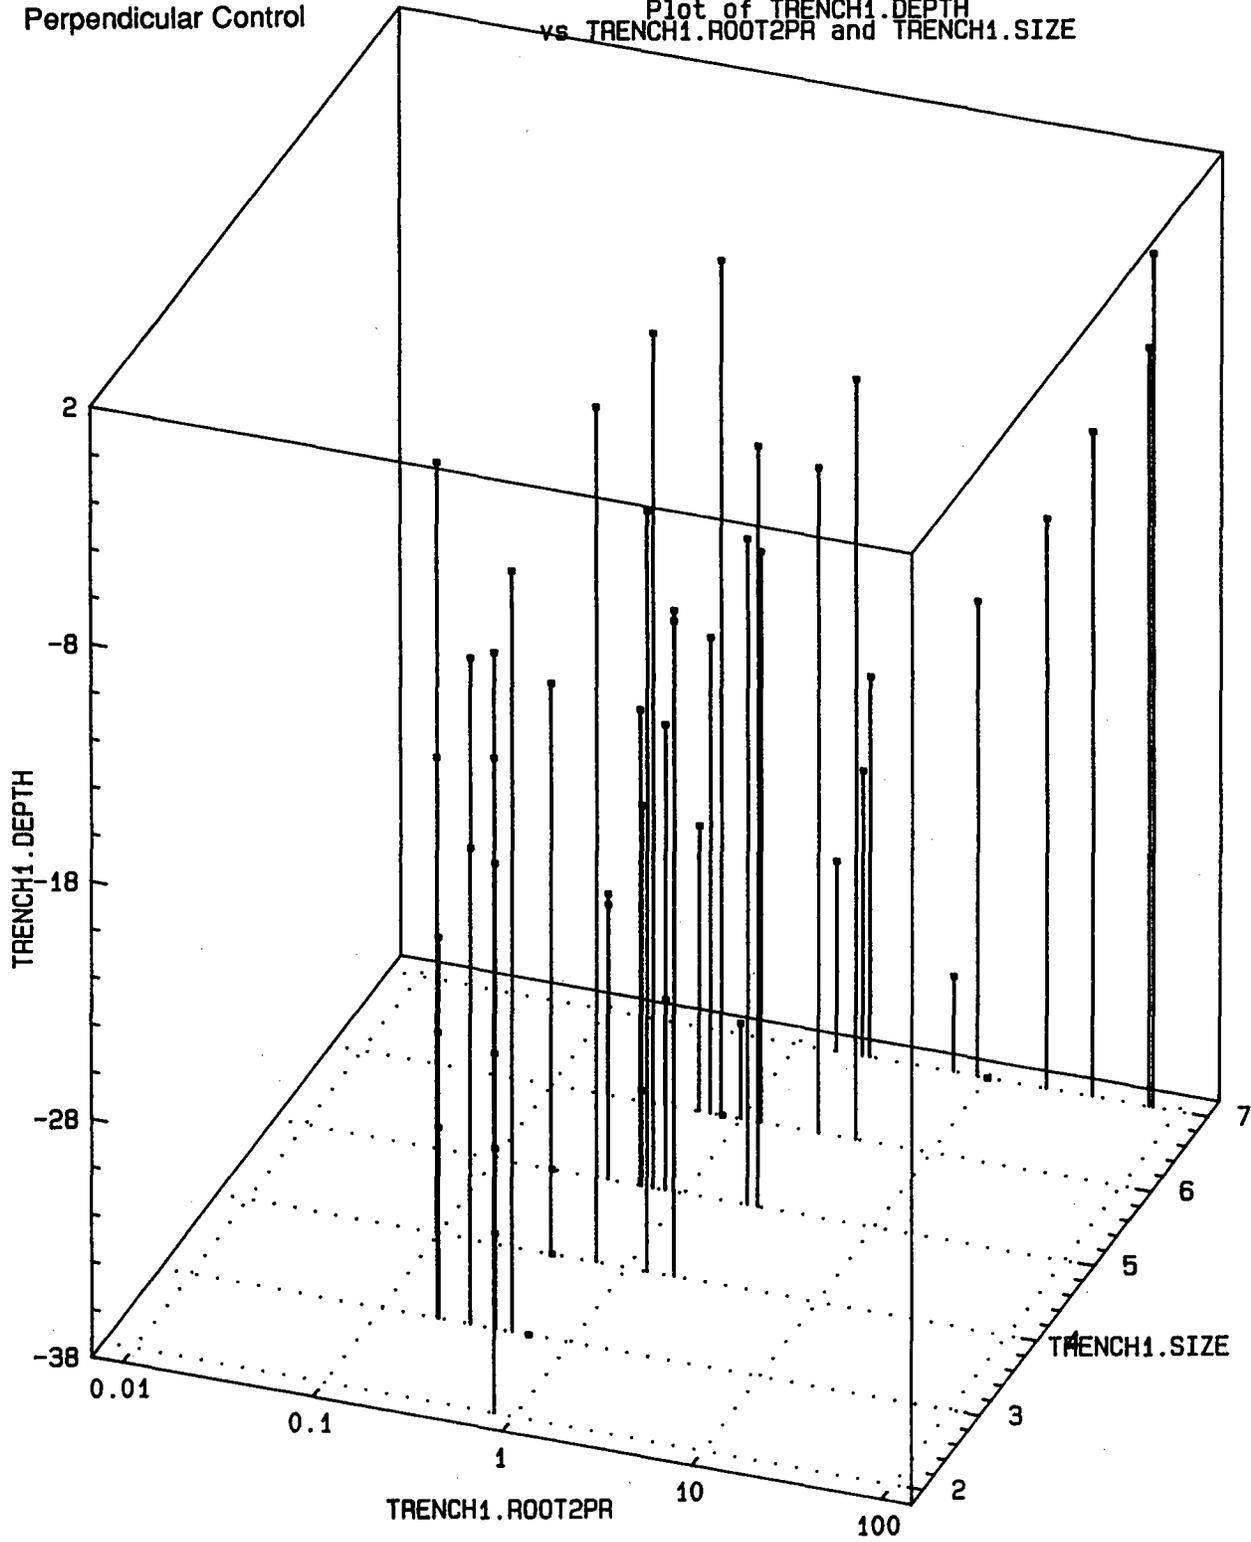
Site 2  
Perpendicular Control

Plot of TRENCH1.DEPTH  
vs TRENCH1.ROOT2PR and TRENCH1.SIZE
