# REPAIR, EVALUATION, MAINTENANCE, AND REHABILITATION RESEARCH PROGRAM

TECHNICAL REPORT REMR-EI-5

## THE EFFECTS OF VEGETATION ON THE STRUCTURAL INTEGRITY OF SANDY LEVEES

Final Report

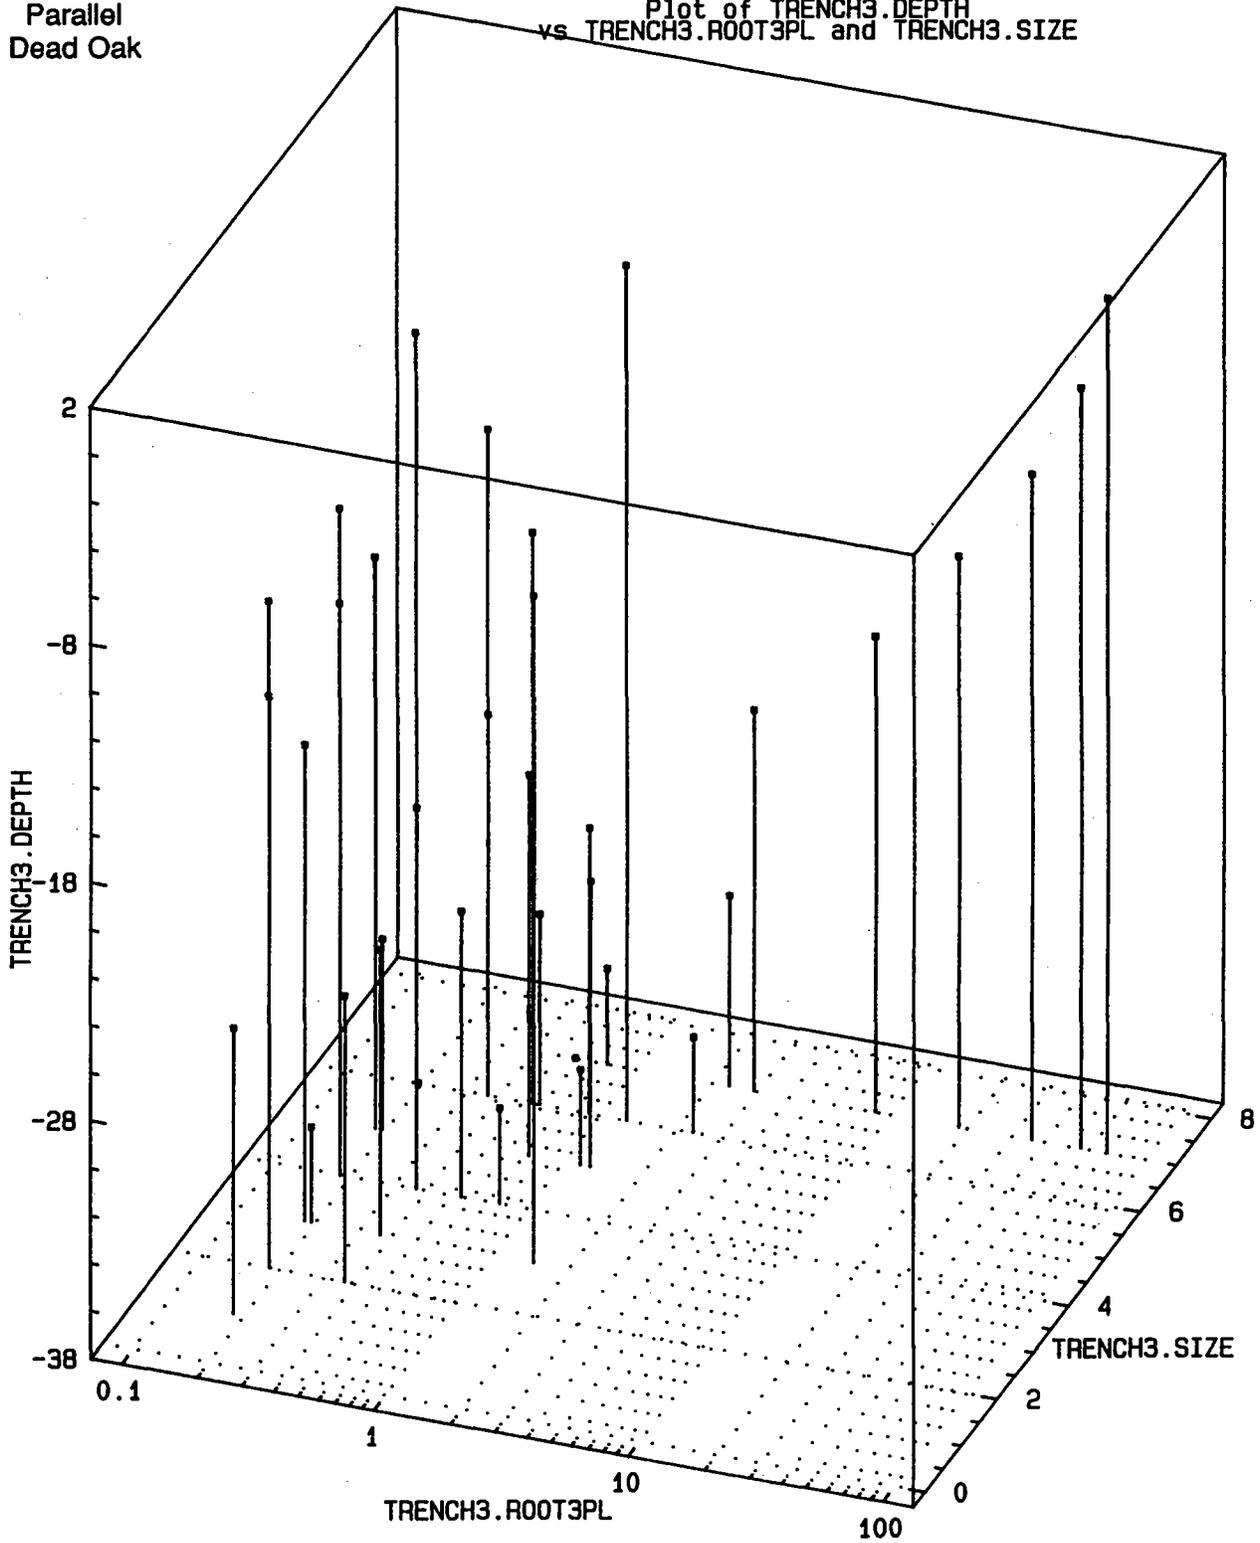
Site 3  
Parallel  
Dead Oak

Plot of TRENCH3.DEPTH  
vs TRENCH3.ROOT3PL and TRENCH3.SIZE

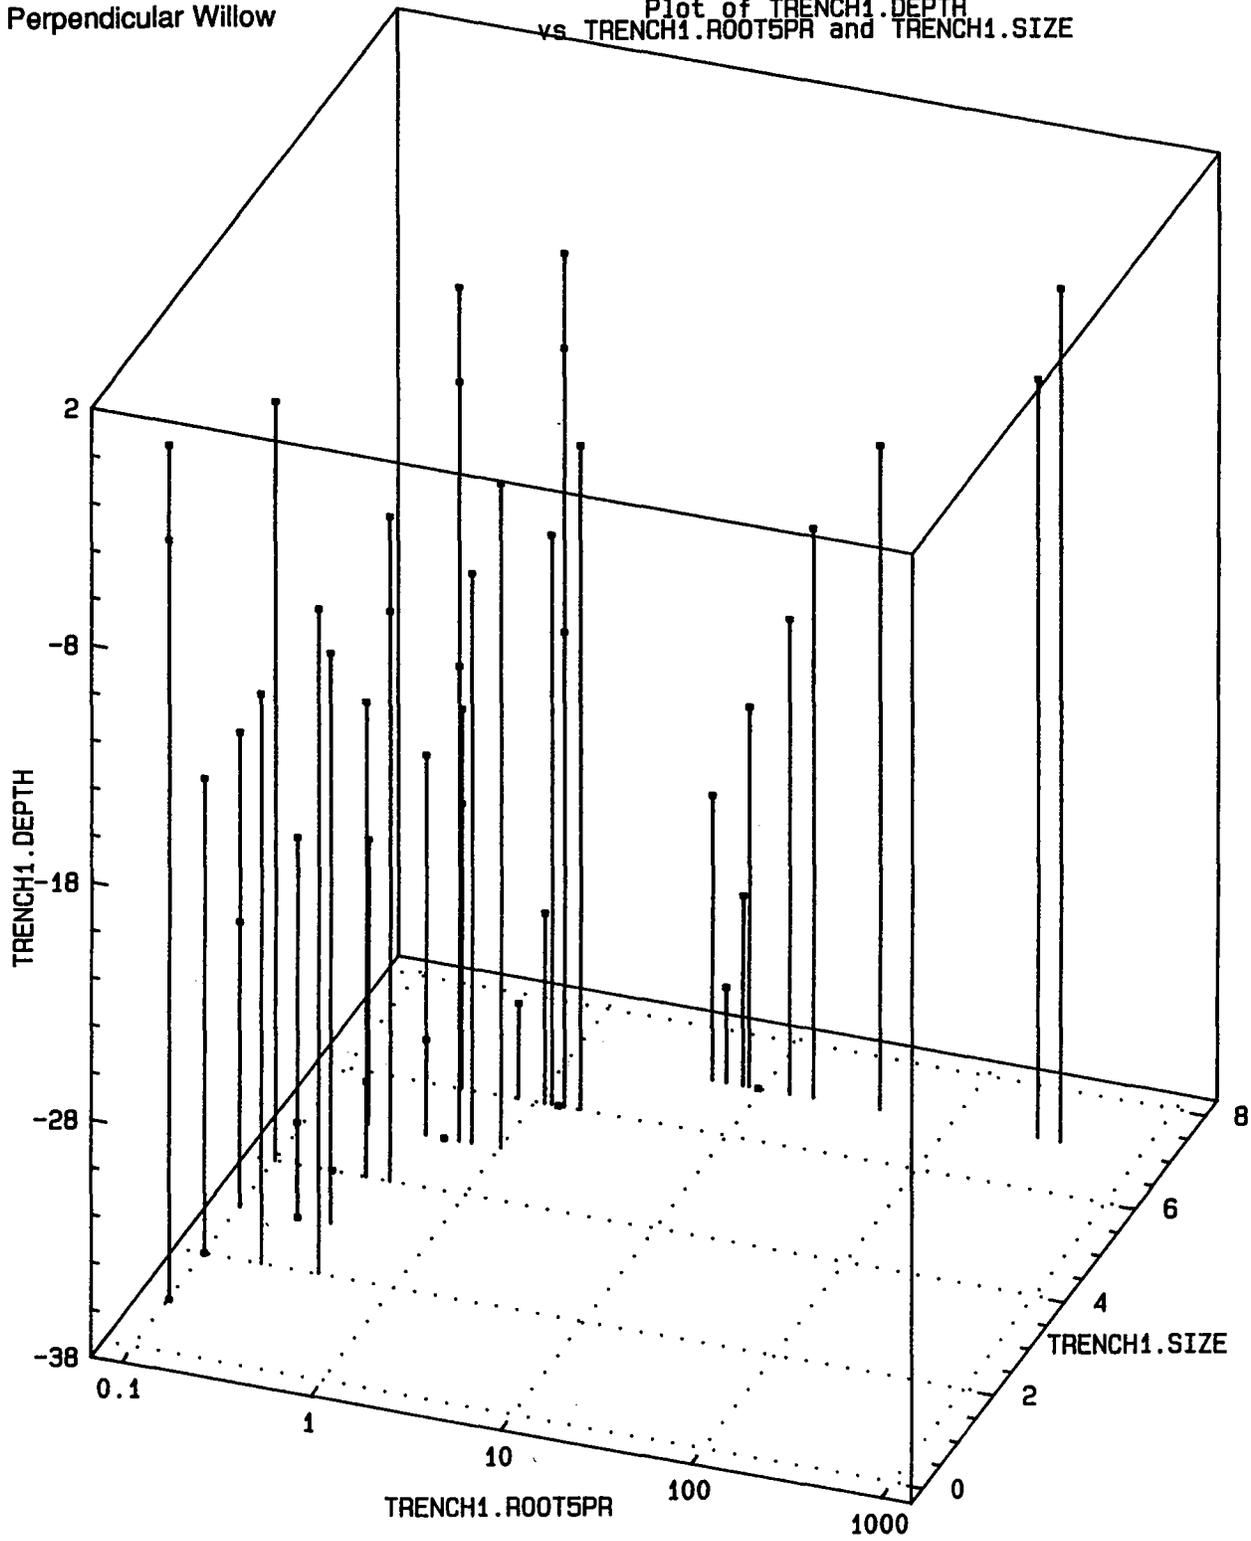
Site 5  
Perpendicular Willow

Plot of TRENCH1.DEPTH  
vs TRENCH1.ROOT5PR and TRENCH1.SIZE

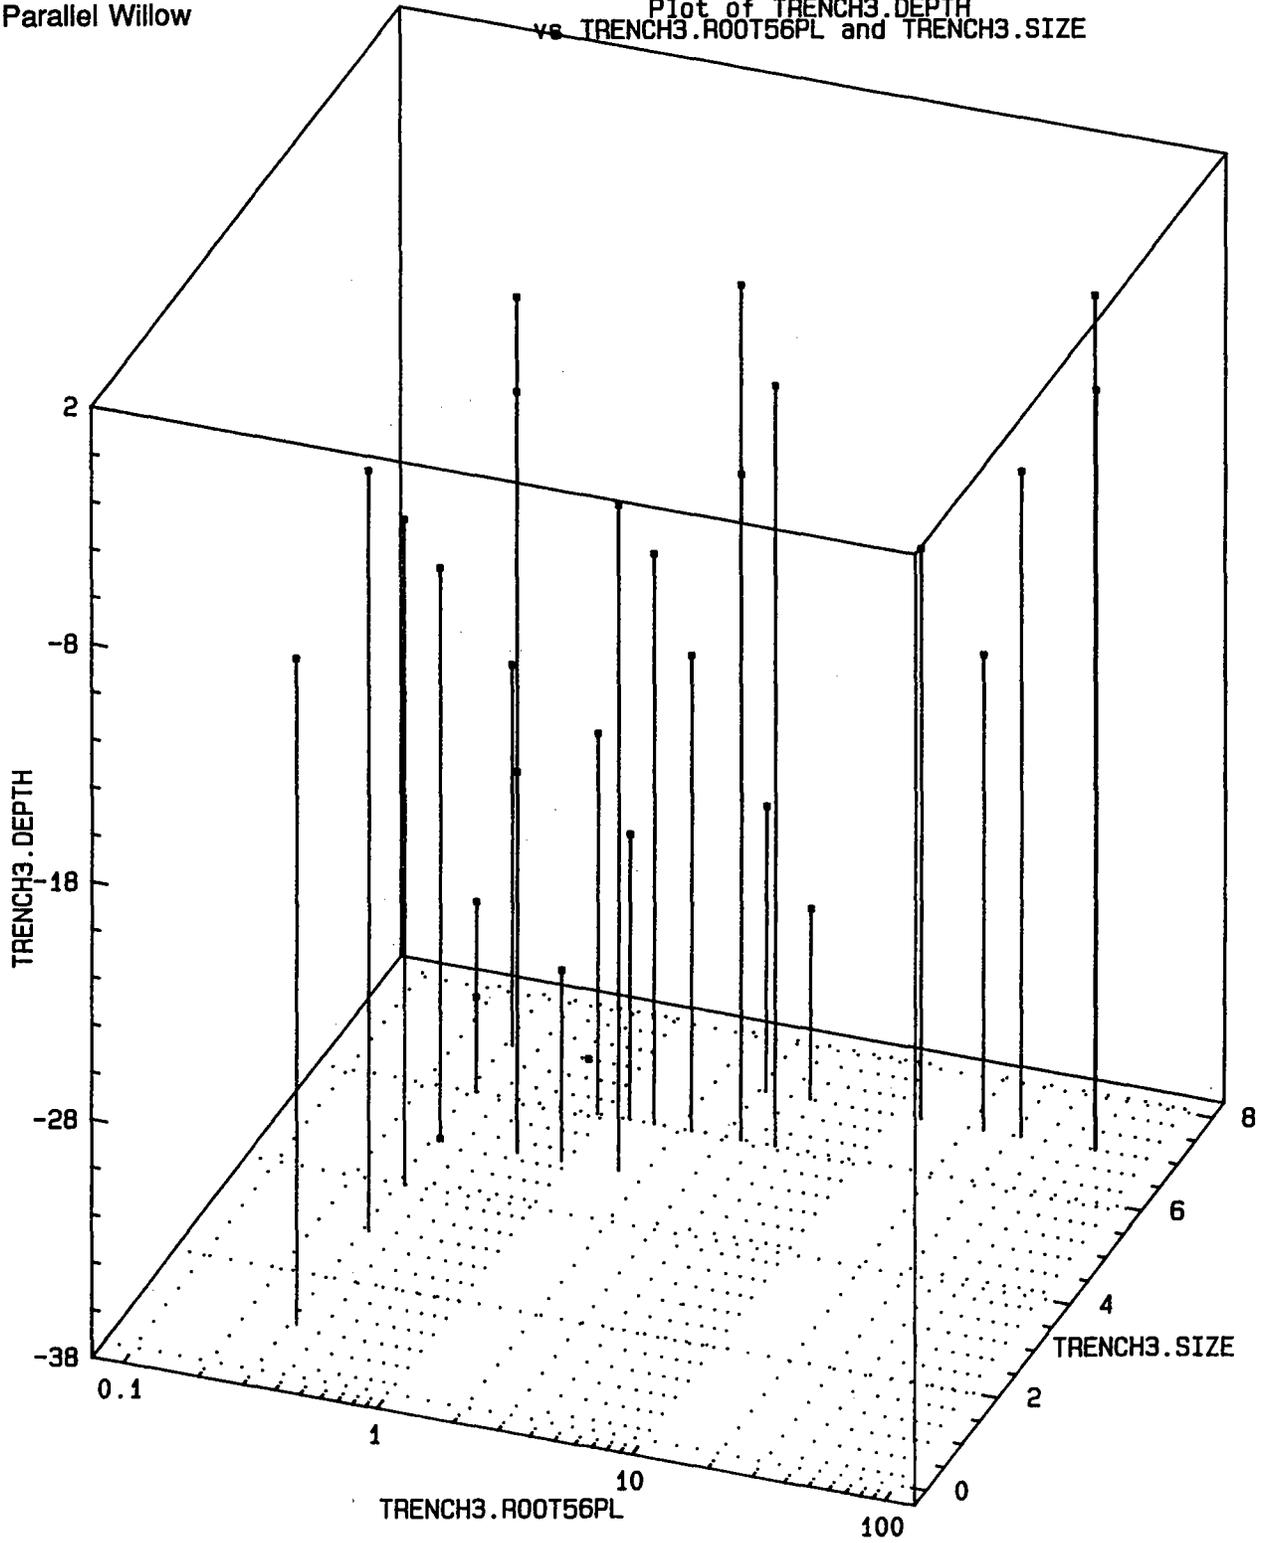
Site 5  
Parallel Willow

Plot of TRENCH3.DEPH  
vs TRENCH3.ROOT56PL and TRENCH3.SIZE

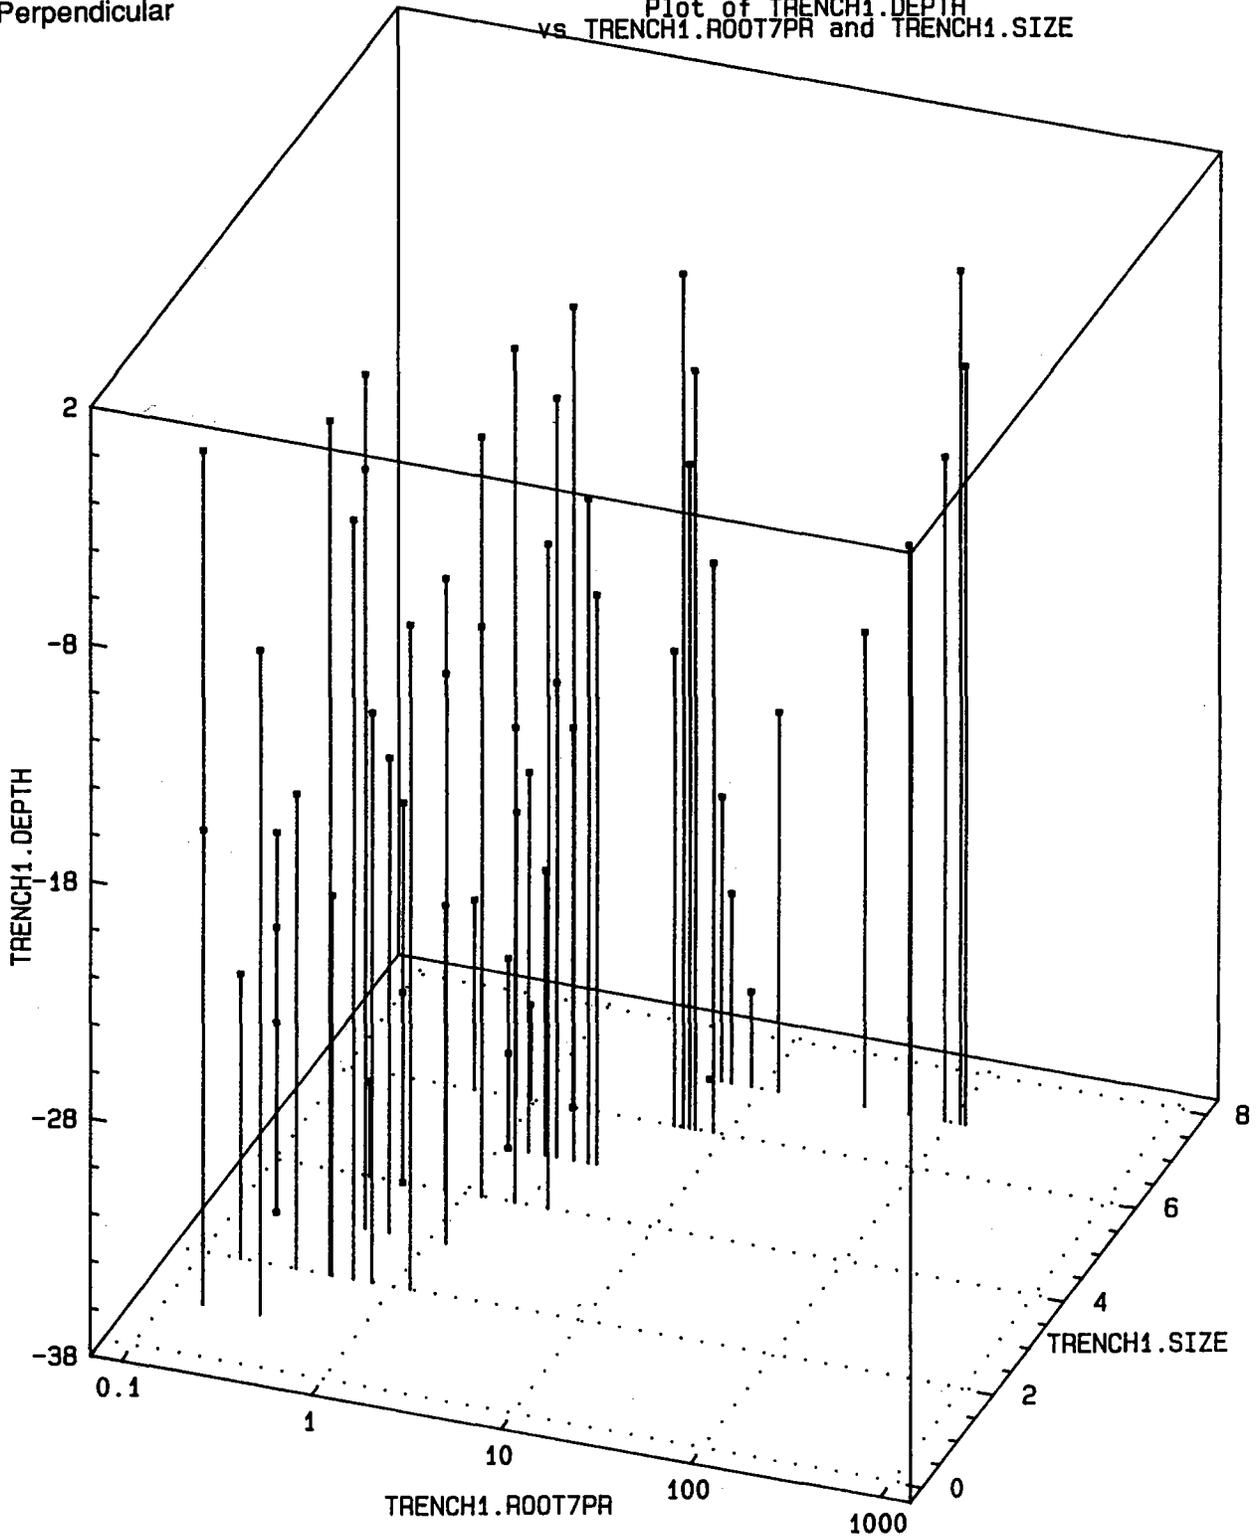
Site 7  
Perpendicular

Plot of TRENCH1.DEPTH  
vs TRENCH1.ROOT7PR and TRENCH1.SIZE

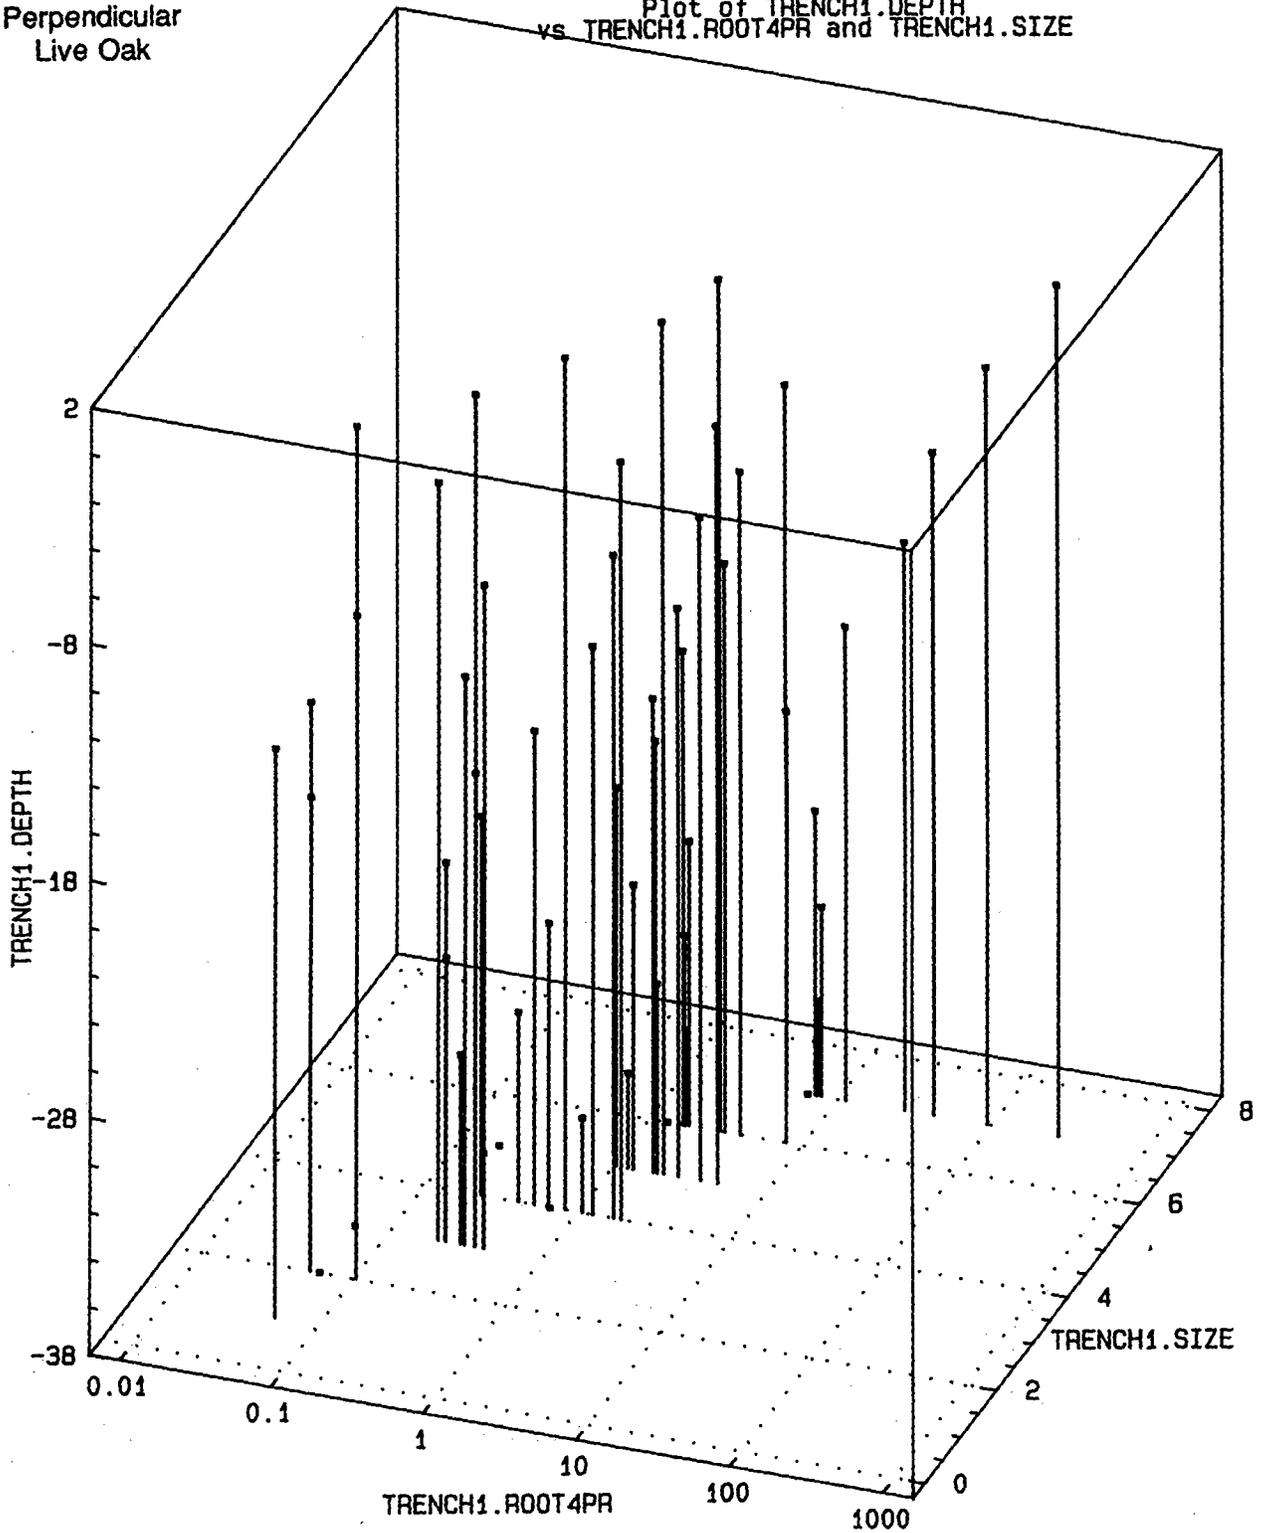
Site 4  
Perpendicular  
Live Oak

Plot of TRENCH1.DEPTH  
vs TRENCH1.ROOT4PR and TRENCH1.SIZE

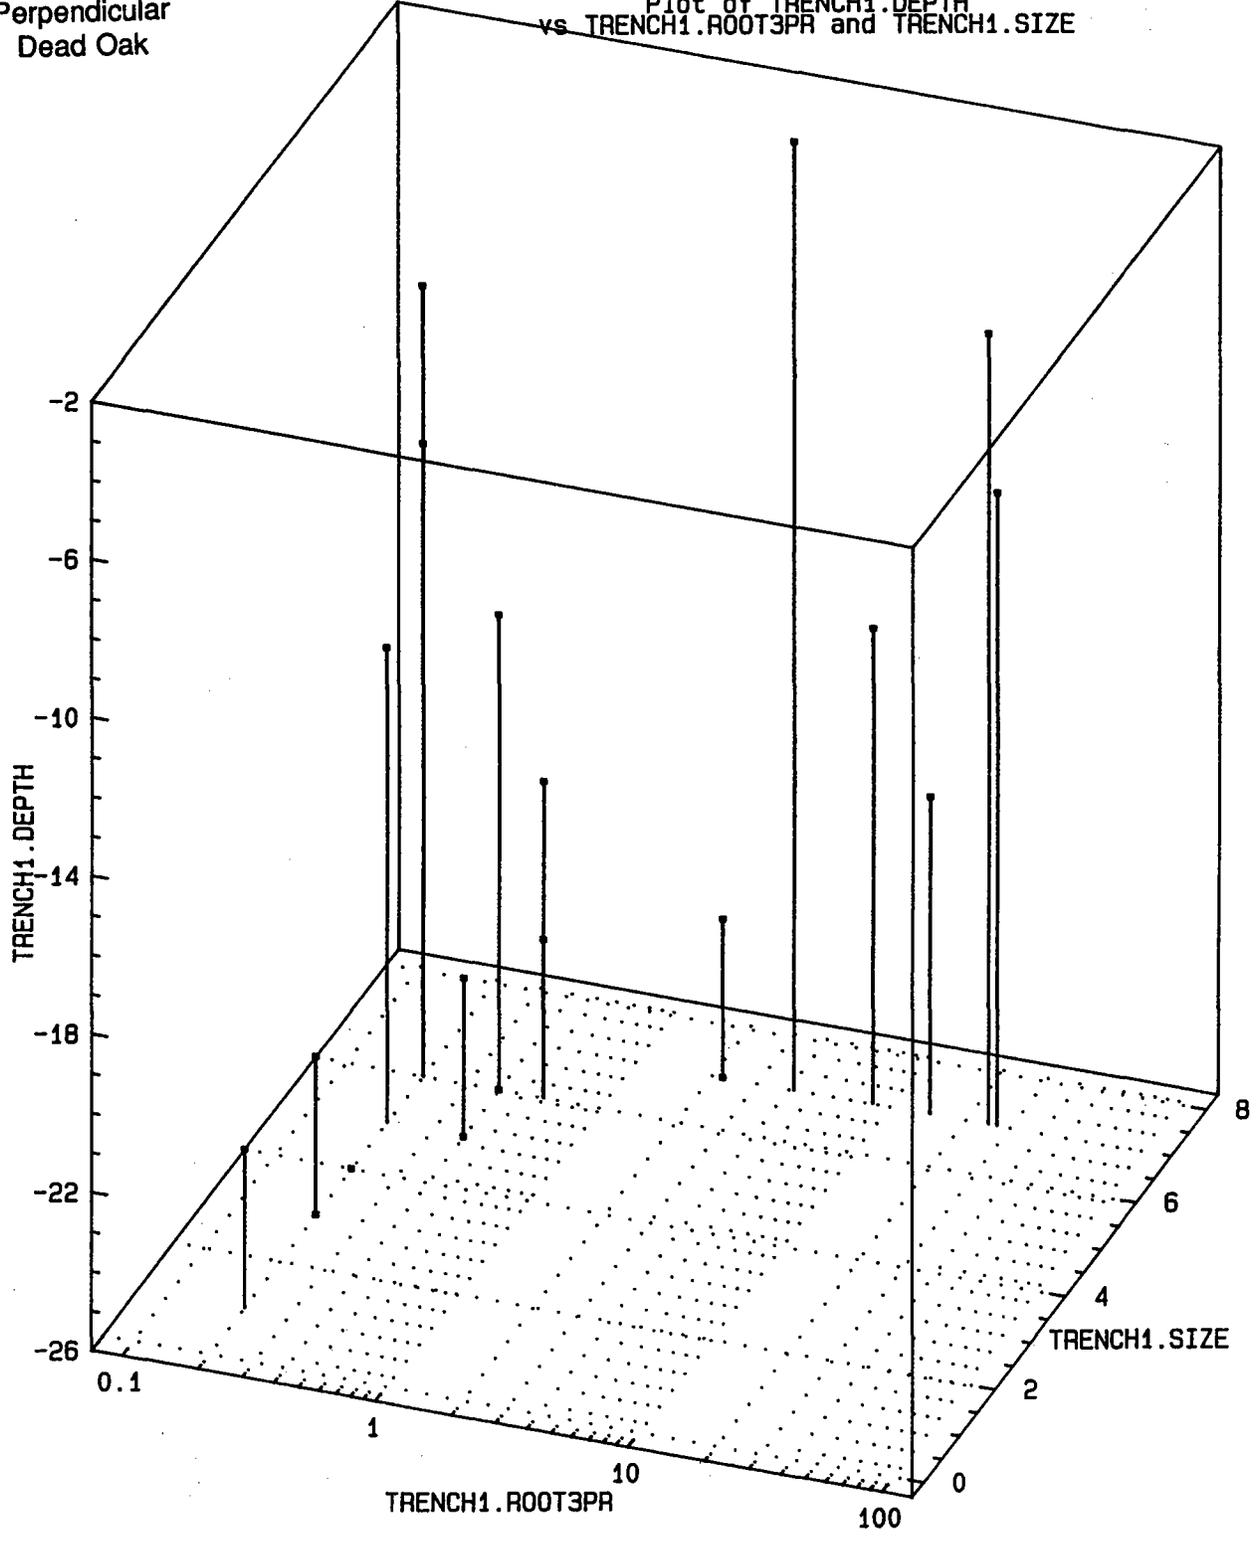
Site 3  
Perpendicular  
Dead Oak

Plot of TRENCH1.DEPTH  
vs TRENCH1.ROOT3PR and TRENCH1.SIZE

Z (vertical) axis--depth below surface in inches times -1. The upper limit of +2 was set by the automatic scaling routine in the plot software--there has been some trouble with the software when attempts are made to manually set the scales. Note that all plots have Z axes scaled from +2 to -38, except site 2 (parallel) and site 3 (perpendicular).

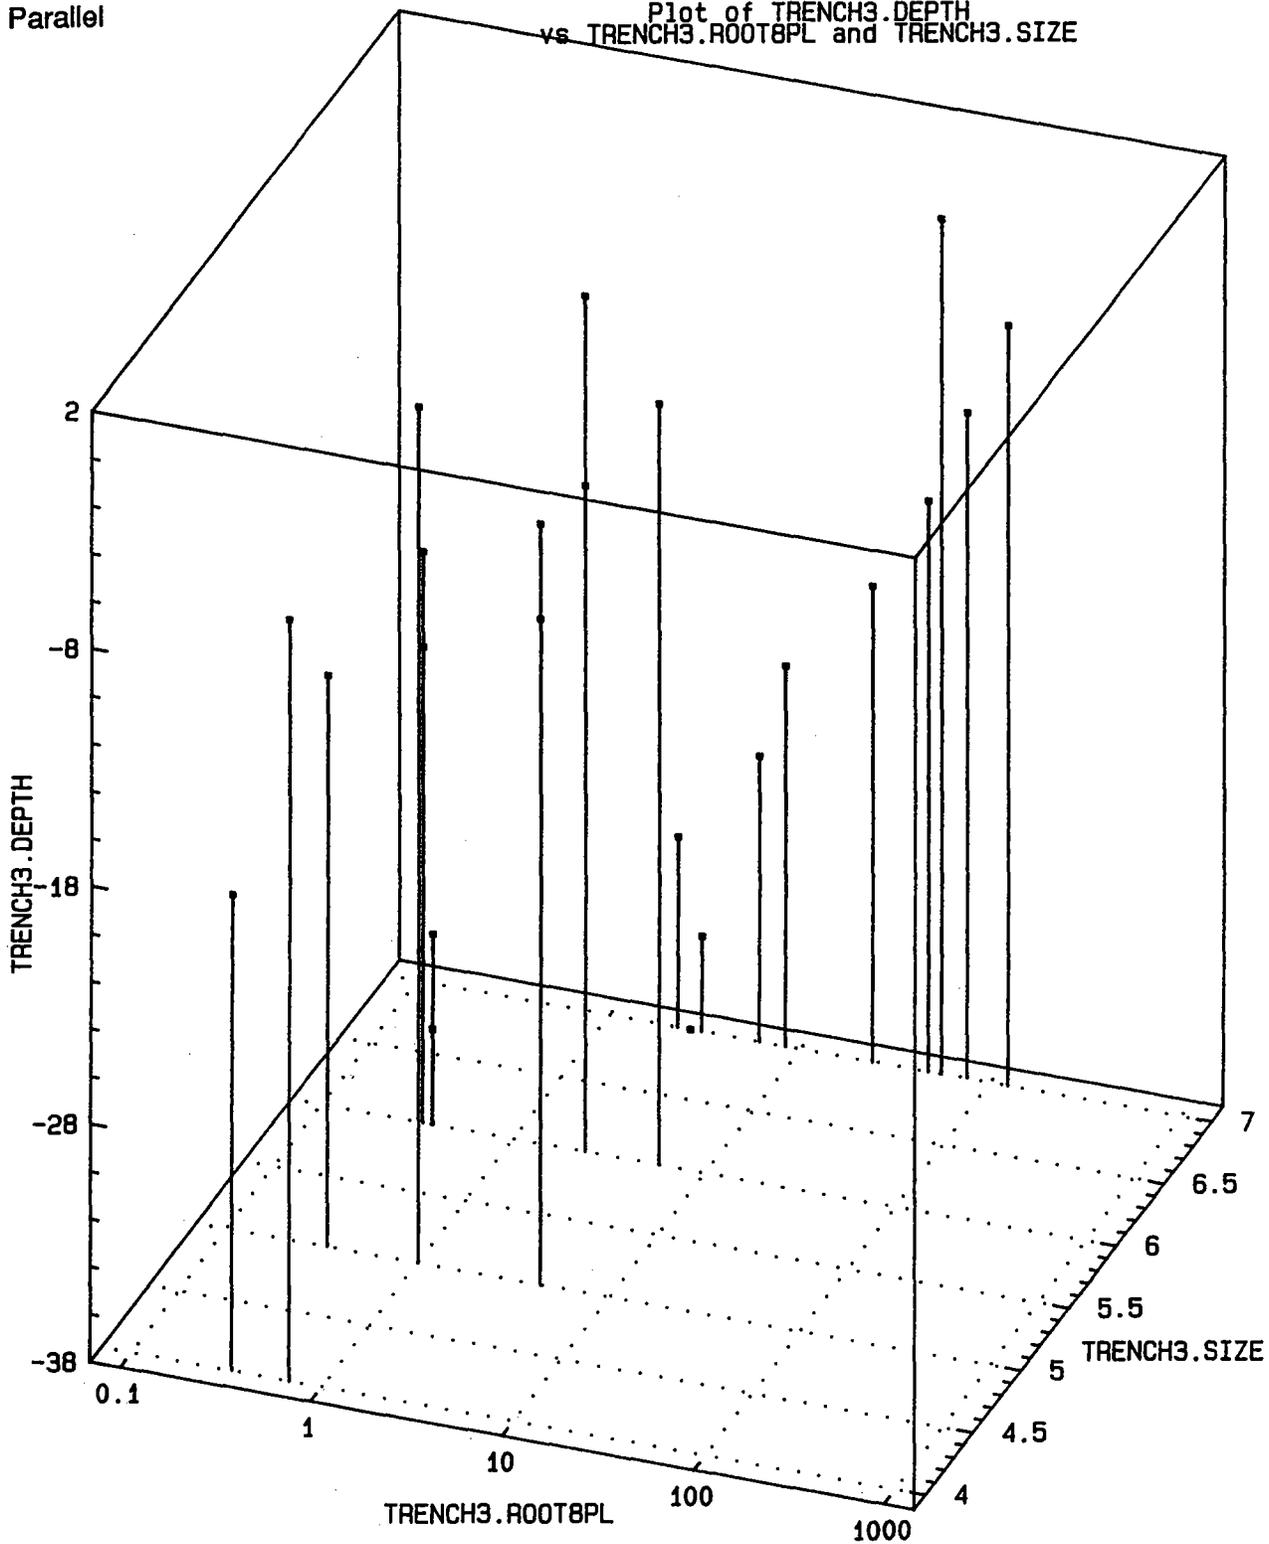
Site 8  
Parallel

Plot of TRENCH3.DEPTH  
vs TRENCH3.ROOT8PL and TRENCH3.SIZE

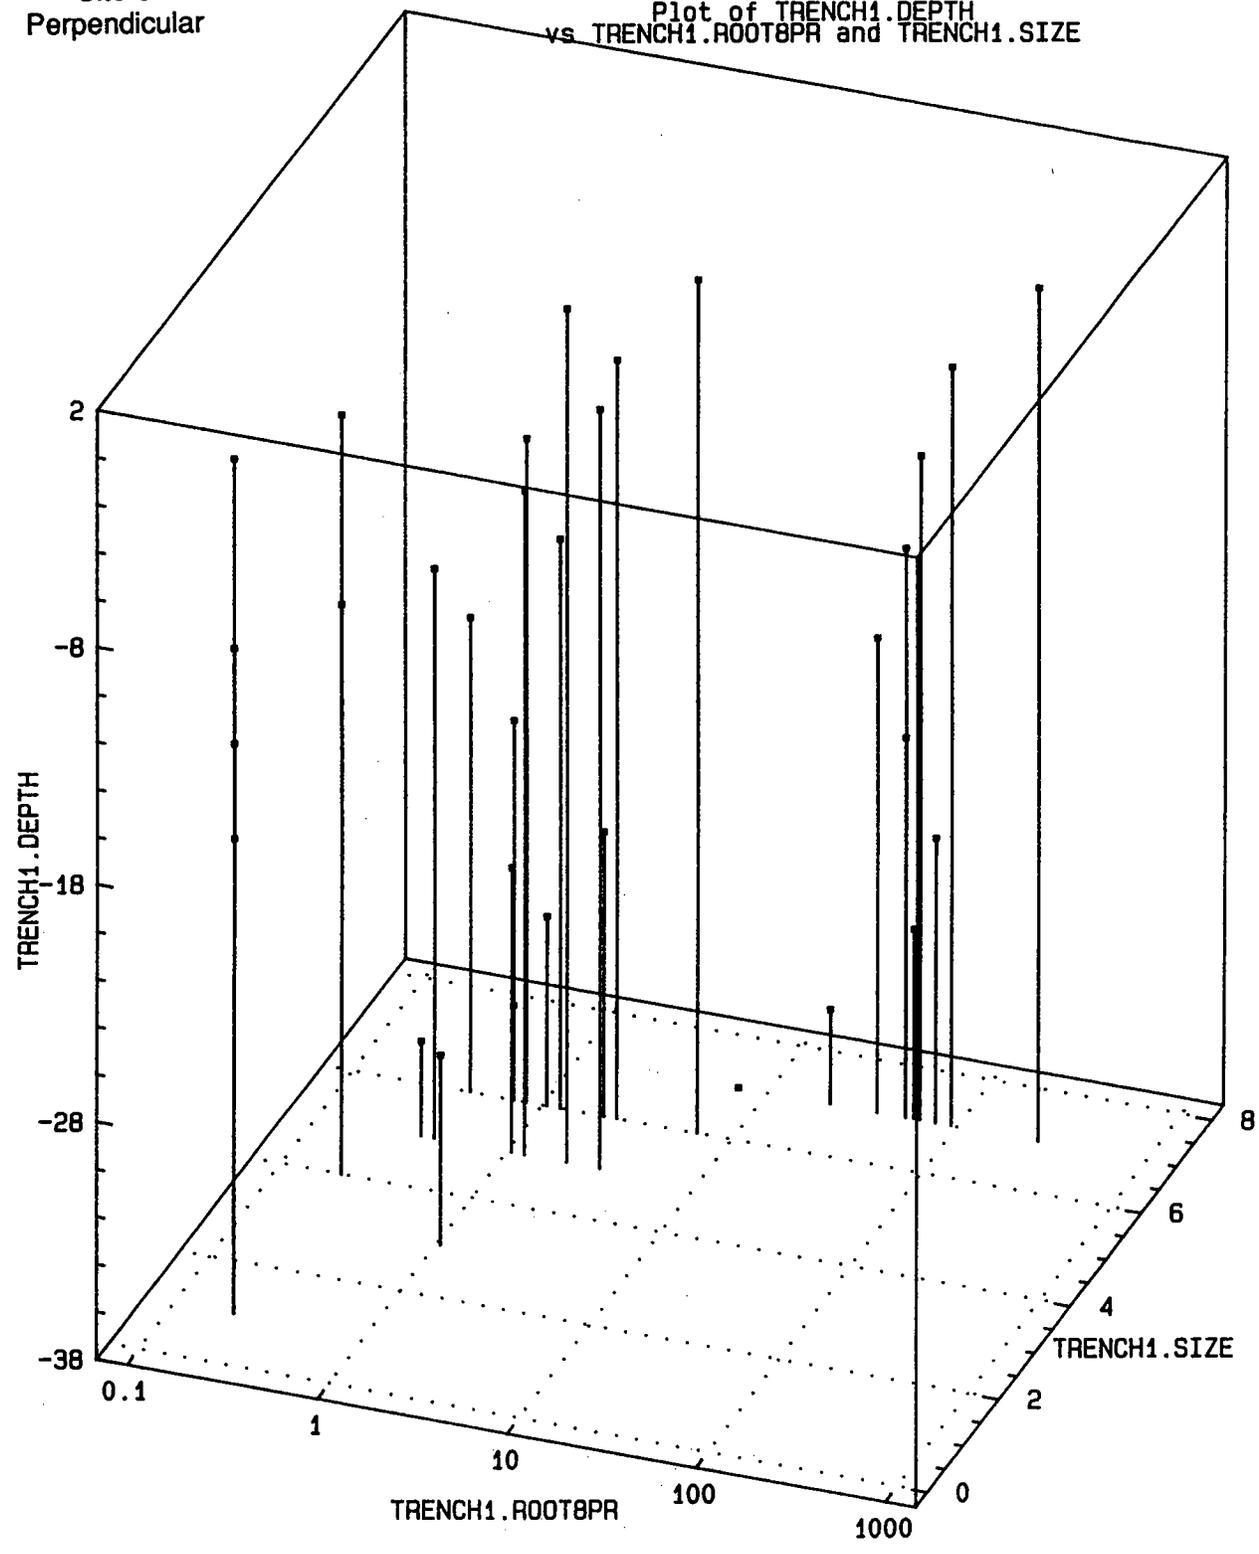
Site 8  
Perpendicular

Plot of TRENCH1.DEPTH  
vs TRENCH1.ROOT8PR and TRENCH1.SIZE
