CALIFORNIA DEPARTMENT OF WATER RESOURCES (DWR)

REVIEW REPORT OF SERIOUS ACCIDENT

San Luis Field Division Dive Fatalities

Date of Accident: February 7, 2007

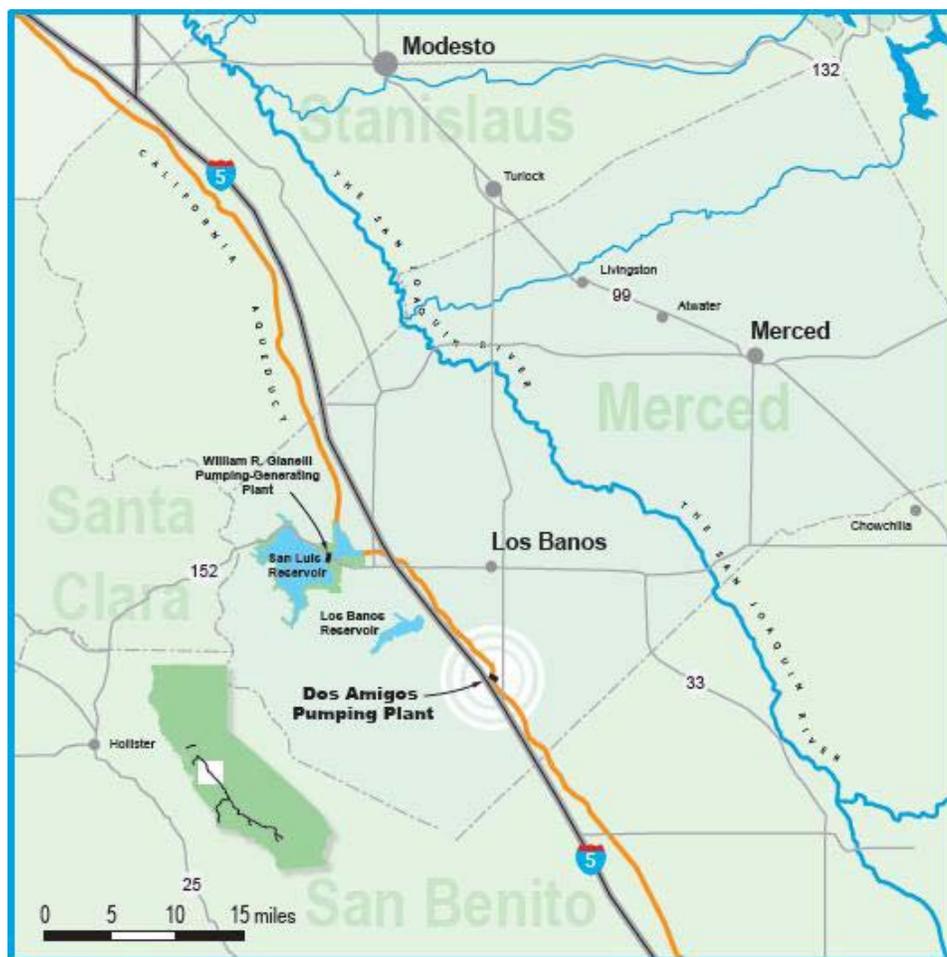
Figure 1

The accident occurred in the California Aqueduct just upstream of the Dos Amigos pumping plant (DAPP). DAPP is located approximately nine miles south of Los Banos, California in Merced County (See Figure 1). Water flows within the California Aqueduct by gravity from O'Neil Forebay to DAPP. The plant houses six pumps that lift water 113 feet where it then reenters the aqueduct downstream of the plant. The water is then able to flow by gravity within the aqueduct to the next pumping station 162 miles south of DAPP.

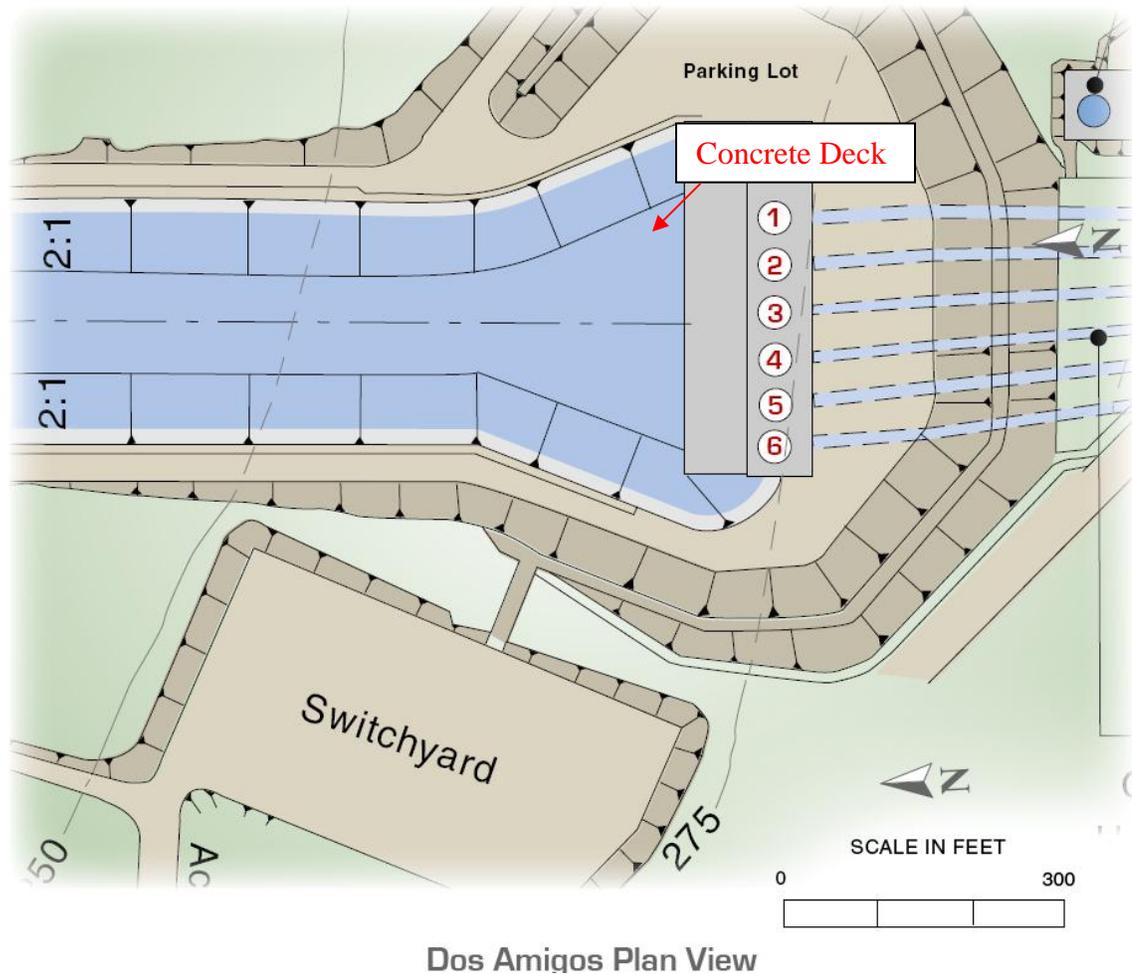
Figure 2

The aqueduct is a lined concrete trapezoidal channel, 110 feet wide at its base with 2:1 side slopes. The aqueduct flares out to the pumping plant which is 388 feet wide. The depth of water within the aqueduct varies, but is generally about 30 feet. A concrete deck crosses the intake above the trashracks (See Figures 2 and 3).

Each unit is capable of pumping approximately 2700 cfs. The pumps are numbered Units 1 to 6 with Unit 1 located on the east side of the plant and Unit 6 located on the west side of the plant (See Figure 2). Units 1, 3 and 5 are variable speed, capable of pumping any amount of flow between half and full capacity. Units 2, 4 and 6 can pump only at full capacity or off. Shutting off the pumps causes water to momentarily reverse the direction of the water flow back into the aqueduct. Observations by team members during recent tests confirm that shutting down a pump results in reverse flow that causes water to push any accumulated debris approximately 30 to 50 feet upstream.

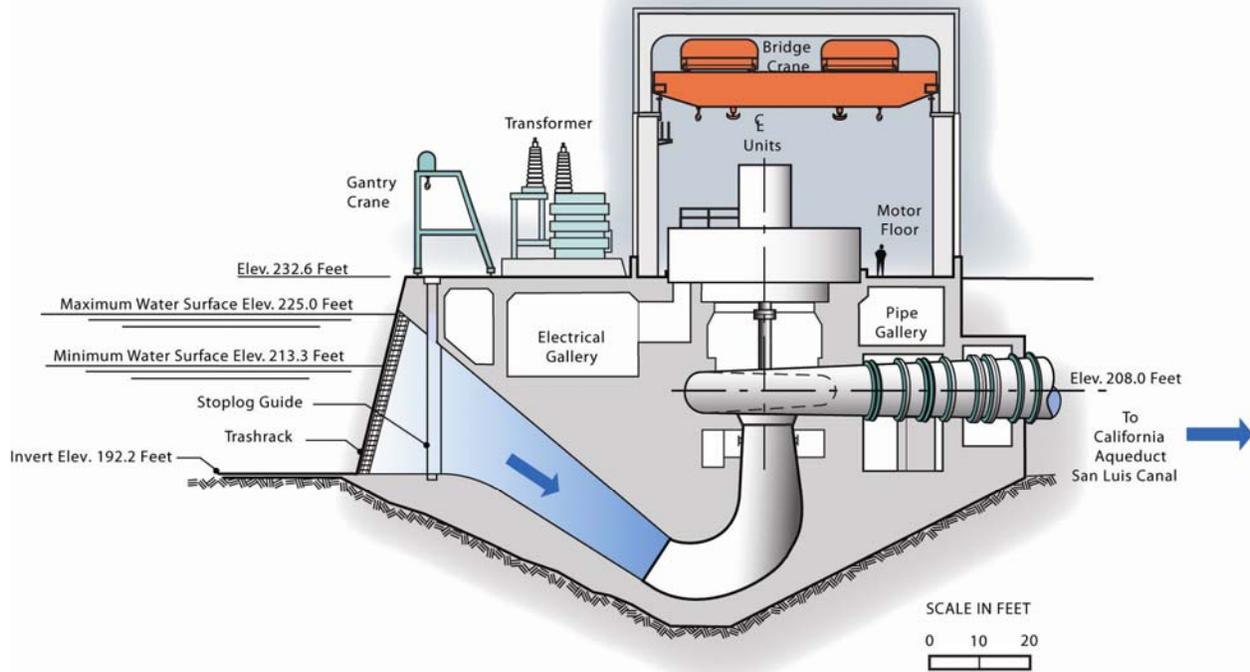
Figure 3

Dos Amigos Cross Section

Each pump is protected by three trashracks, each about 34 feet tall by 10 feet wide. The trashracks are made of steel bars that have a spacing of six inches. The trashracks are inclined at an angle of 14 degrees from vertical (See Figure 3). The purpose of the trashracks is to prevent large debris from entering the pumps. Debris buildup clogs the trashracks of operating units, which can have a significant effect on water velocities near the trashracks.
