BULLETIN No. 149-66

PROJECT LEVEE  
MAINTENANCE AND REPAIR  
1966 INSPECTION REPORT

Bulletin No. 149-66 PROJECT LEVEE MAINTENANCE AND REPAIR  
1966 INSPECTION REPORT May 1967

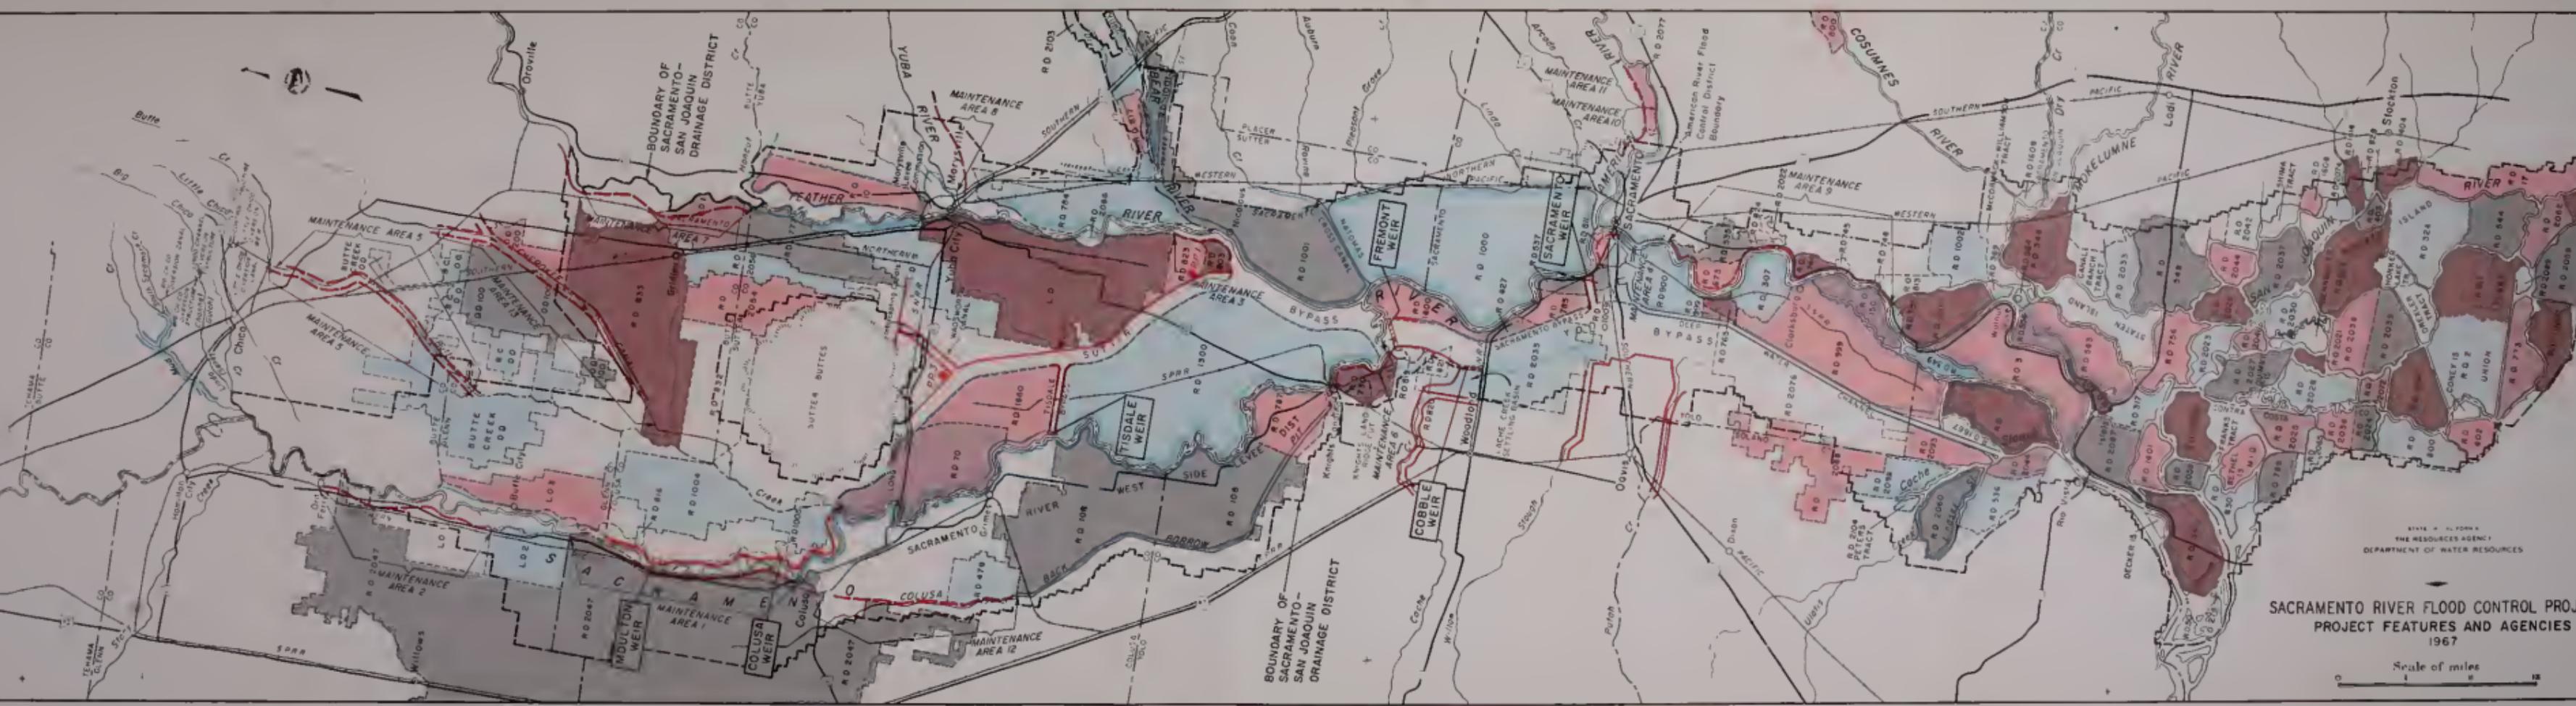
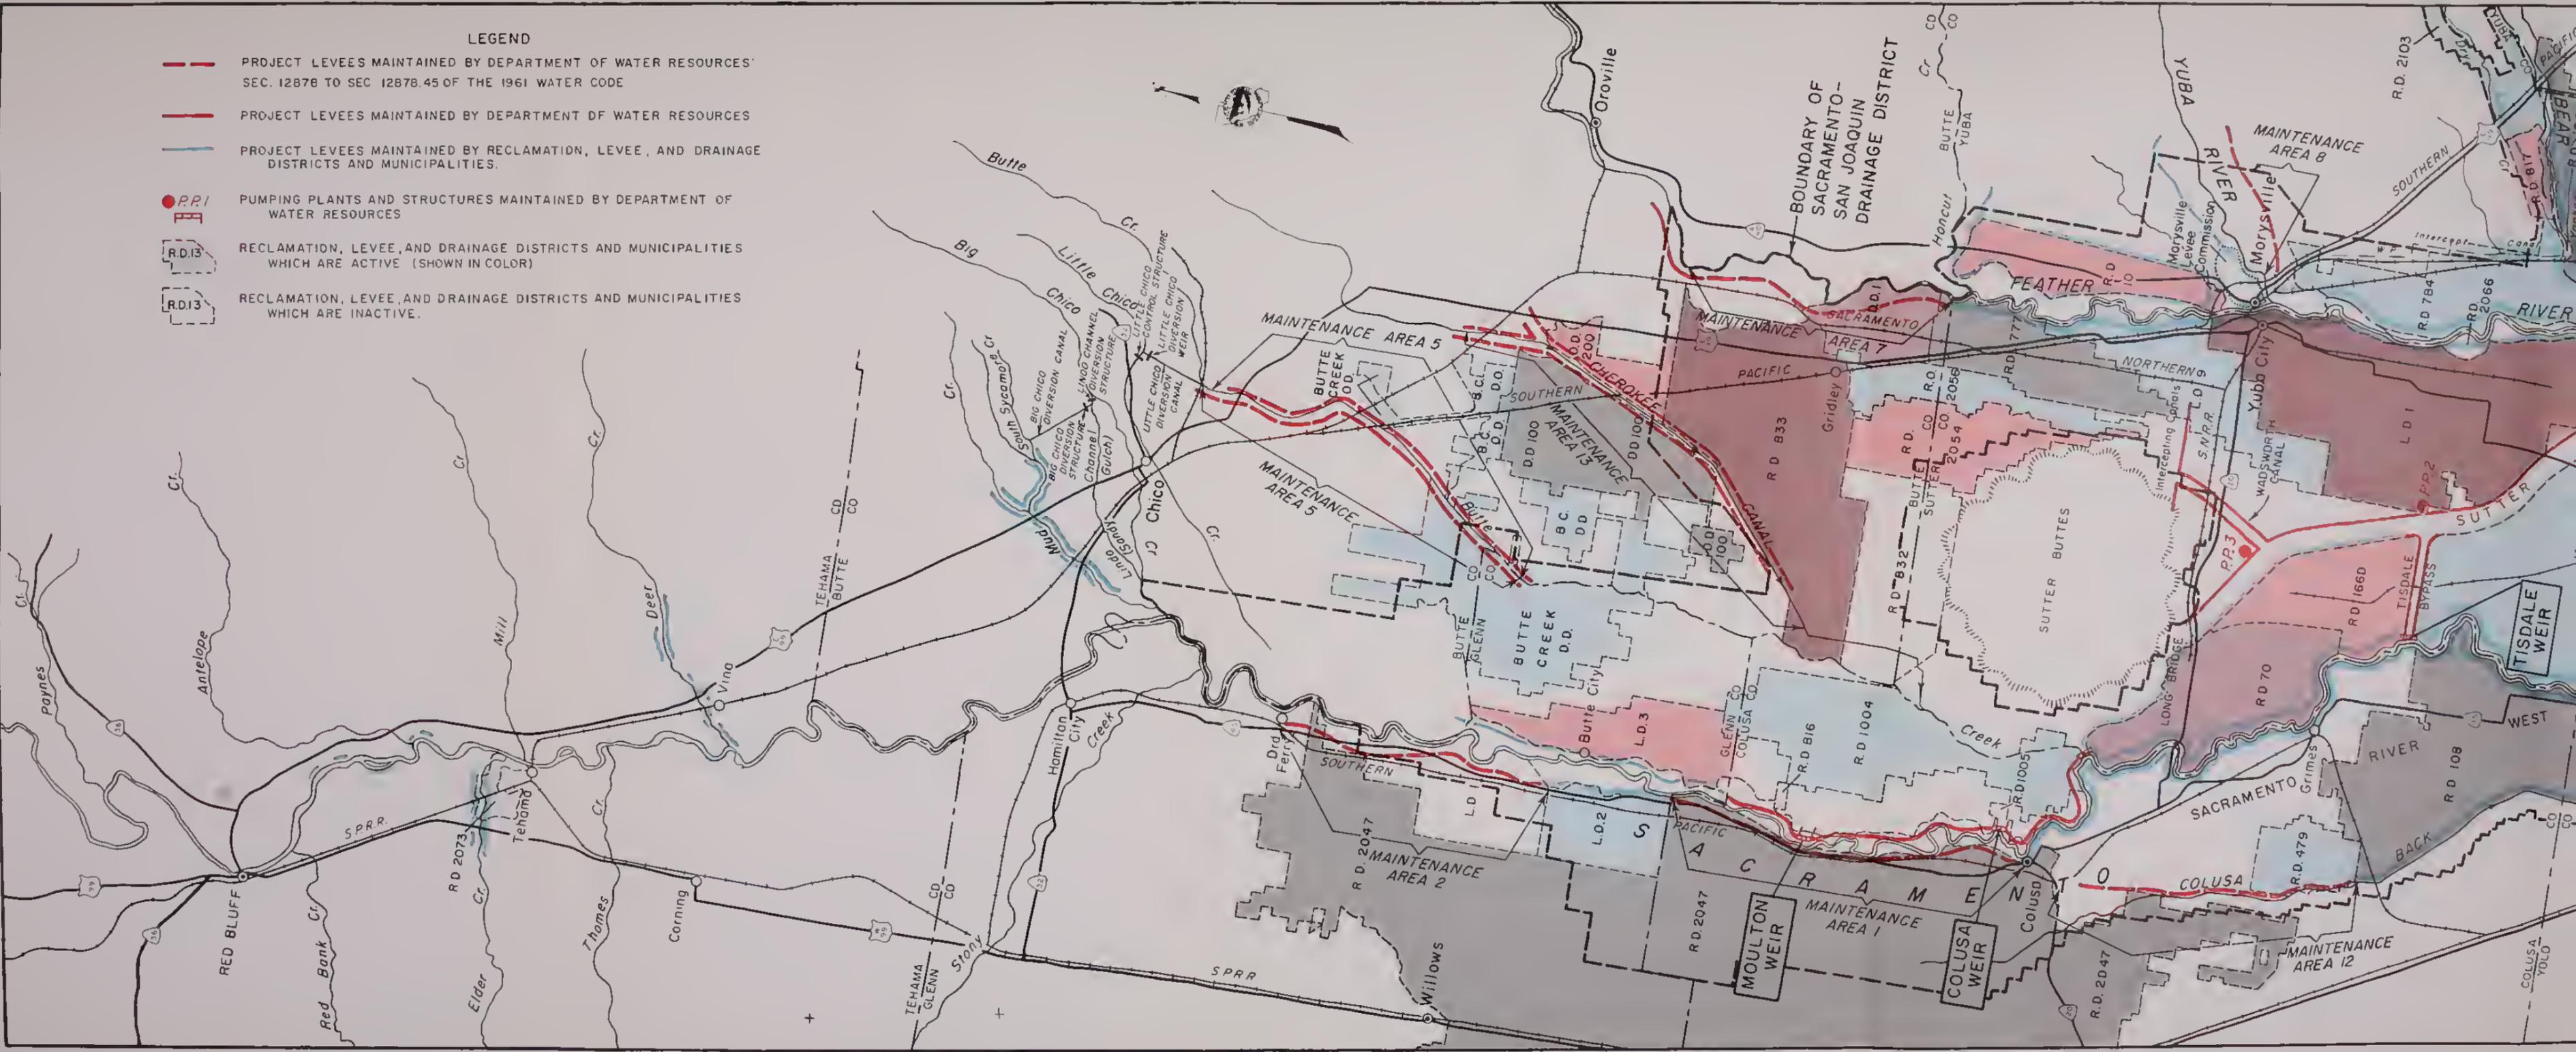
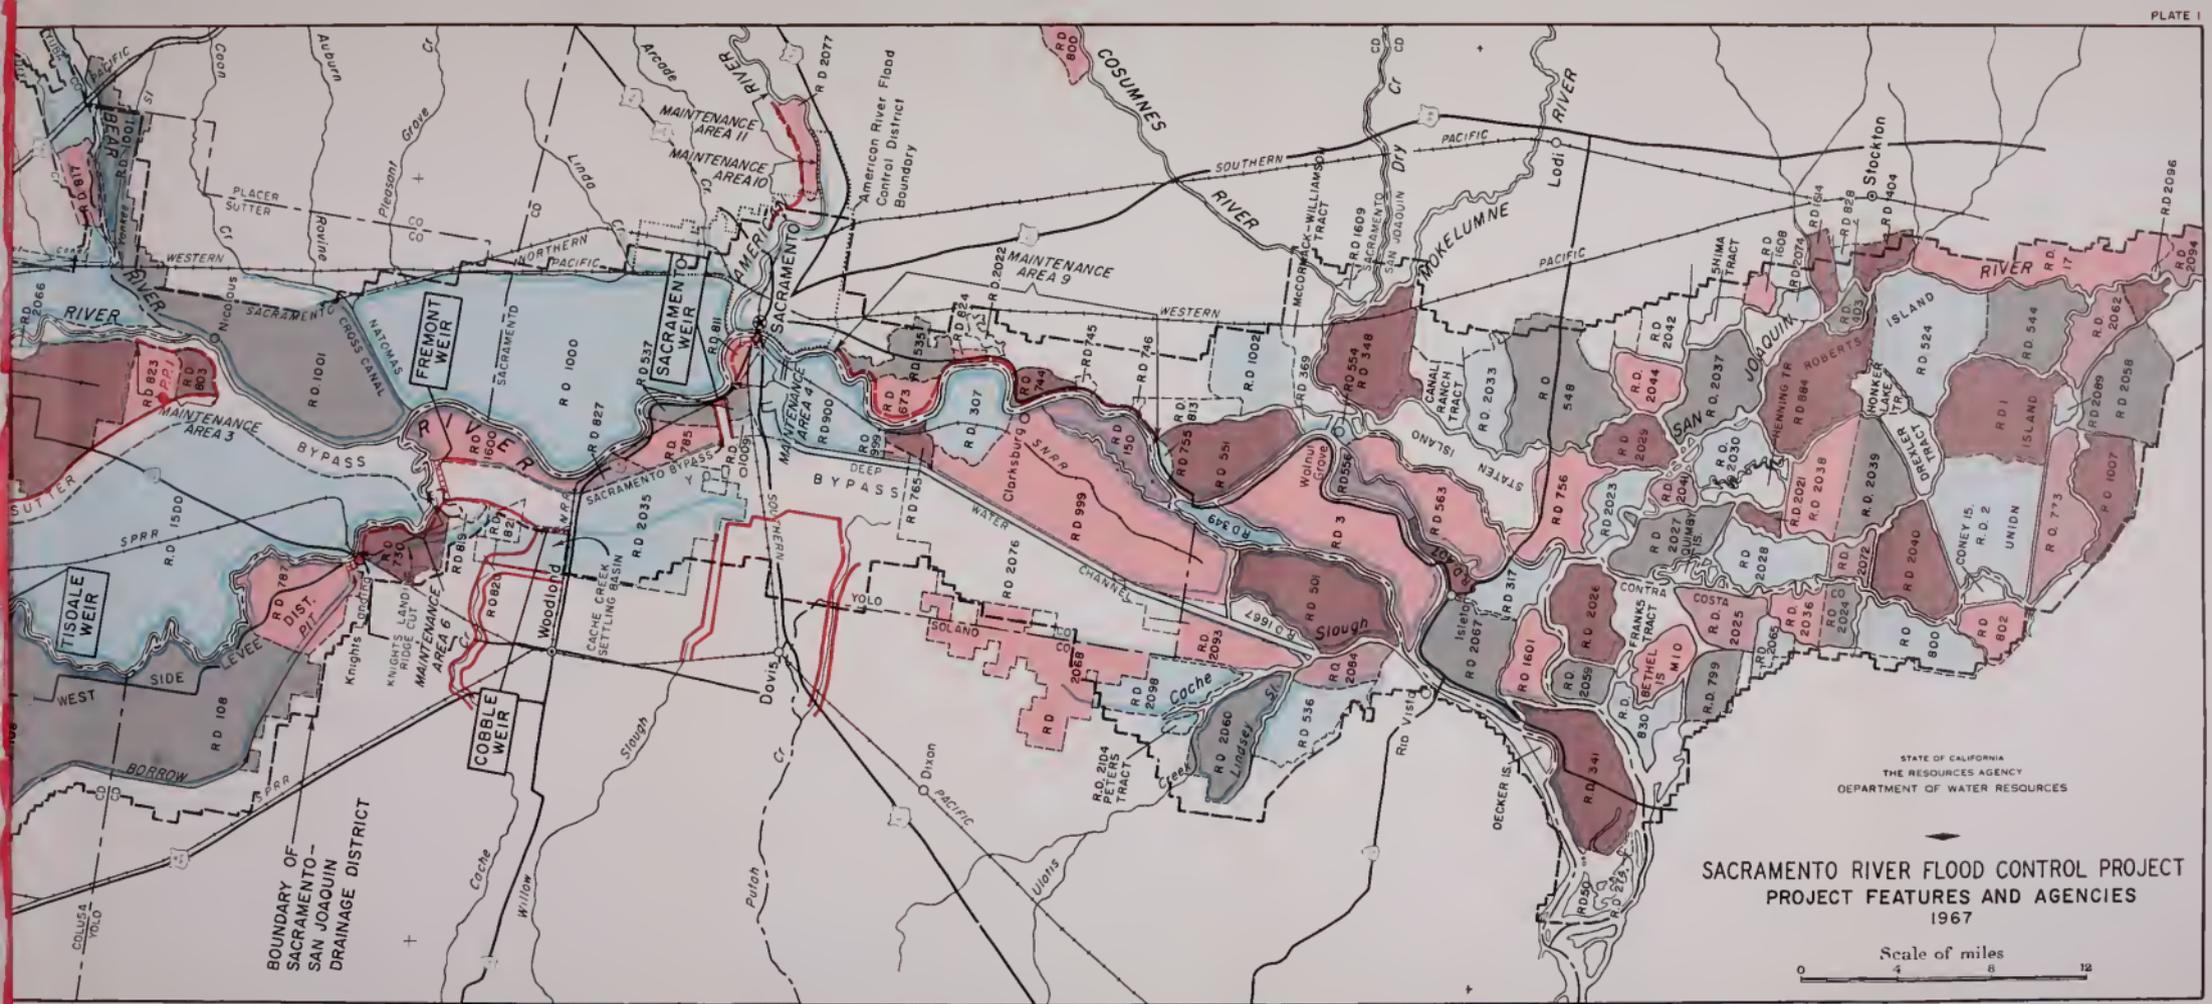
SACRAMENTO RIVER FLOOD CONTROL PROJECT  
PROJECT FEATURES AND AGENCIES  
1967

- PROJECT LEVELS MAINTAINED BY DEPARTMENT OF WATER RESOURCES' SEC. 12878 TO SEC 12878.45 OF THE 1961 WATER CODE
- PROJECT LEVELS MAINTAINED BY DEPARTMENT OF WATER RESOURCES
- PROJECT LEVELS MAINTAINED BY RECLAMATION, LEVEE, AND DRAINAGE DISTRICTS AND MUNICIPALITIES.
- P.P.1 PUMPING PLANTS AND STRUCTURES MAINTAINED BY DEPARTMENT OF WATER RESOURCES
- R.D.13 RECLAMATION, LEVEE, AND DRAINAGE DISTRICTS AND MUNICIPALITIES WHICH ARE ACTIVE (SHOWN IN COLOR)
- R.D.13 RECLAMATION, LEVEE, AND DRAINAGE DISTRICTS AND MUNICIPALITIES WHICH ARE INACTIVE.

BOUNDARY OF  
SACRAMENTO -  
SAN JOAQUIN  
DRAINAGE DISTRICT

The report entitled "Bulletin 149-66, Project Levee Maintenance and Repair" contains ratings of the quality of maintenance performed during 1966 on levees within the flood control projects totaling 1,374 miles in length. / Project levees inspected include the Sacramento, American, San Joaquin, Calaveras, Littlejohns and Truckee Rivers, Merced County Stream Group, Middle Creek, Big Dry Creek Reservoir and Diversion and the Lower San Joaquin Flood Control Project. / The report also contains information in regard to standard maintenance procedures, levee reconstruction completed by the U. S. Corps of Engineers, results of the 1966 bank erosion survey, and foldout plates showing locations of project levees and the various maintaining agencies.

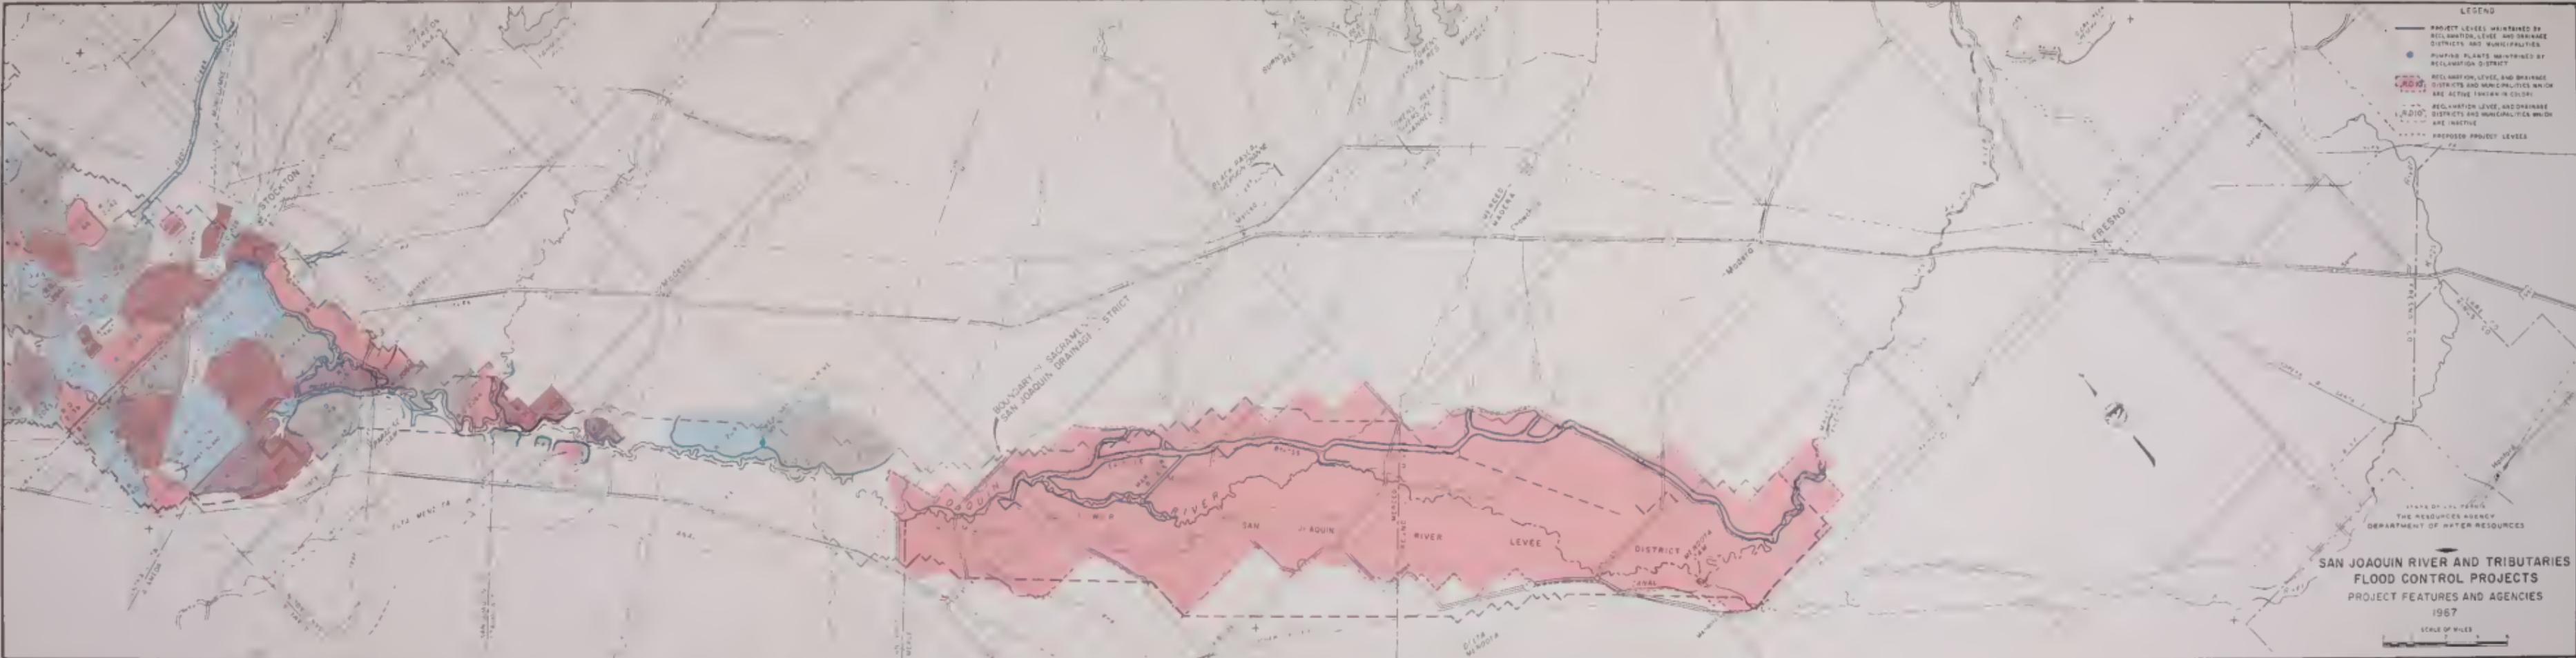
**SAN JOAQUIN RIVER AND TRIBUTARIES  
 FLOOD CONTROL PROJECTS  
 PROJECT FEATURES AND AGENCIES  
 1967**

- LEGEND
- PROJECT LEVELS MAINTAINED BY RECLAMATION, LEVEE AND DRAINAGE DISTRICTS AND MUNICIPALITIES
  - PUMPING PLANTS MAINTAINED BY RECLAMATION DISTRICT
  - RECLAMATION, LEVEE, AND DRAINAGE DISTRICTS AND MUNICIPALITIES WHICH ARE ACTIVE (SHOWN IN COLOR)
  - - - RECLAMATION, LEVEE, AND DRAINAGE DISTRICTS AND MUNICIPALITIES WHICH ARE INACTIVE
  - ..... PROPOSED PROJECT LEVELS
