State of California
THE RESOURCES AGENCY
Department of Water Resources

BULLETIN No. 149-65

PROJECT LEVEE
MAINTENANCE AND REPAIR
1965 INSPECTION REPORT

MAY 1966

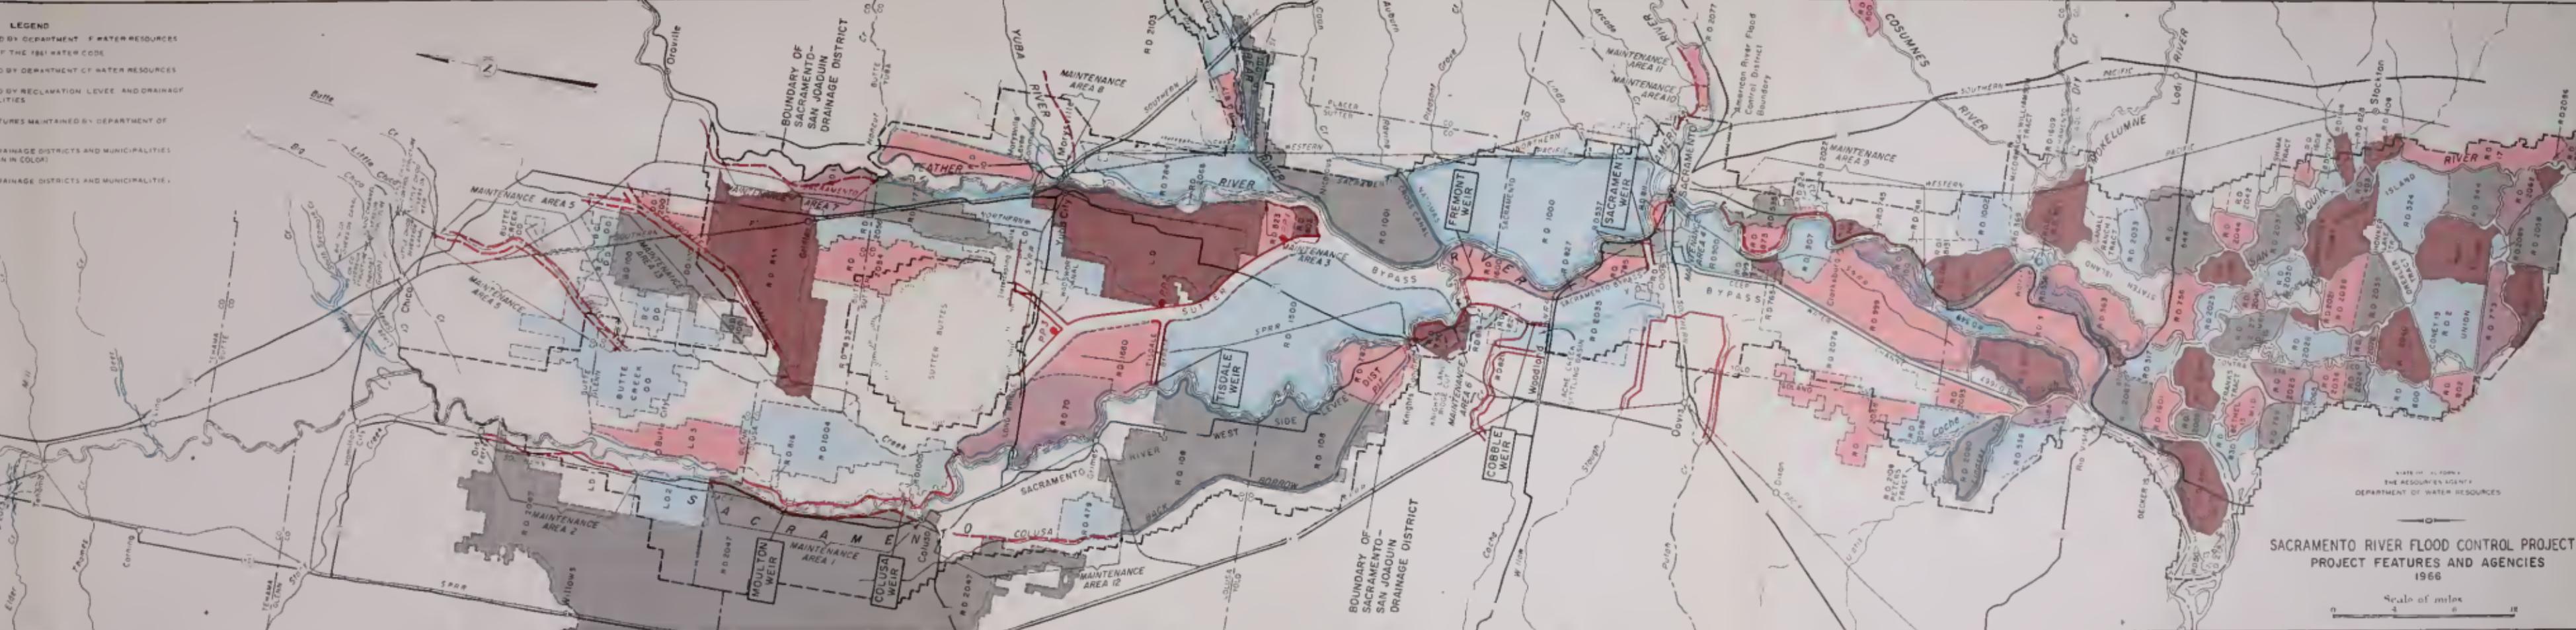
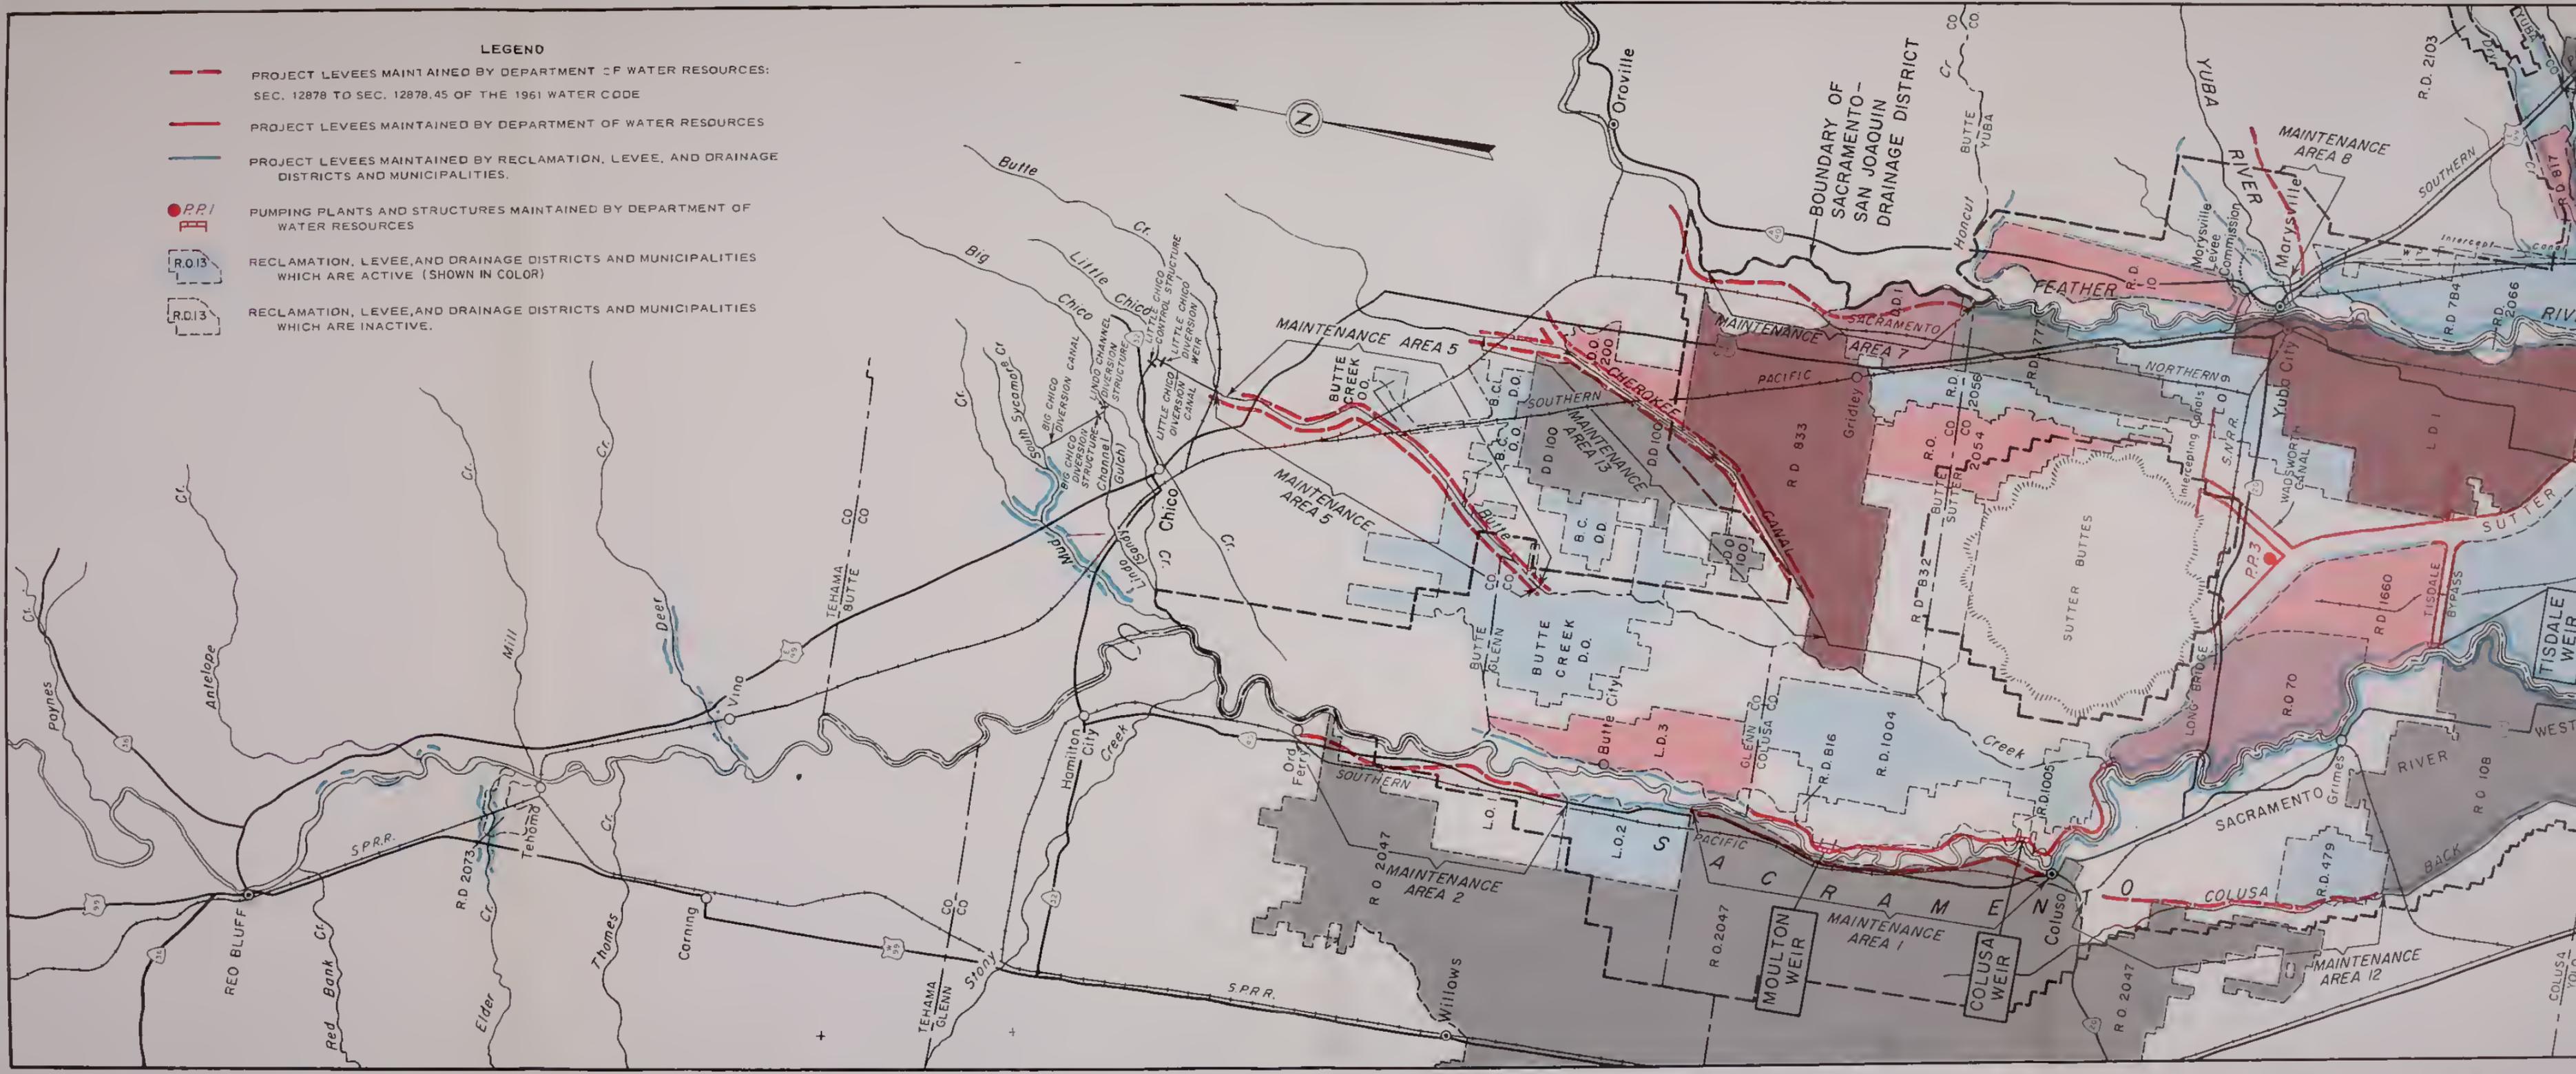
**SACRAMENTO RIVER FLOOD CONTROL PROJECT
 PROJECT FEATURES AND AGENCIES
 1966**

SACRAMENTO RIVER FLOOD CONTROL PROJECT PROJECT FEATURES AND AGENCIES 1966

RECLAMATION, LEVEE, AND DRAINAGE DISTRICTS AND MUNICIPALITIES WHICH ARE INACTIVE.

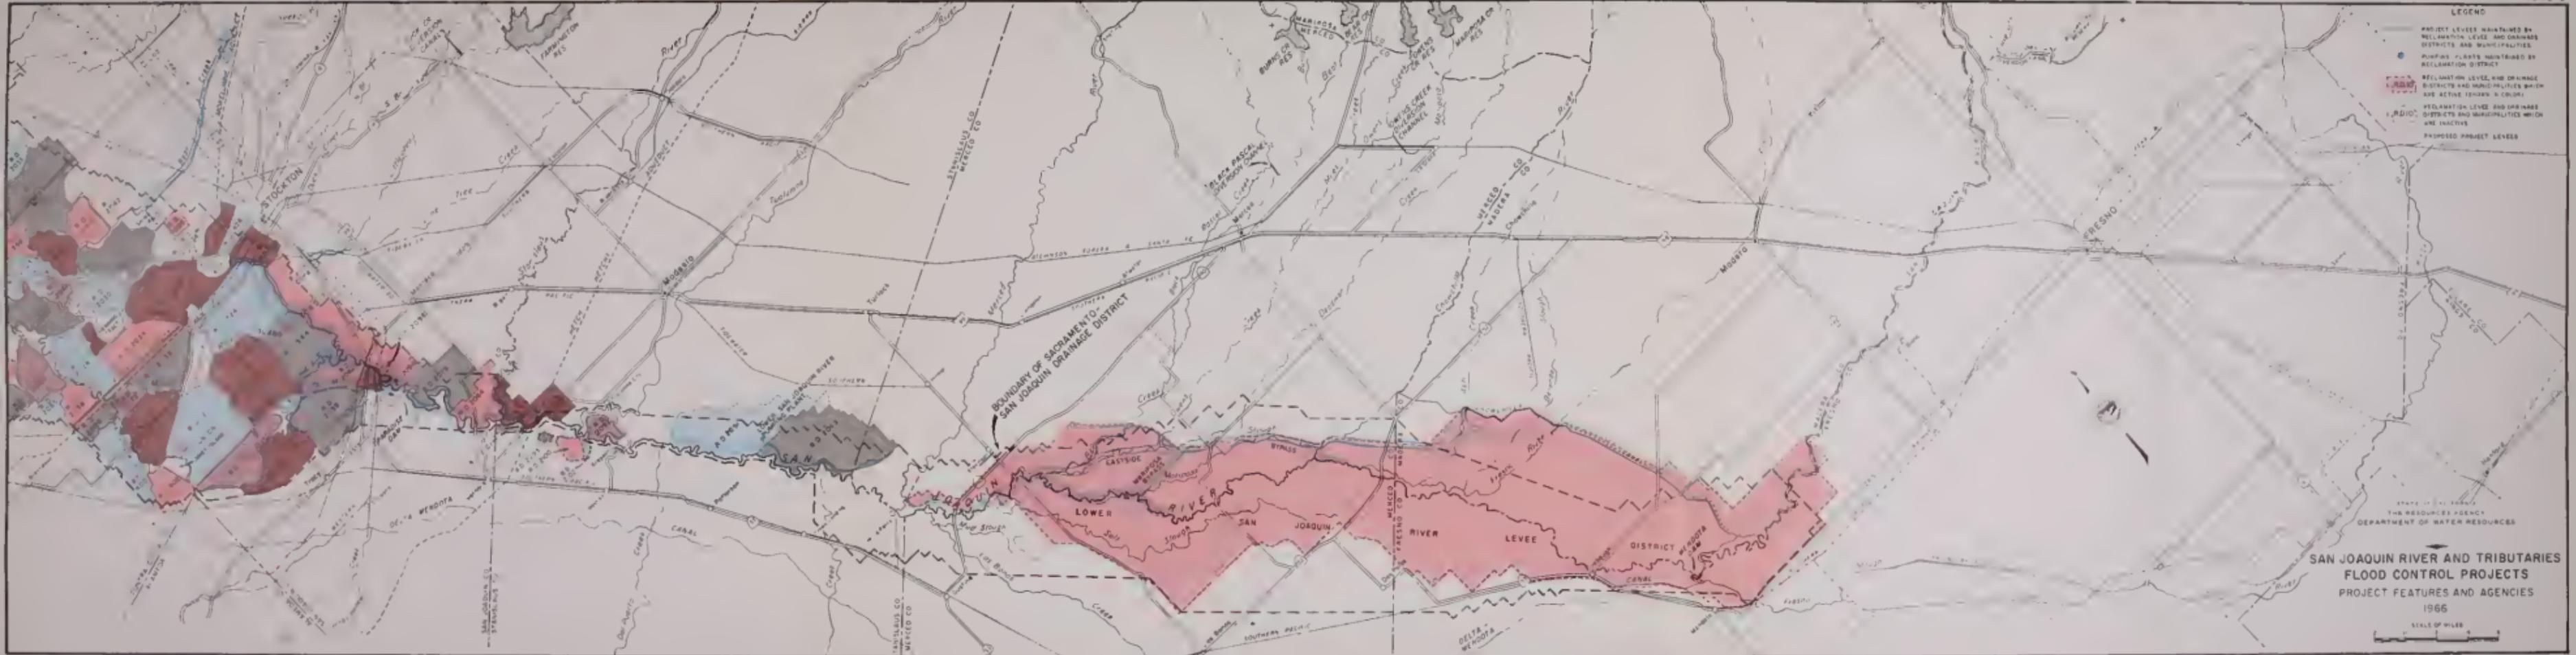
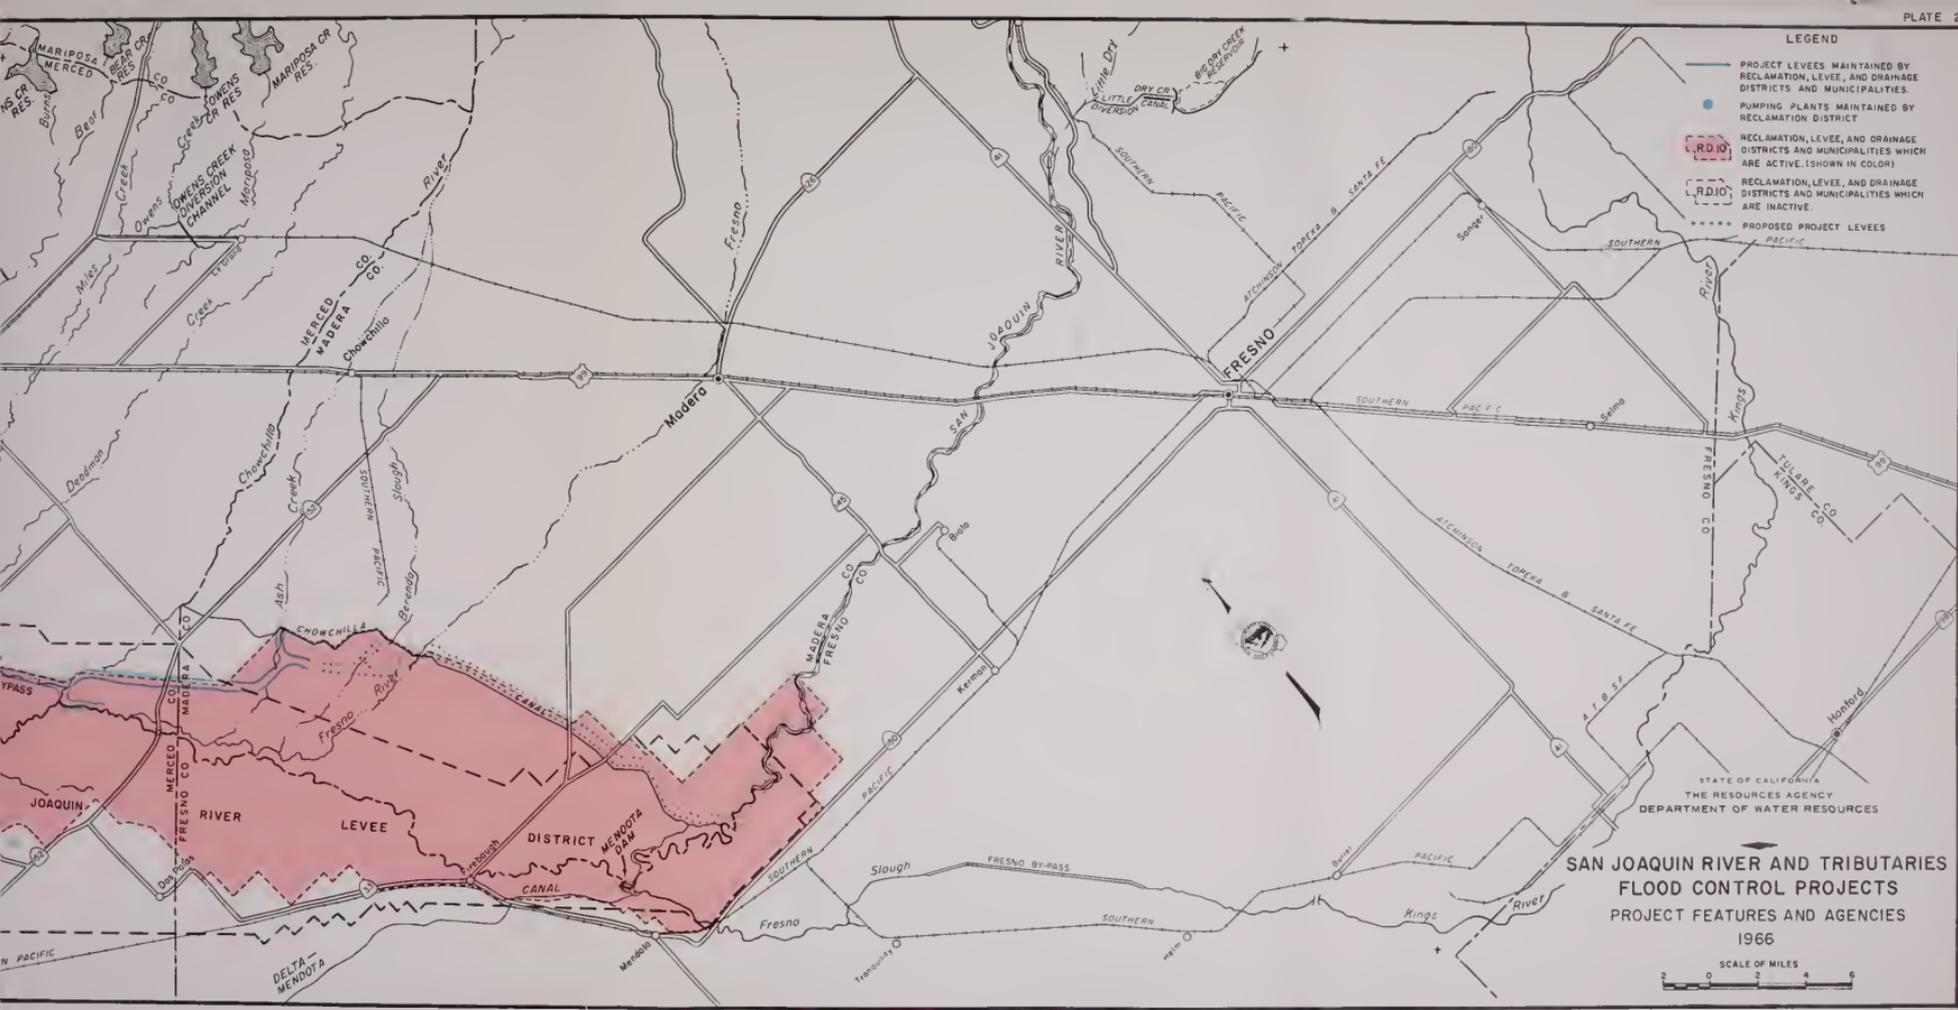
**SAN JOAQUIN RIVER AND TRIBUTARIES
FLOOD CONTROL PROJECTS
PROJECT FEATURES AND AGENCIES**

- PROJECT LEVEES MAINTAINED BY RECLAMATION LEVEE AND DRAINAGE DISTRICTS AND MUNICIPALITIES
- PUMP PLANTS MAINTAINED BY RECLAMATION DISTRICT
- RECLAMATION LEVEE AND DRAINAGE DISTRICTS AND MUNICIPALITIES WHICH ARE ACTIVE (SHOWN IN COLOR)
- RECLAMATION LEVEE AND DRAINAGE DISTRICTS AND MUNICIPALITIES WHICH ARE INACTIVE
- PROPOSED PROJECT LEVEES
