BULLETIN NO. 167

# PILOT LEVEE MAINTENANCE STUDY

Sacramento-San Joaquin Delta

JUNE 1967

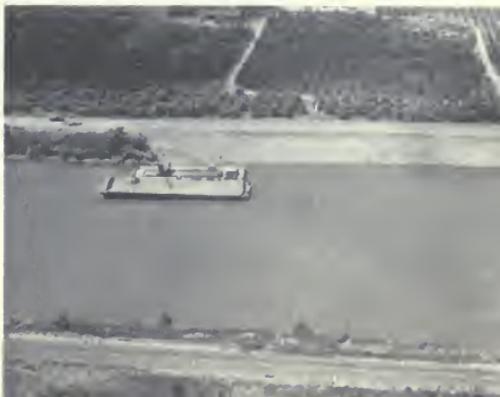
*Barge placing rip-rap on newly reconstructed levee for flood control*

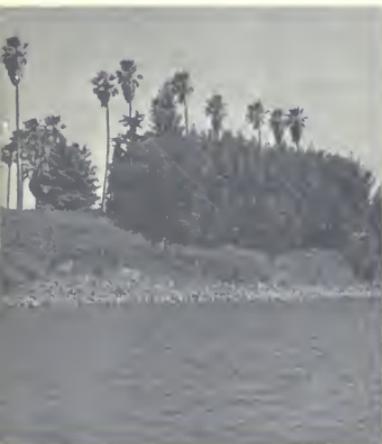
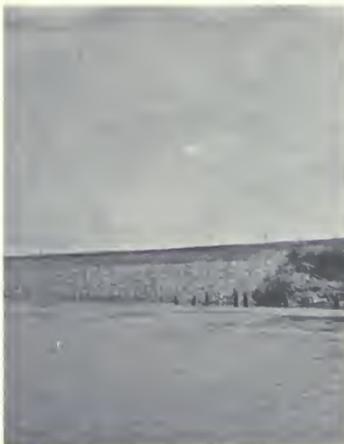
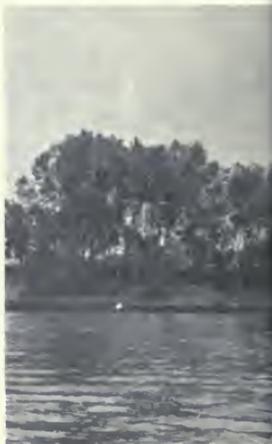
Examples of the wide variation in levee appearance

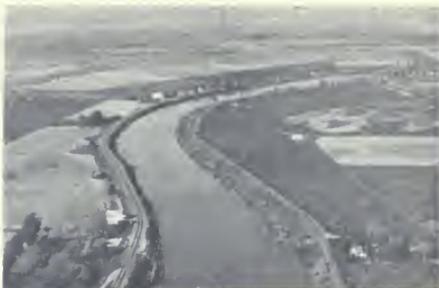
Ryde test site

This site, near the town of Ryde on the left bank of the Sacramento River, is owned and maintained by local interests.

The levee and berm in this area were recently reconstructed and have little undergrowth and no large trees. A 3,000-foot section of levee and berm was used to conduct the various tests.

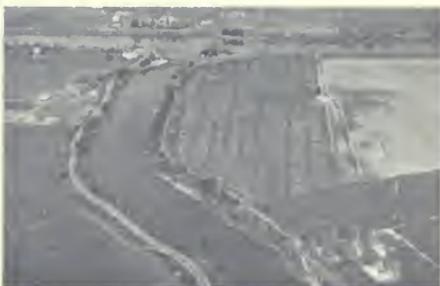
Steamboat Slough test site

This test site lies along both banks of Steamboat Slough, from its junction with the Sacramento River to a point approximately 3,000 feet downstream. There are no berms on either bank; however, dense undergrowth and a large number of trees cover the levee slopes.

The area is accessible by water and road and is used extensively for recreation. There are two small sandy beaches on the left bank and one on the right bank. This section of the slough is extremely popular with cruiser boaters, who tie up for extended periods of time.

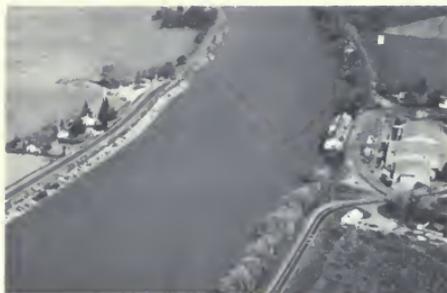
The Hood test site is on the right bank of the Sacramento River opposite the town of Hood. A 400-foot section of levee, recently reconstructed and covered with quarry rock, was used as the test area.

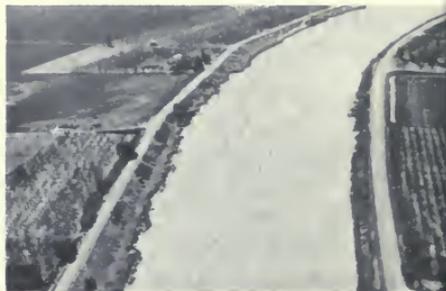
The Isleton test site is on the left bank of the Sacramento River about 2 miles upstream from the town of Isleton.

A section of levee and berm approximately 1 mile long was used to conduct the various tests. This site exhibited a varying range of hydraulic, levee, and vegetative conditions and was selected for the final phase of field testing.

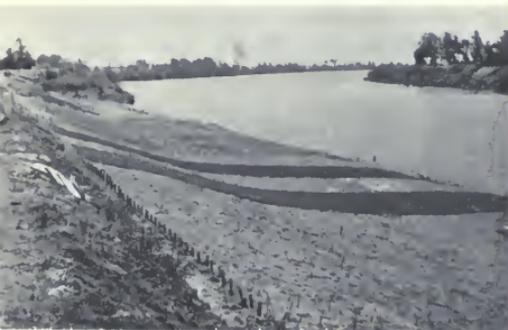
Ground cover adaptation plots at the Ryde test site

Plantings at the test sites were accomplished in the spring and fall of 1964 and in the spring of 1965. Of the 15 species planted under irrigation during the spring seasons, six became well established and grew vigorously. These six were: coastal bermuda, creeping wild-rye, Tifway bermuda sod and stolons, and Tifgreen bermuda sod and stolons. Other species which showed promise for berm and levee slope stabilization were kikuyu grass and matgrass. The remaining species ranged from partial stands to complete failures.

The nine species of fall plantings, which generally grow well in cooler weather, developed good initial stands; however, without water the following year, they failed to develop.

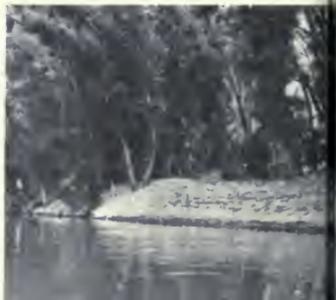
Kikuyu grass  
test plot at  
Garcia Bend

Erosion Control. Two locations on the Garcia Bend test site, each approximately 50 feet by 250 feet, were used to conduct specific tests on vegetative erosion control capability. The plots were cleared and planted with kikuyu grass in July 1963 and irrigated by hand until November 1963.

The purpose of this test was to determine: 1) the effectiveness of the kikuyu grass plantings against erosion, and 2) the ability of the kikuyu grass to establish itself, not only on the berm and slope area, but also in the tidal fluctuation zone. The kikuyu grass and the other plants in the ground cover adaptation test plots also were tested for their ability to withstand inundation and silt deposition.

Test results showed that the kikuyu grass was not able to establish itself in the tidal zone sufficiently to control erosion. However, new ground covers, as well as native grasses, established above the tidal zone did effectively control erosion. It is evident that the protection of levee slopes against erosion at normal water levels must be accomplished by the use of some form of revetment.

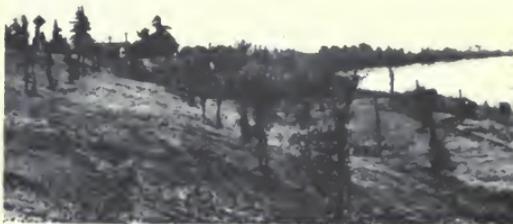
Tree adaptation test at the Ryde test site

Tree Adaptation. In June 1964, a tree adaptation test was started at the Ryde test site. Based on recommendations made by the U.S.D.A. Soil Conservation Service, the following 10 species of 5-year stock trees were selected for

The trees were watered only during the initial year of establishment to test their ability to survive without constant irrigation. In general, the trees on the waterward slope of the levee failed to survive, while those planted on the berm closer to the water adapted very well to the new environment.

On the waterward slope of the levee, the red ironbark and the purple plum demonstrated the greatest ability to survive. The Arizona ash, trident maple, and the beefwood indicated only partial adaptation; all the other trees tested failed to survive.

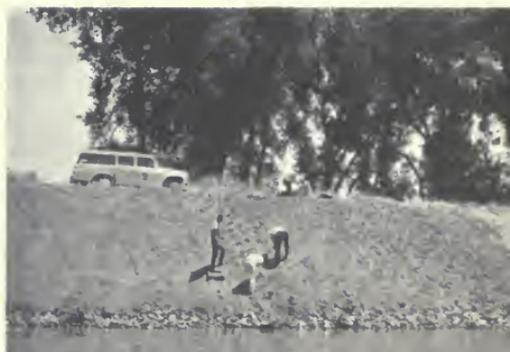
*Experiment on the esthetic treatment of revetment at the Garcia Bend test site*

*Cobblerock revetment  
hand-placed around  
existing trees*

Plantings Over Rip-Rap. At the Garcia Bend test site, a 300-foot section of berm was cleared of all vegetation, resloped to 2:1, and covered with cobble-rock revetment in June 1963. One year later, 250 tons of fill material were spread to a depth of 6 inches over the cobblestone. Three separate bermuda, and creeping wildrye were planted on the fill material to stabilize the soil.

Revetment Around Trees. A test involving the placement of cobblerock around existing trees was conducted on a 200-foot section of berm at the Garcia Bend test site. The area was selectively cleared, resloped to 1-1/2:1, and revetted with 660 tons of 4-inch-minimum cobblerock. Most of the sloping and rocking was done by hand, as the remaining trees prevented the use of equipment normally used for such work.

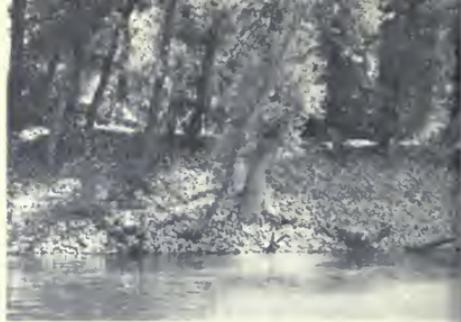
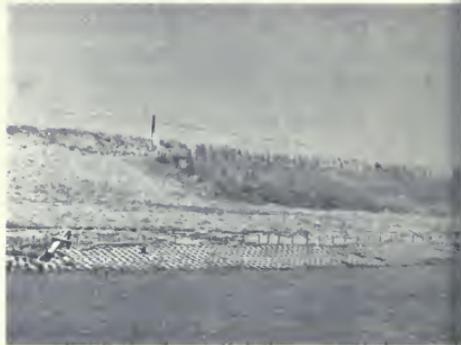
*Installation of specially built concrete block revetment*

Concrete Block Revetment. The final test in the series was conducted at the Ryde test site. This involved the installation of a specially fabricated concrete block revetment. The blocks were 18"x24"x4" and had 3"x6" voids built in. The idea was to install the blocks in a continuous mat and allow the vegetation to propagate through the voids.

Shortly after the blocks were installed, the continuity of the mat was broken by undermining at certain locations. The blocks were not fully effective in controlling erosion in the tidal fluctuation zone. Also, the majority of the plantings failed to propagate through the voids in the tidal zone.
