Appendix E Bay Area and Delta Watersheds outside the FPIP Geographic Scope

Introduction

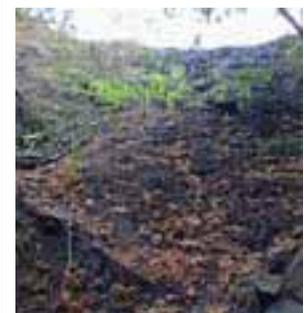
**Photo E-11 York Creek—
dam, downstream face/DWR
photo**

Saint Helena Upper Dam (also referred to as York Creek Dam) is identified as an impediment to fish passage ([Table E-6](#)). The diversion structure downstream was modified in 2004 to provide passage for adult and juvenile steelhead. York Creek Dam, forming Upper Reservoir on York Creek, is a 50-foot-high earthen dam built around the turn of the 19th century ([Photo E-11](#)). The dam blocks steelhead from approximately 2 miles of habitat found upstream. Little is known about the history of the dam other than it was originally built to provide a water source for private landowners. The city of Saint Helena purchased the dam and maintained it for many years to impound water for release downstream to the diversion structure, which conveys water to Lower Reservoir. Lower Reservoir is still used by the city as a source of irrigation water. Since the city has owned York Creek Dam there have been four silt discharges from the dam into York Creek in 1965, 1973, 1975, and 1992. After the 1992 discharge, DFG filed a complaint with the Napa County District Attorney. As a result, the city agreed to a settlement in 1993 that mandated the removal of York Creek Dam. Since 1993, Upper Reservoir has not been used by the city as a water source, but the reservoir has been dredged by the city and it functions as a detention basin.

Major modifications of the diversion structure were completed in 2004. The modifications involved removal of the concrete masonry diversion structure, creation of cascading steps with resting pools of sufficient depth for steelhead, bank stabilization, and native plant generation. A proposed infiltration gallery designed to prevent juvenile salmonid entrainment may be placed in the streambed after a one- or two-year trial period without any water diversion structure. Approximately 2.5 miles of high-quality habitat is now accessible.
